SERVICE BULLETIN

APPLICABILITY: 2012 and 13MY Impreza and XV Crosstrek™ **NUMBER:** 11-125-12
 Models Equipped With FB Engine **DATE:** 12/03/12

SUBJECT: DTCs P0365, P0366, P0390 and P0391
 Misfire DTCs P0301, P0302, P0303 and P0304

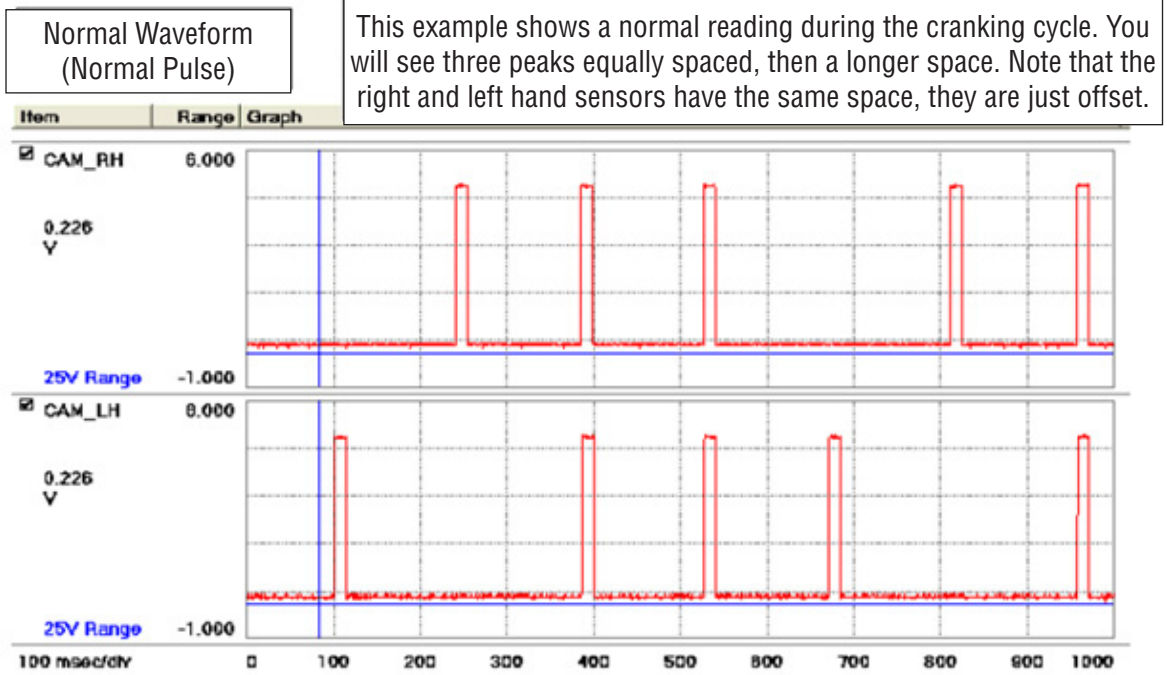
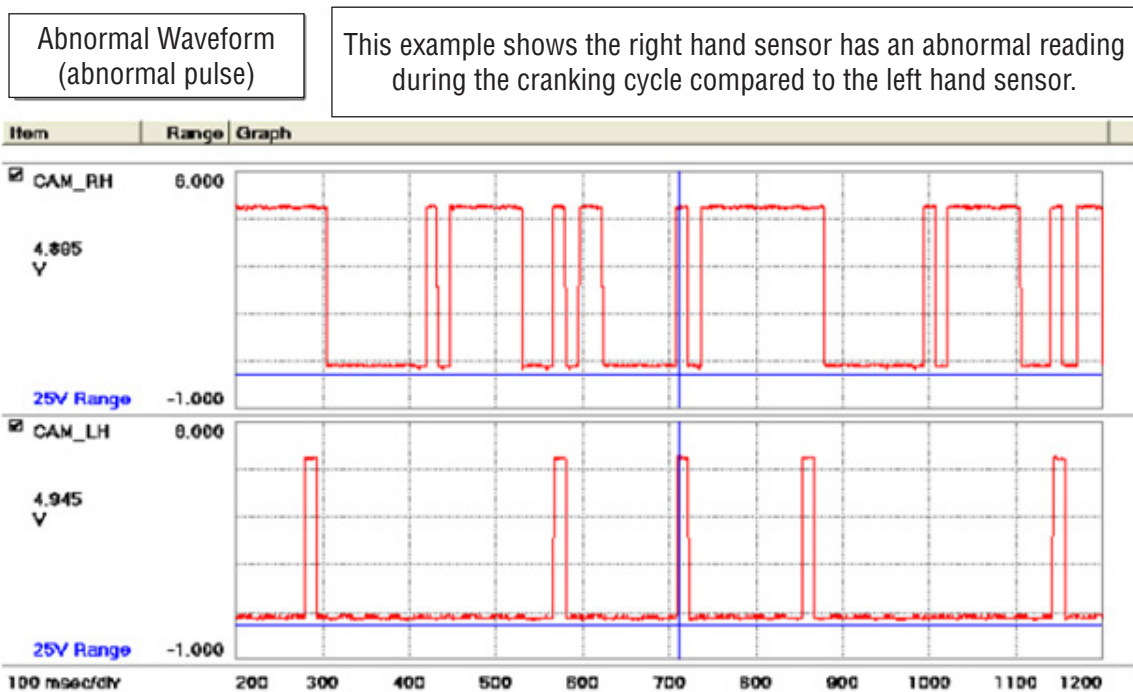
The following illustrations show a normal oscilloscope pattern followed by an abnormal pattern.

If an abnormal pattern is verified similar to those shown in the illustration above, measure the clearance between the end of the exhaust camshaft position sensor and the sensor plate using the following procedure.

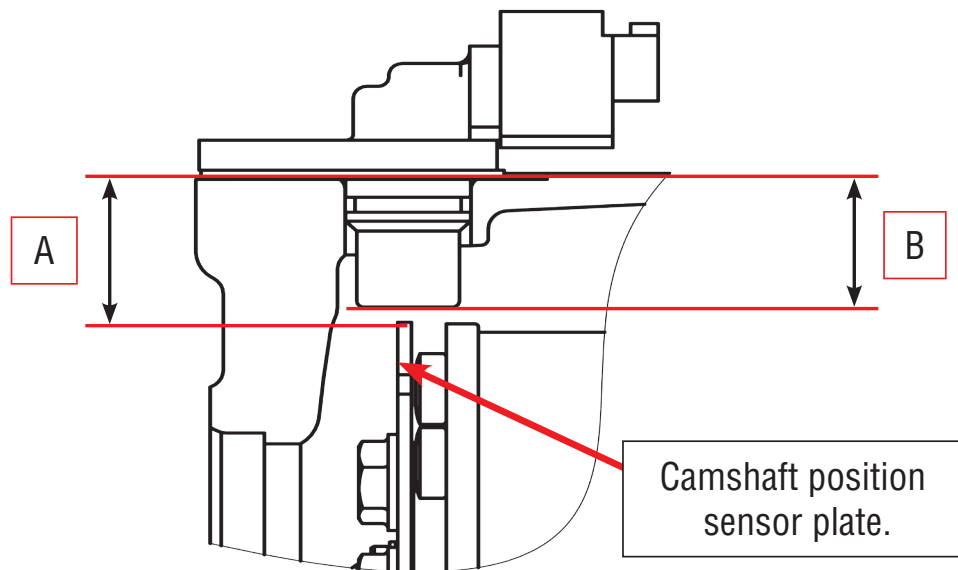
Measurements

A = Top of timing chain cover to camshaft position sensor plate

B = Camshaft position sensor mating surface to the bottom of the sensor

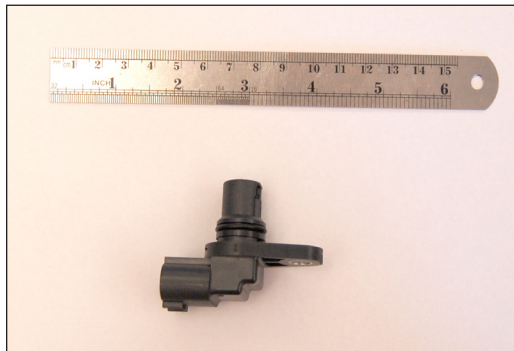
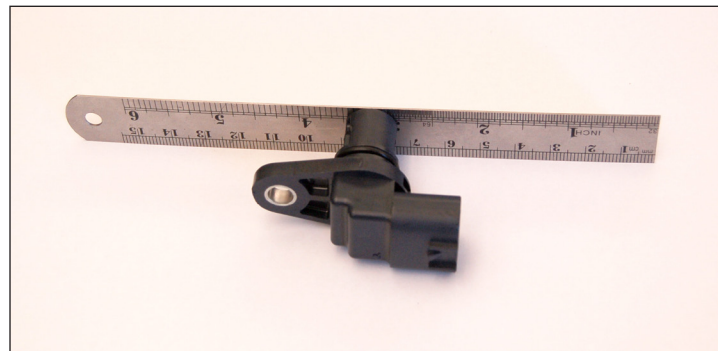
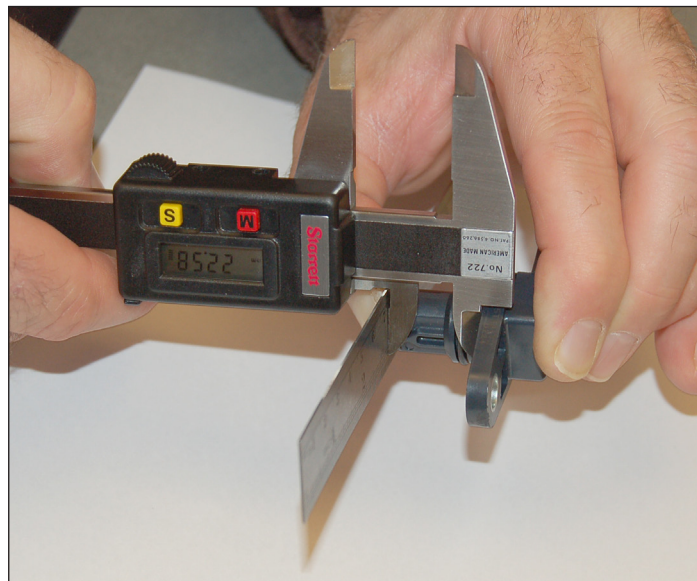
When taking measurement “B”, use a flat steel ruler or equivalent.

Measure the camshaft position sensor mating surface (the area that sits flush on the timing chain cover) to the bottom of the sensor and record measurement.
