**SERVICE BULLETIN**

**APPLICABILITY:** 2015-16MY Outback

**NUMBER:** 15-192-16

**SUBJECT:** Loose / Gapping Accessory Front Wheel Arch Moldings

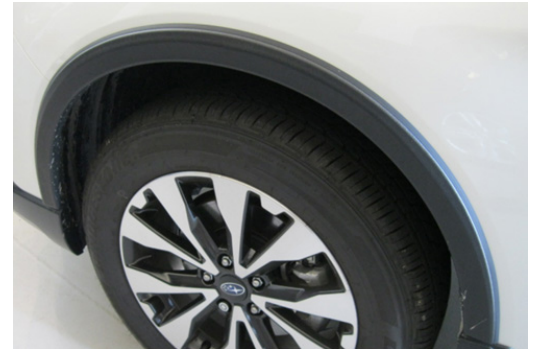
This bulletin provides a service procedure to address customer concerns of loose or gapping accessory front wheel arch molding(s) (E201SAL000 Molding Kit). There are 2 retaining clips on each molding which have been improved to enhance retention of the molding to the fender lip thereby eliminating any gap between the molding and the body. This bulletin applies to the **FRONT** wheel arch moldings only.

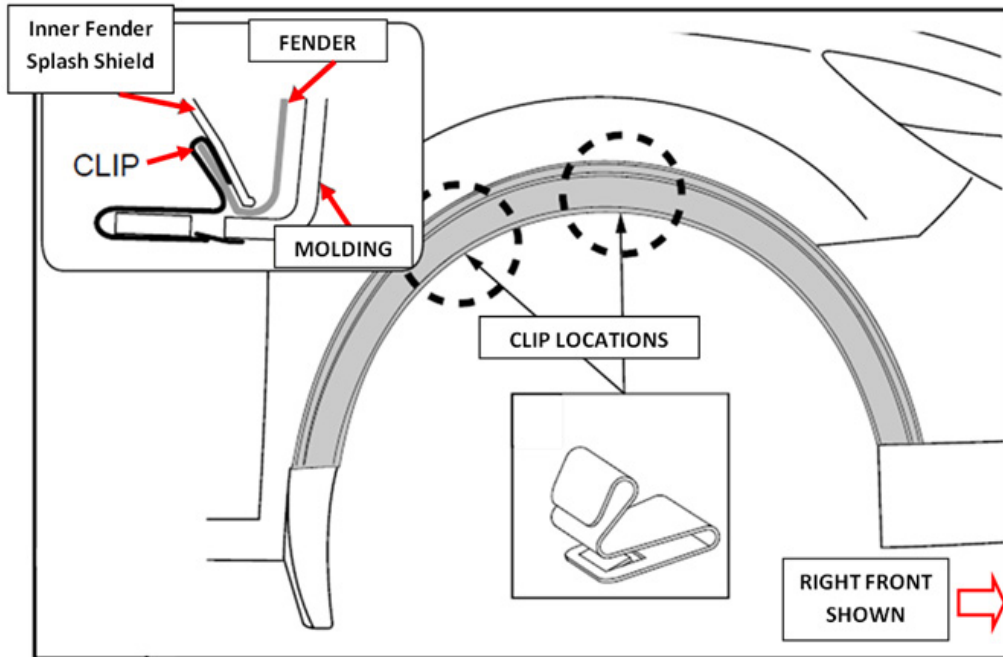
Four new replacement clips come as a kit by ordering p. n. **SOA930H100**. The cross-section illustration below shows the retaining clip locations and how the clip attaches the inner lip portion of the molding to the fender's inner lip.

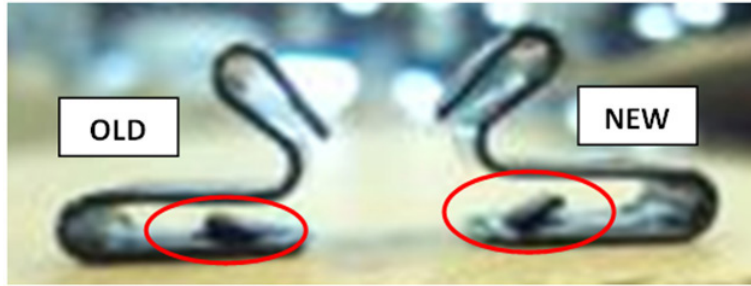
The depth and angle of the lock “tang” portion (circled) of the clip have been changed to provide better retention. The photo shows a comparison between the old and new -style retaining clips.

**IMPORTANT:** If either front wheel arch molding is loose or gapping or if any of the 4 retaining clips are found to be loose or missing, **ALL 4** of the clips must be replaced. The original clips will be destroyed when removed therefore, never attempt to “adjust” them back into shape and reuse them.
