**TECHNICAL SERVICE BULLETIN****23-2115****Lack Of Heat Or Cooling From The Cabin Vents, Temperature Door Or Door Actuator Binding/Inoperative - DTC B1081:07**

14 April 2023

Ford
2015-2020 F-150
2017-2022 F-Super Duty

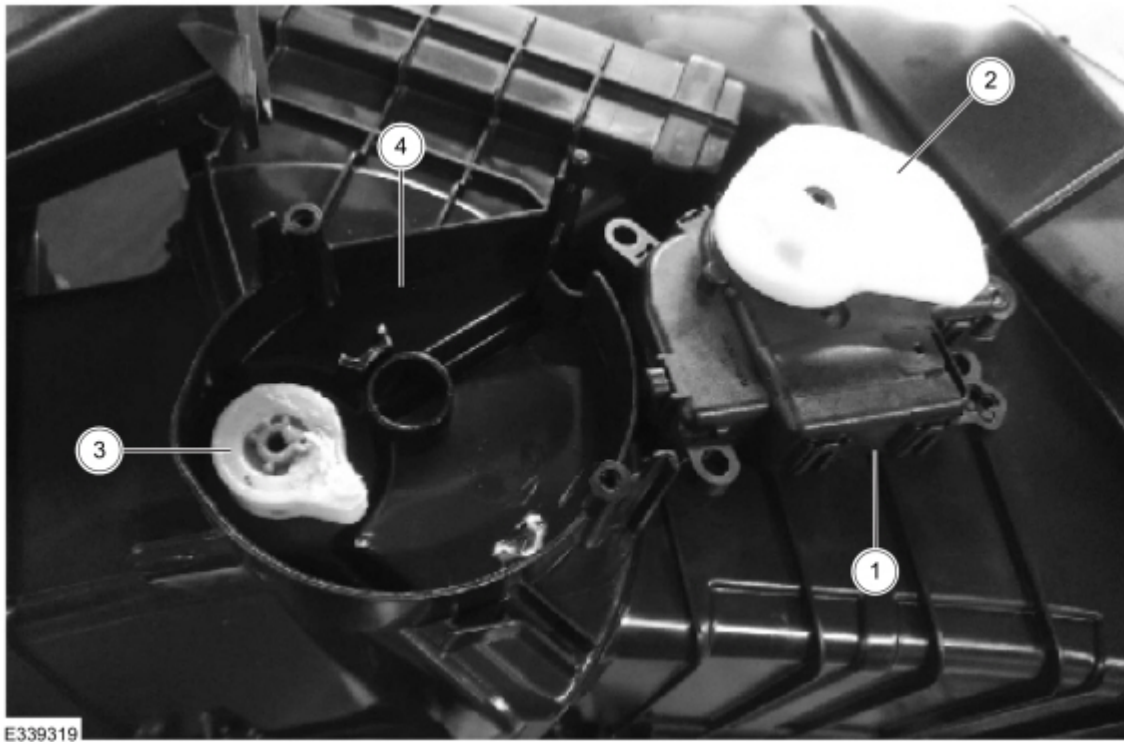
Figure 1

NOTE: Do not remove the cam follower from the climate control housing blend door. It is critical to be gentle when cleaning the cam follower as damaging the temperature blend door shaft will require replacement of the climate control housing. (Figure 1)

- Remove the driver side temperature blend door actuator.
- Gently wipe the driver side temperature blend door actuator, cam, and cam follower attached to the climate control housing blend door to remove any debris and existing lubricant.
