SERVICE BULLETIN

NUMBER: 15-162-13R

SUBJECT: Service Procedure for Replacement of the Bluetooth
 Microphone for Kenwood Audio / Navigation Systems

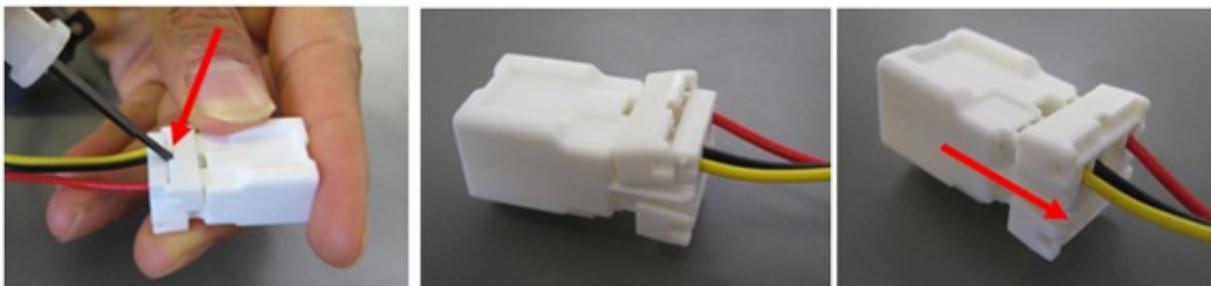
Before unlock

After unlock

Holder slid backward

- Unlock the holder of the new microphone's harness connector. Insert a small flat-blade screwdriver under the indentation of the holder then lift up gently to unlock it as shown in the photos below. Once unlocked, slide the holder backward.
