TECHNICAL SERVICE BULLETIN

Illuminated ABS Indicator, Engine Will Not Turn Off And/Or Various Electrical Symptoms

23-2133

Ford 2020-2022 F-Super Duty

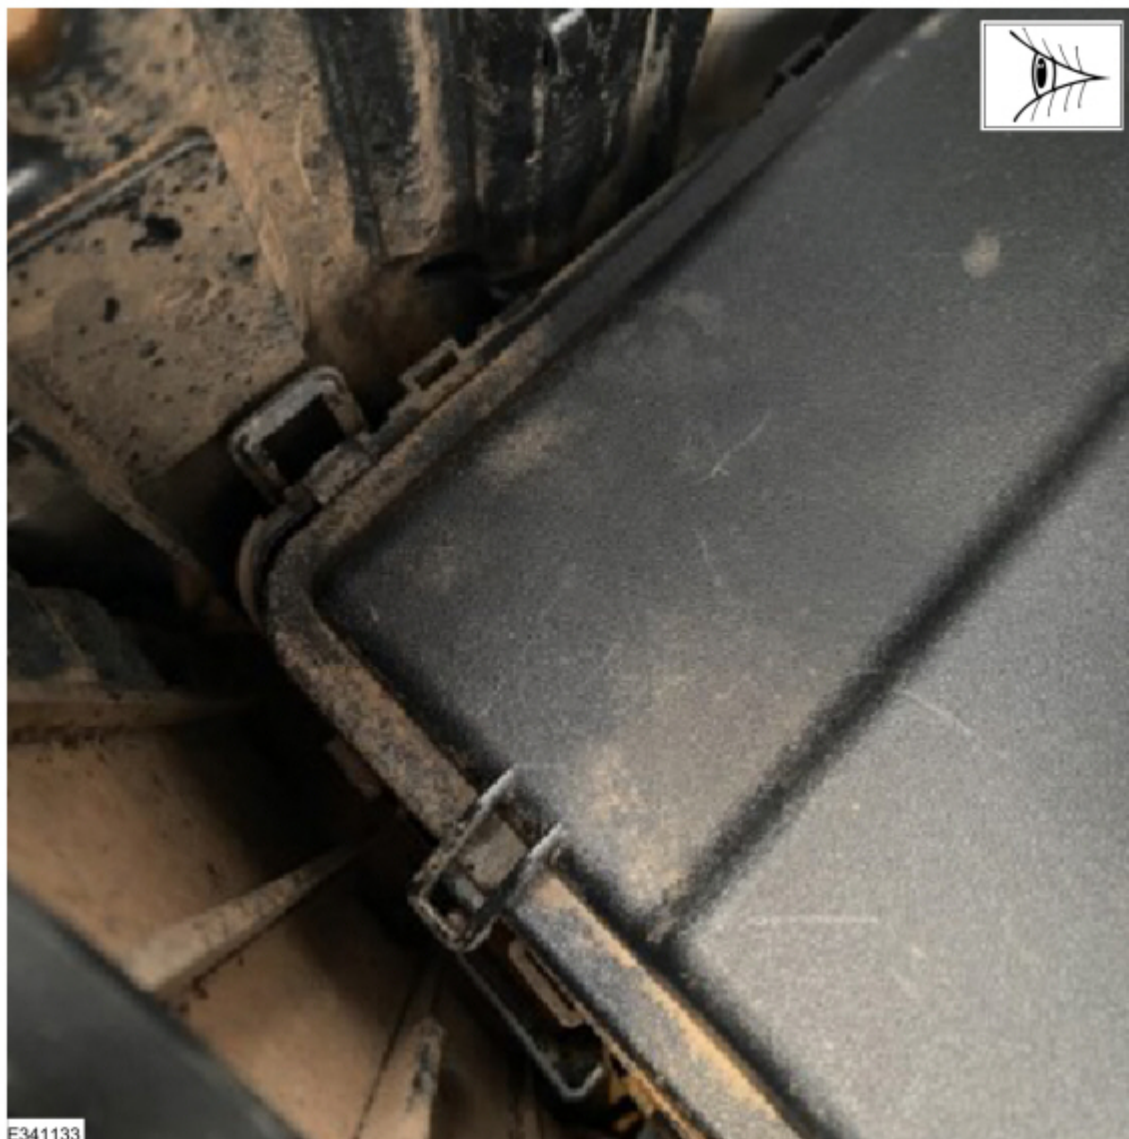
1. Visually inspect the BJB for signs of water/moisture intrusion. (Figure 1-2) Are there signs of water/moisture intrusion into the BJB and/or broken cover tabs/locking fingers?

Figure 1 - Example of moisture intrusion with BJB cover on

2. Replace the BJB assembly and cover.

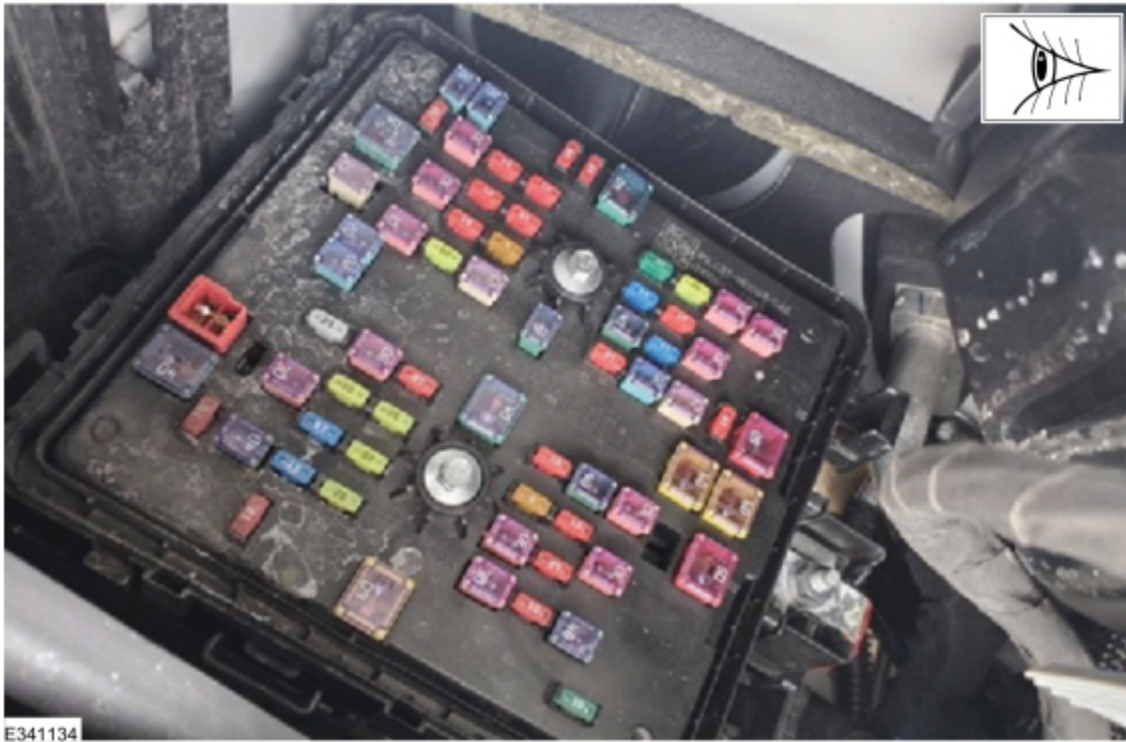
Figure 2 - Example of moisture intrusion with BJB cover off

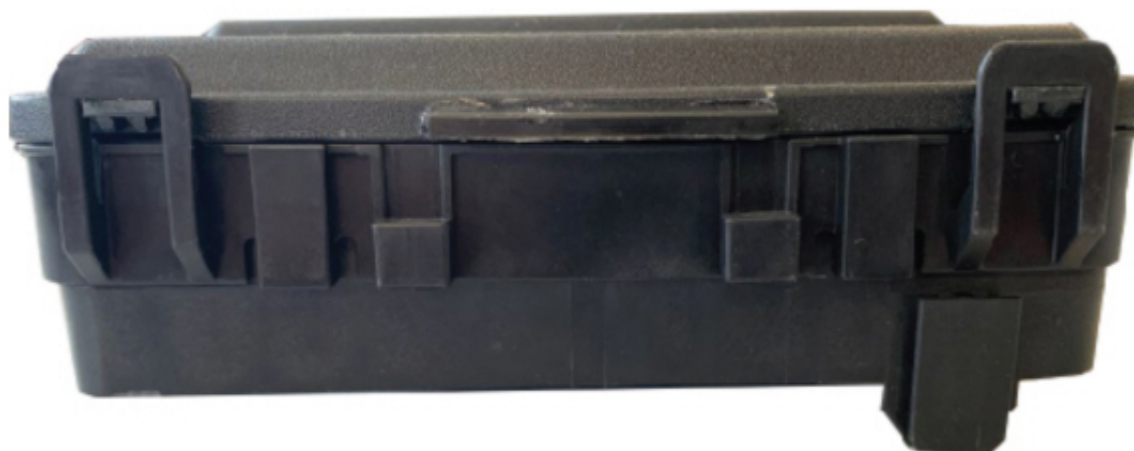
E341135

Figure 3 - Correct cover installation

- (9). Install the new BJB cover making sure the cover tabs/locking fingers are installed correctly. (Figures 3-6)
- (10). Install the battery tray and battery back into the vehicle. Refer to WSM, Section 414-01.

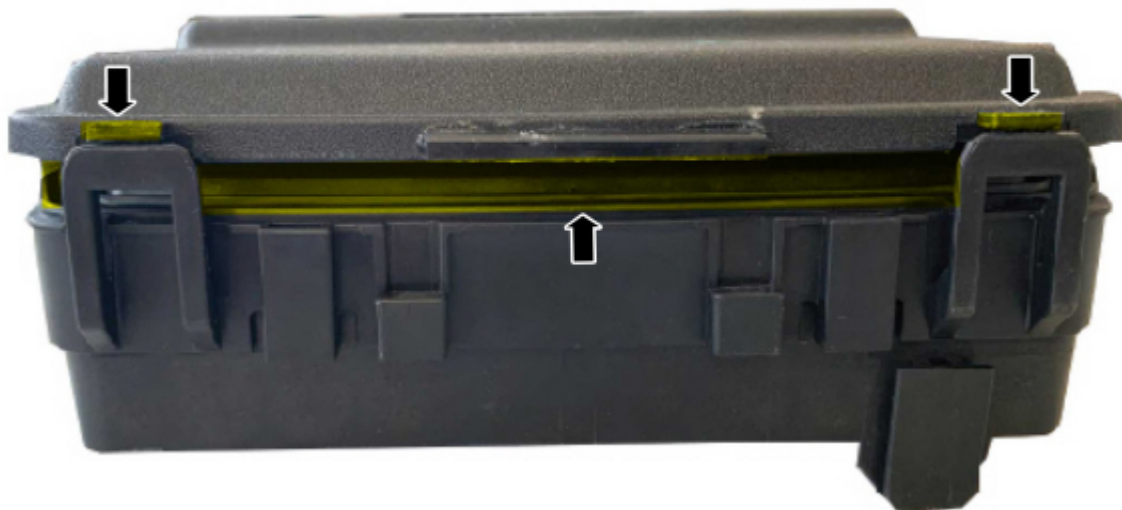
E341136

Figure 4 - Incorrect cover installation

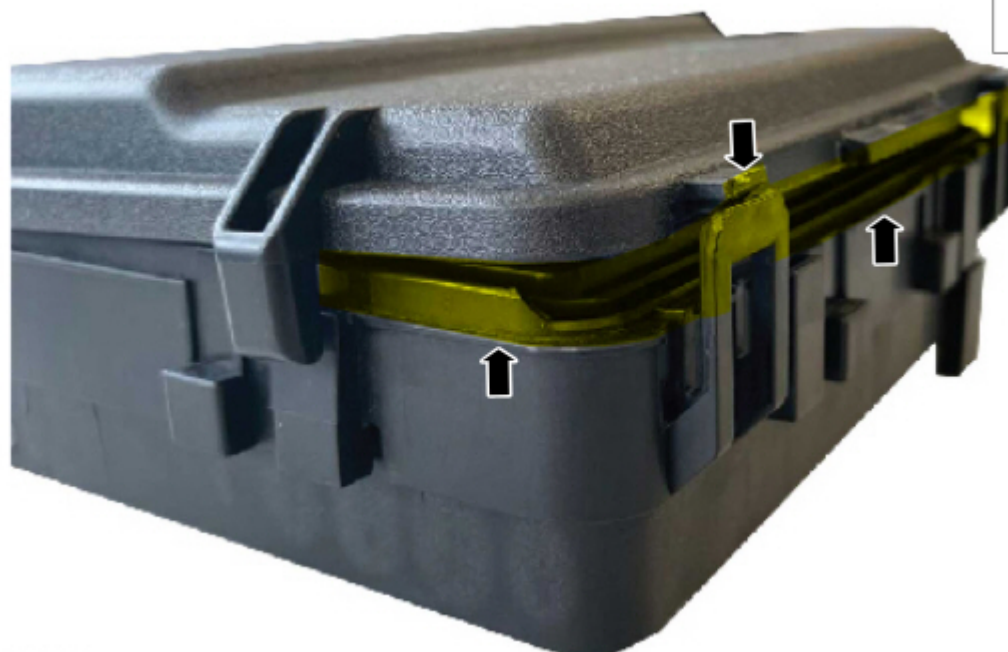
E341138

Figure 6 - Incorrect cover installation
