SERVICE BULLETIN

APPLICABILITY: Legacy and Outback 2000-2009MY w/ 5MT
 Forester 1999MY and Later w/ 5MT
 Impreza (Including WRX) 1999MY and Later w/ 5MT

NUMBER: 03-70-12R
DATE: 12/13/12
REVISED: 01/03/13

SUBJECT: Repair Procedure for High-Pitched Sound from Extension Housing Area Using Latest Generation Production Parts

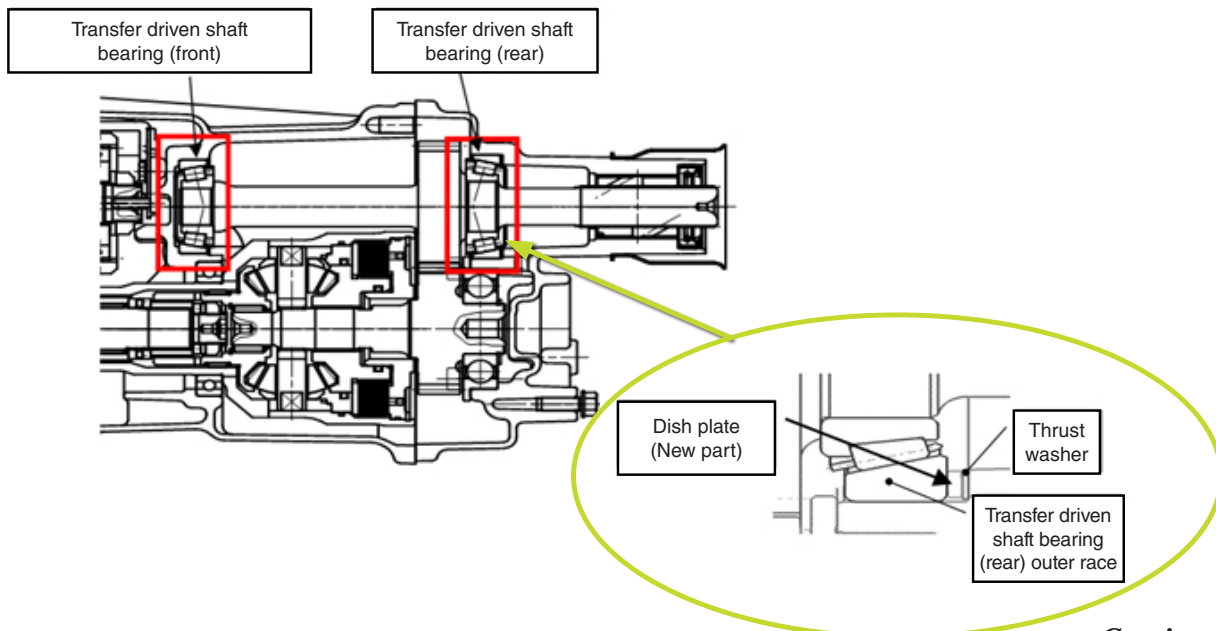
In cold temperatures, thermal contraction causes shrinking of the transmission case. In high temperatures, expansion of the case occurs. These temperature changes affect the amount of pre-load on the transfer driven shaft bearings. In some rare cases, when preload is very near the limit of specification combined with unusual driving conditions, this thermally-induced pre-load change may cause damage to the bearings and result in the sound heard by the customer.

A change has been made to the extension case and a new “Dish Plate” added. The machining depth of the extension case has been increased to accommodate the new dish plate. When used along with a selective thrust washer, the spring tension of the dish plate helps to maintain a consistent amount of pre-load on these bearings throughout varying temperature conditions.
