SERVICE BULLETIN

APPLICABILITY: 2013 Legacy & Outback Models with 2.5L
 FB Engines

NUMBER: 02-143-13R

SUBJECT: Surface Treatment Change To Oil Control
 Piston Rings

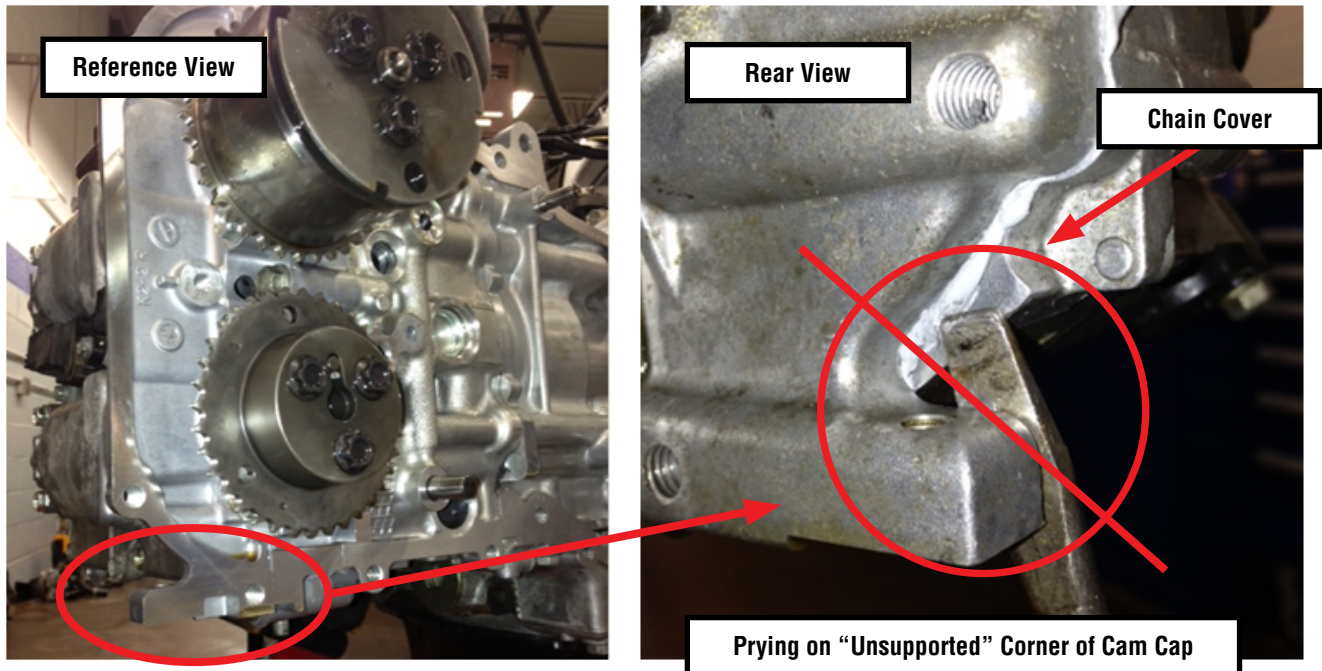
- **IMPORTANT:** After all 32 bolts securing the chain cover are removed, be **VERY** careful where you pry and what you pry on to break the silicone sealant bond. The photos below show an example of where NOT to pry. In this case, the cam cap became cracked requiring a complete cam carrier replacement. Patience is the key!
