## SERVICE BULLETIN

**APPLICABILITY:** 2013-14MY Legacy and Outback Models  
 with 2.5L FB Engines  
 2011-14MY Forester Models with 2.5L FB Engines  
 2015 MY Forester (Manual Transmissions Only)  
 with 2.5L FB Engines  
 2012-13 MY Impreza and XV Crosstrek Models  
 with 2.0 FB Engines  
 2014-15 MY Impreza and XV Crosstrek Models  
 (Manual Transmissions Only) with 2.0 FB Engines

**NUMBER:** 02-157-14R

**SUBJECT:** Surface Treatment Change To Oil Control  
 Piston Rings

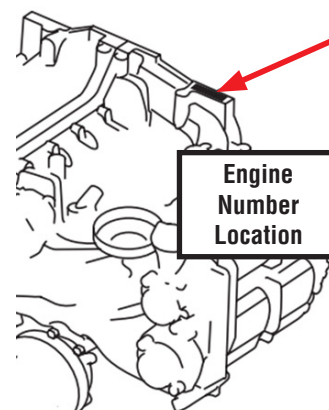
**\* NOTE:** When determining the engine number, use the **LAST 8** characters of the number stamped into the boss on top of the block adjacent to the starter and shown in the illustration. The engine number range for the FA1 assembly line is 800000 to 930025 and the FB2 range is 000000 to 652640.

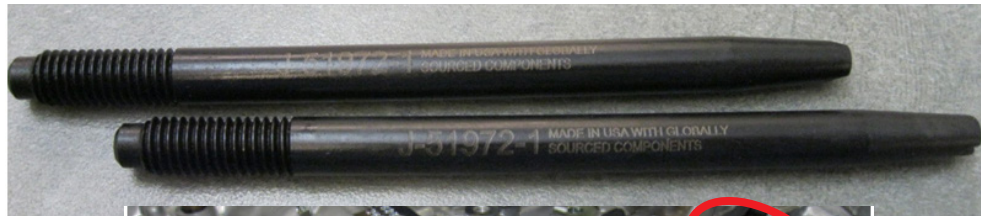
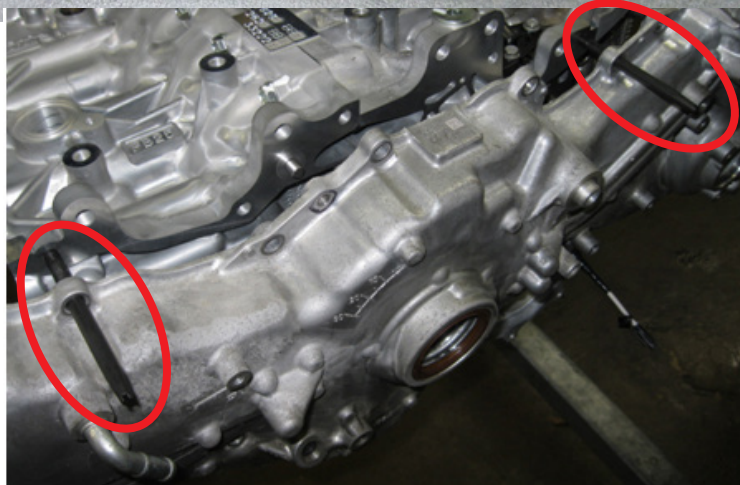
- **IMPORTANT:** When re-installing the front cover assembly, be very careful to not allow it to contact any of the timing sprockets. If contact does occur, it will most likely be with the exhaust sprockets and it is almost a guarantee the fresh silicone sealer beads applied to the cover will be disturbed. To minimize the possibility of this happening, alignment pins as shown in the photos below have been developed to “guide” the cover into its proper position without disturbing the fresh sealer. The Subaru Special Tool number for the alignment pin kit is J-51972. Each kit includes 2 pins.

- If alignment pins are not used and the sealer gets disturbed during the cover installation, unless properly addressed, the affected area(s) will most likely be the source of an oil leak after reassembly. Don't hesitate to use a helper for the cover installation to prevent this from happening.
