SERVICE BULLETIN

APPLICABILITY: 2013MY Legacy and Outback with Subaru STARLINK™ / Aha™ with Fujitsu-Ten (F10) Audio /Navigation System

NUMBER: 15-169-13
DATE: 01/02/14

SUBJECT: Customer Satisfaction - Navigation SD Card Update Program

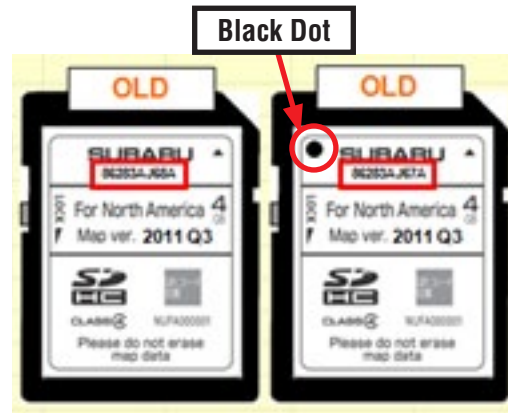
IMPORTANT: The old SD card must be one of the two shown in the illustration below. If it is not, do not proceed further until it can be confirmed the audio / navigation unit is applicable for the reprogram.

The part number on the old SD card must be 86283AJ68A or 86283AJ67A (w/ black dot).

- The 86283AJ67A (with the black dot) indicates the vehicle is a 2013MY Legacy or Outback that received an Aha upgrade / exchange unit.
- The 86283AJ68A is used from the mid-2013MY running production change when Aha was added.
- A 86283AJ67A **WITHOUT** a black dot is **NOT** eligible for this update as the audio / navigation unit used with that card is not Aha-equipped and therefore will not support the specific software provided in the update referenced in this bulletin.
