SERVICE BULLETIN

APPLICABILITY: 2013MY BRZ

NUMBER: 07-79-13

SUBJECT: Countermeasures for Frozen Power Windows

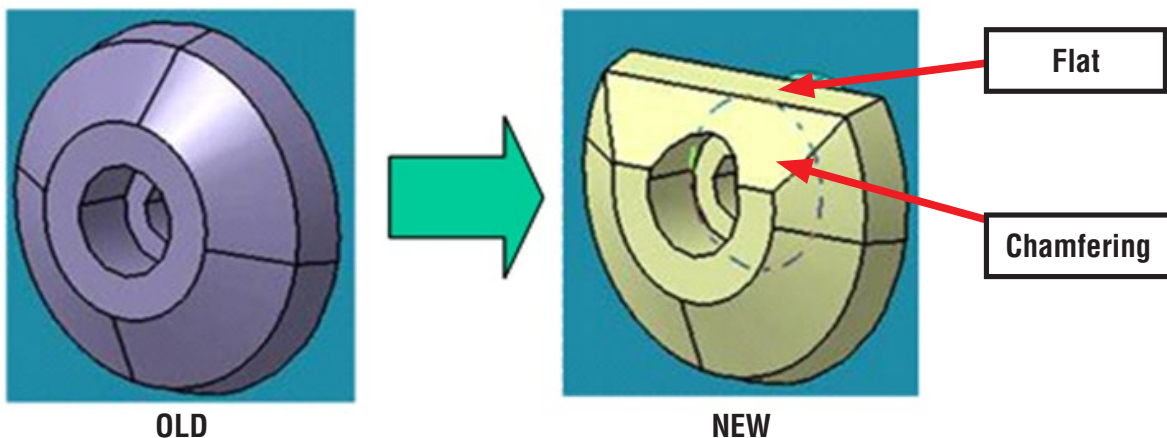
IMPORTANT: The guide door lifters **must** be replaced at the same time the countermeasure power window switches are installed. See the comparison illustration below.
