SERVICE BULLETIN

APPLICABILITY: 2013MY Outback Models

NUMBER: 12-159-13

SUBJECT: Outside Odors Entering the Vehicle Interior

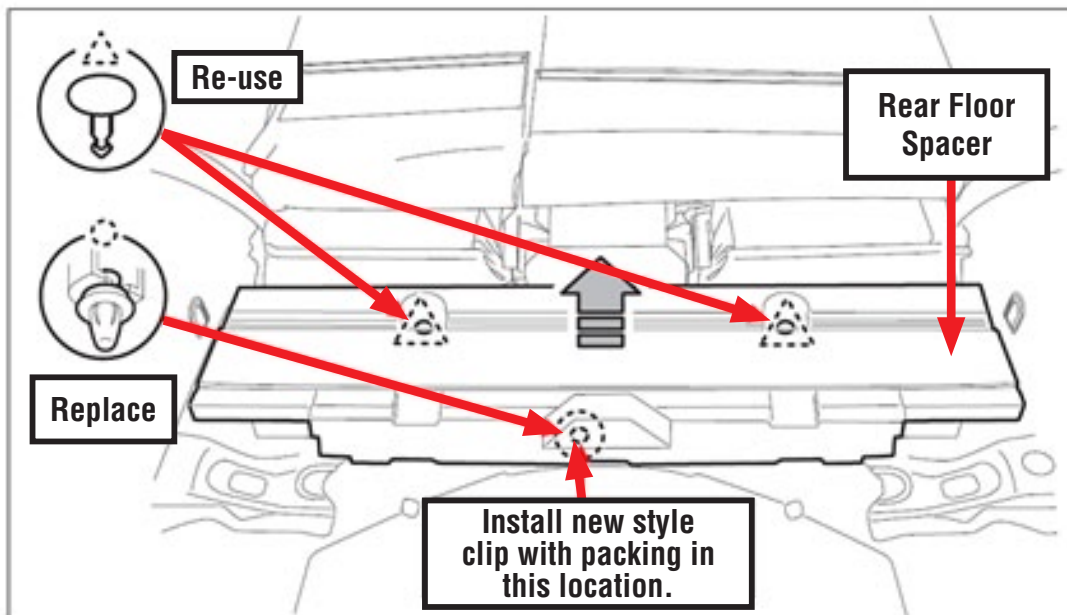
Should you receive a customer concern of outside odors getting inside the vehicle, this bulletin provides a repair procedure to address a possible entry point. Packing material has been added to the center retaining clips for the rear floor spacer and the keyless access / Push Button Start center antenna.

- If the vehicle **is not** equipped with Keyless Access / Push Start, the only repair is to install the revised rear floor spacer retaining clip as shown in the illustration below. Always use the proper trim clip removal tool to avoid damaging the clips and/or the spacer.
