SERVICE BULLETIN

APPLICABILITY: 2010-2011MY Impreza Models
 2010-2011MY WRX and STI Models
 2010-2011MY Forester Models

NUMBER: 15-162-13R

SUBJECT: Service Procedure for Replacement of the Bluetooth Microphone for Kenwood Audio / Navigation Systems

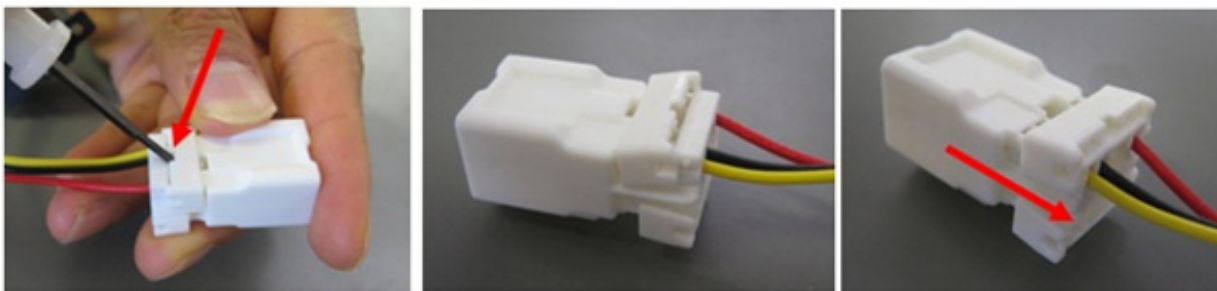
Before unlock

After unlock

Holder slid backward

- Unlock the holder of the new microphone's harness connector. Insert a small flat-blade screwdriver under the indentation of the holder then lift up gently to unlock it as shown in the photos below. Once unlocked, slide the holder backward.

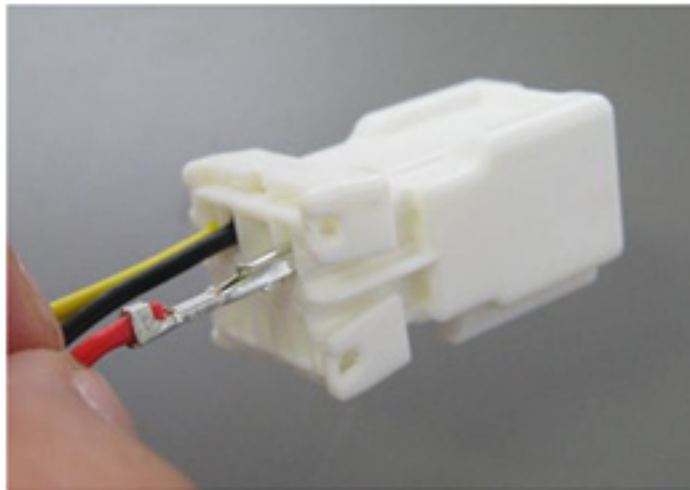
Proper orientation when reinstalling terminals

- Remove all three wires from both the replacement and the vehicle's original microphone harness connectors.
- Reinstall the terminals of the replacement microphone's harness into the vehicle's original microphone harness connector as shown below. The connector is being viewed from the front in these two illustrations.

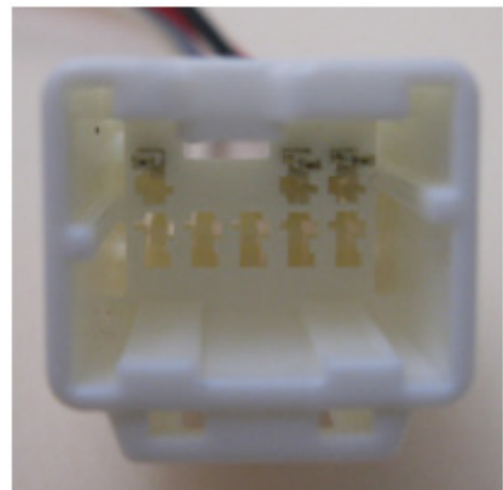
View from front of connector
