TECHNICAL SERVICE BULLETIN

Various Concerns With The Active Exhaust System

23-2132

Ford 2018-2023 Mustang	non-Shelby GT350
----------------------------------	------------------

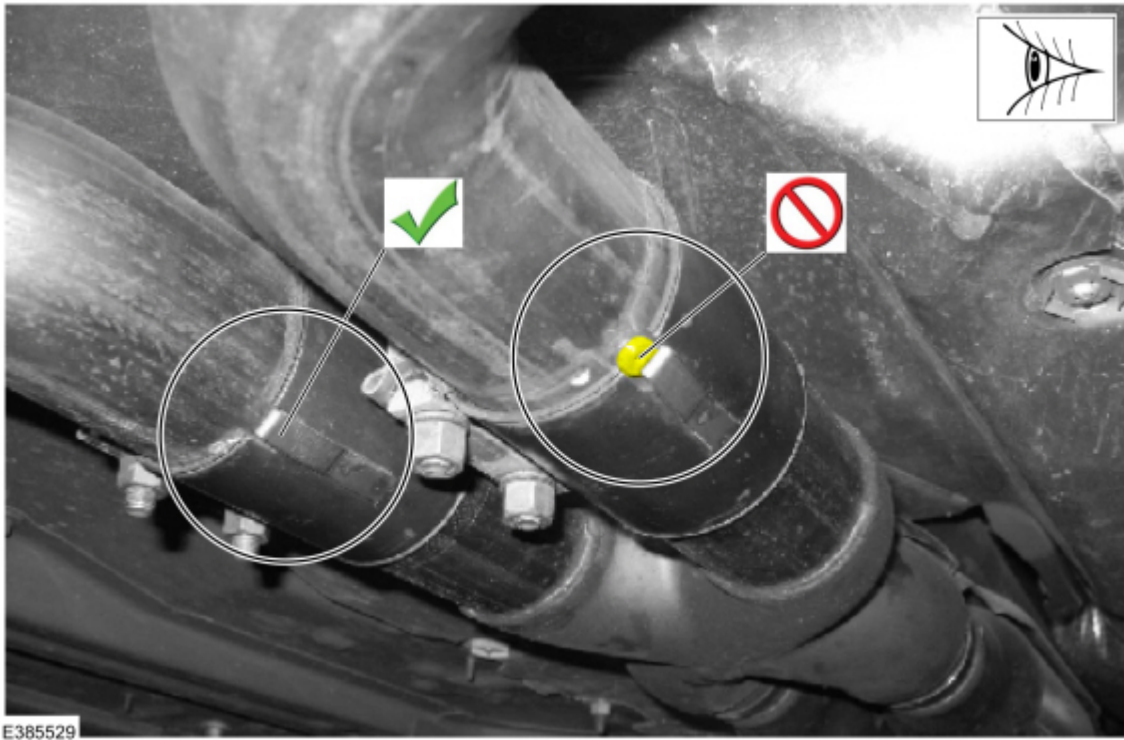
Figure 1 - Exhaust clamp locking tabs.

4. Is the concern still present?
 - (1). Yes – proceed to Step 5.
 - (2). No – repair is complete.
5. Inspect the muffler and tailpipe assembly and both catalytic converters for proper positioning of the exhaust clamps securing them together. Make sure the exhaust clamp locking tab is fully engaged to the catalytic converters (Refer to Figure 1). Make sure the knurled/ridge area of the muffler and tailpipe assembly are covered by the exhaust clamps (Refer to Figures 2-3). Adjustments can be made by loosening the exhaust clamps and repositioning the muffler and tailpipe assembly. (Figures 1-3)

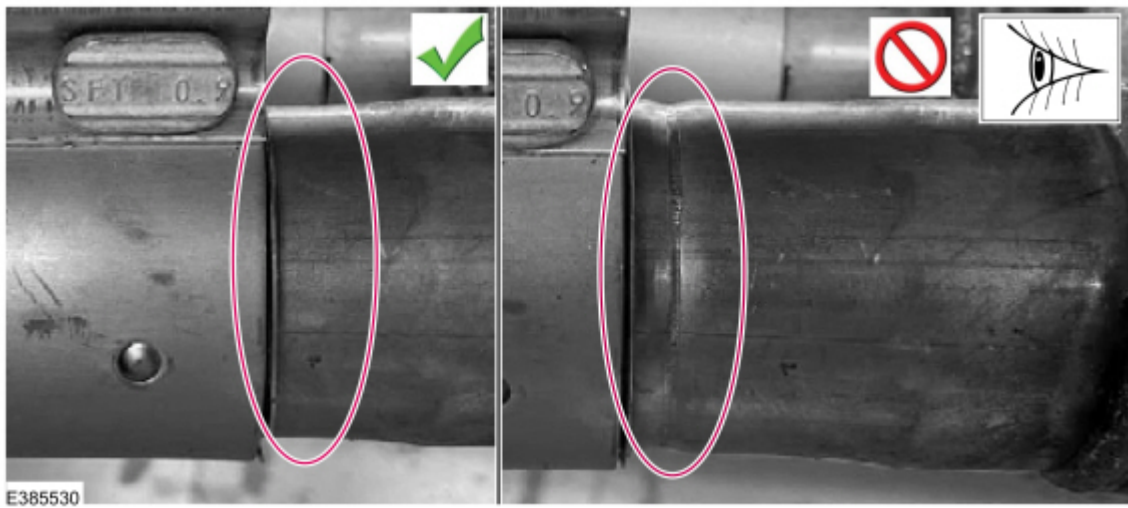
Figure 2 - Non-GT500 exhaust with ridge.

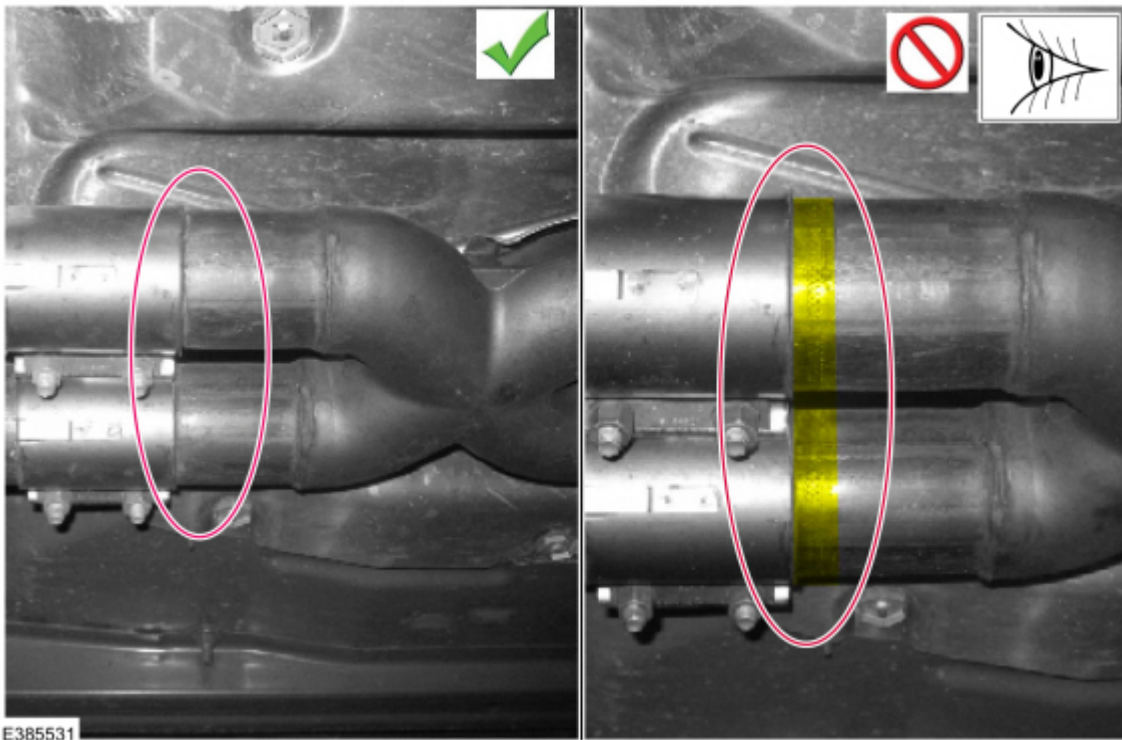
Figure 3 - GT500 exhaust with knurled area.
