TECHNICAL SERVICE BULLETIN

Headliner Detached With Exposed Edges At A-Pillar Trim Panel Or Gaps Between The A-Pillar Trim Panel And The Weatherstrip Seal

23-2136

Ford 2022-2023 Maverick	Built on 10-Jul-2022 and through 25-Jan-2023
-----------------------------------	--

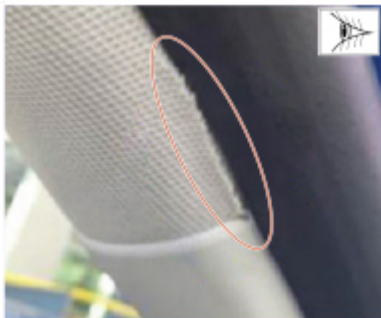
Issue: Some 2022-2023 Maverick Vehicles built on 10-Jul-2022 and through 25-Jan-2023 may exhibit a condition where the headliner is detached with exposed edges at the A-pillar trim panel or gaps between the A-pillar trim panel and the weatherstrip seal. This may be due to a misaligned or out of position pin retainer. To correct this condition, follow the Service Procedure to diagnose and replace the side curtain airbag.

Figure 1 – Example of headliner detached with exposed edges

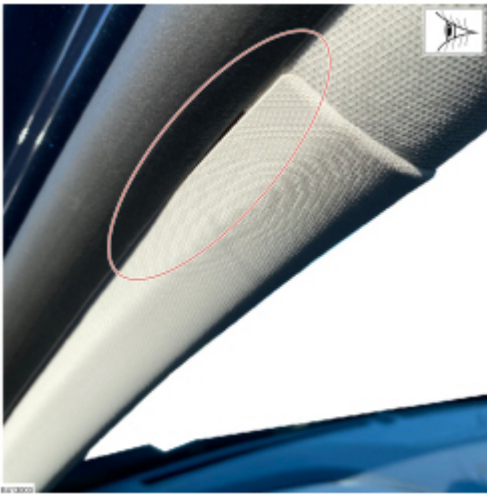
Figure 2 – Example of gaps between the A-pillar and the weatherstrip seal

- NOTE: Do not remove the C-pillar trim panels.**
- (2). No - proceed to Step 6.
6. Inspect the A-pillar for a gap between the A-pillar and weatherstrip. If the gap persists, replace the A-pillar trim panel. Refer to WSM, Section 501-05 Interior Trim and Ornamentation > Removal and Installation > A-Pillar Trim Panel.

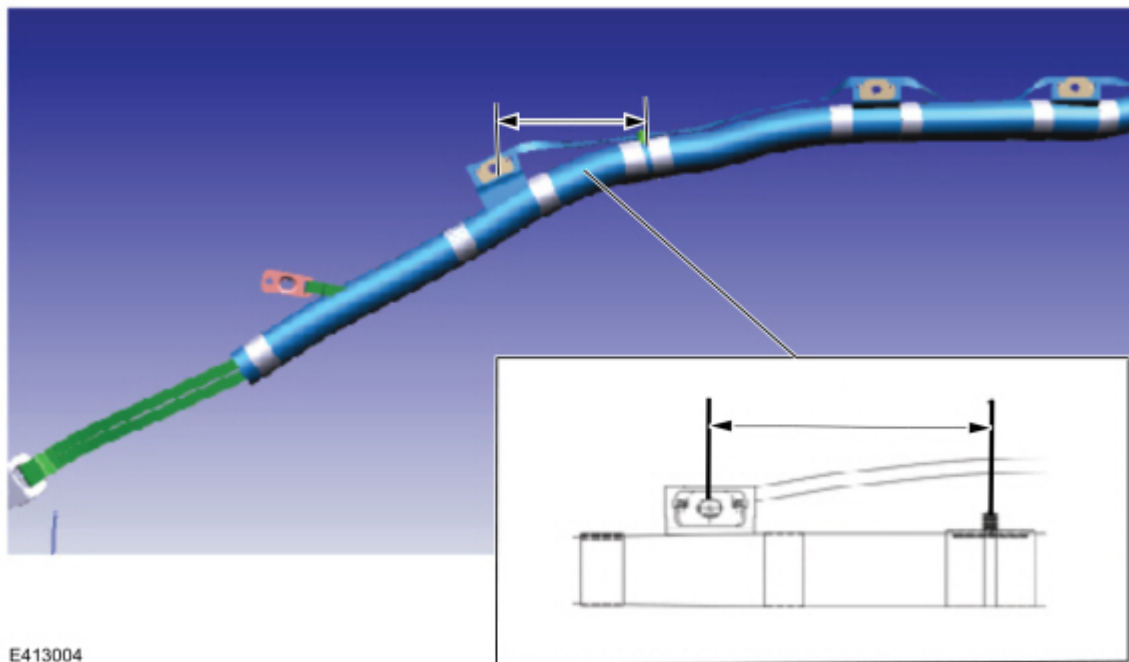
Figure 3

NOTE: Measure the distance between the hanger and the pin retainer in the affected side curtain airbag. (Figure 3). The distance should be between 137-143 mm. Document the measurements in the warranty claim.

2. Remove and replace the affected driver or passenger side curtain airbag.
