TECHNICAL SERVICE BULLETIN

3.0L/6.7L - Illuminated MIL With Various Reductant System Related DTCs

23-2161
22 May 2023

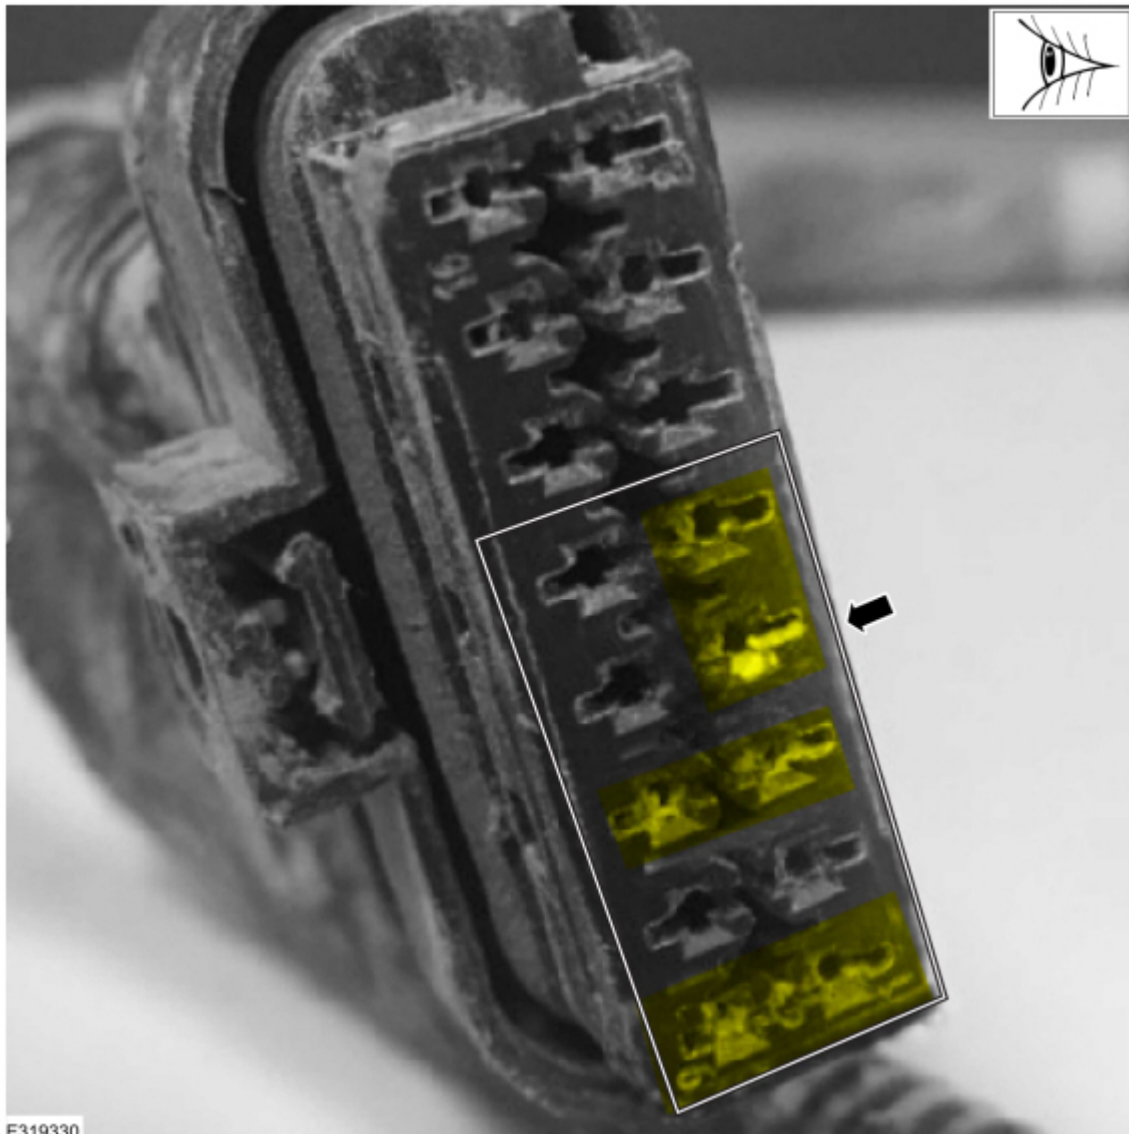
Figure 1

- Visible green corrosion on multiple terminals on the harness side of connector C3613. (Figure 1)

- If there is corrosion or discoloration on the reductant tank harness connector only and not on the reductant pump/heater assembly, only replace the reductant tank harness.

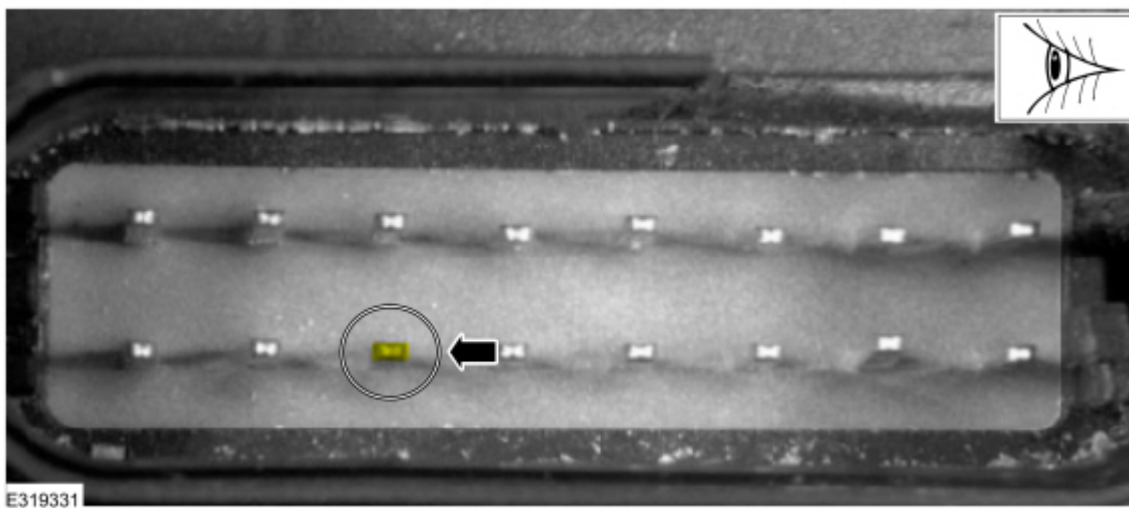
Figure 2

- Corroded pins on the reductant pump/heater assembly at connector C3613. (Figure 2)

- If there are signs of corrosion or discoloration on the reductant pump/heater assembly, replace both the reductant tank harness and the reductant pump/heater assembly. Refer to WSM, Section 303-08.

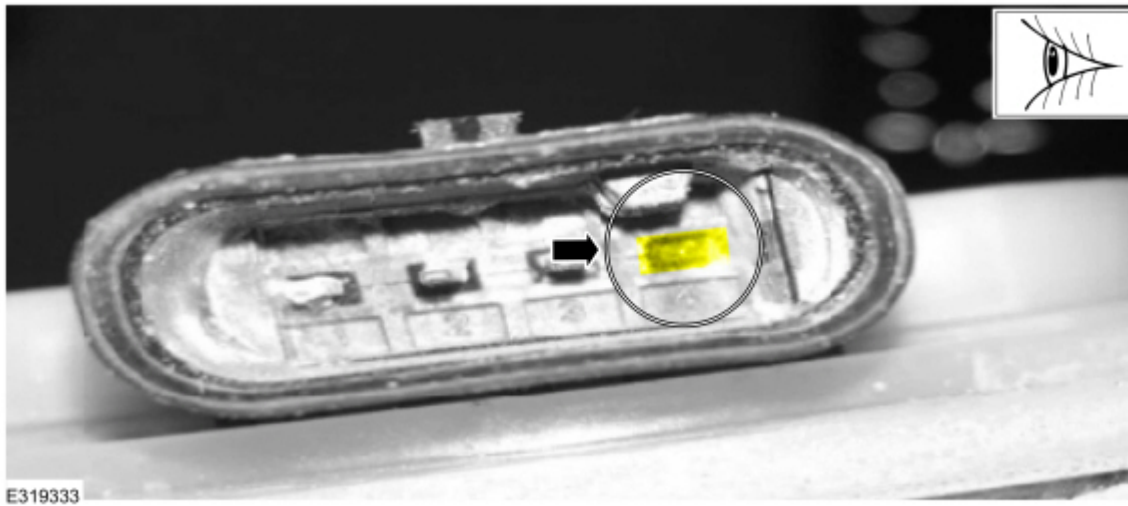
Figure 3

- Visible green corrosion on the reductant level sensor/quality module side of connector C4851/C3610. (Figure 3)

- If there are signs of corrosion or discoloration on the reductant level sensor/quality module, replace both the reductant tank harness and the reductant tank (reductant level sensor/quality module built in).

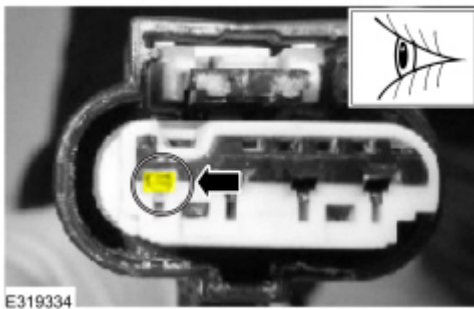
Figure 4

- Visible green corrosion on the harness side of connector C4851/C3610. (Figure 4)

- If there is corrosion or discoloration on the reductant tank harness connector only and not the reductant level sensor/quality module, only replace the reductant tank harness.
