## SERVICE BULLETIN

**APPLICABILITY:** 2019-**23**MY Impreza  
 2019-**23**MY Crosstrek (Including Hybrid Model)  
 2019-**24**MY Forester  
 2019MY Legacy & Outback  
 2019-**21**MY WRX  
 2019-**21**MY BRZ- Navigation -equipped Models ONLY  
 2019-**22**MY Ascent

**NUMBER:** 15-256-19R  
**DATE:** 11/08/19  
**REVISED:** 05/02/23

**SUBJECT:** FOTA (Firmware Over-The-Air) Reprogramming  
 Procedure to Optimize Harman Gen 3.1 Audio / Navigation Units

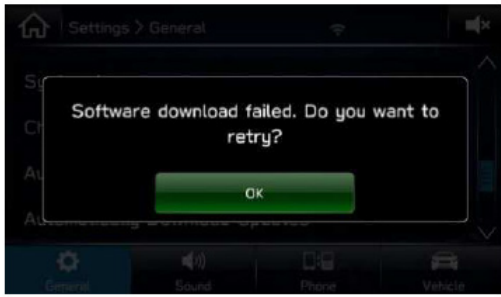
1.5.6) If the H/U display shows “Software download failed. Do you want to retry?”, there is possibility the H/U is not receiving the clock information correctly.

1.5.7) Move the vehicle to a location where the Navi can receive GPS signal or connect to a smartphone via Bluetooth. Ensure that transferring of phonebook data has been approved on the phone. (To review clock setting procedures, refer to Step 1 above.)

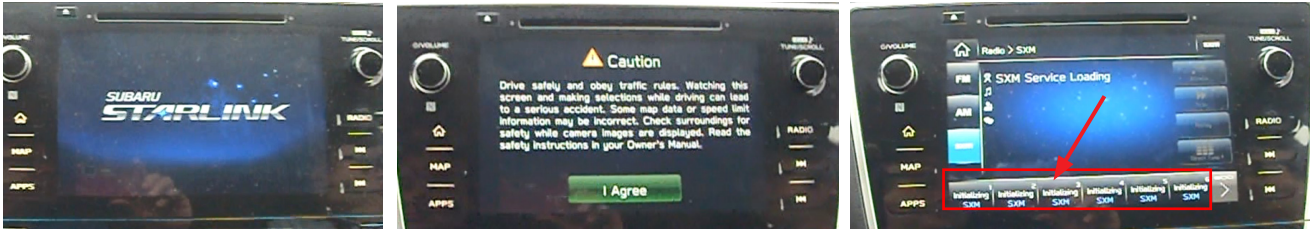
- The next step of update will be different depending on the software version installed prior to FOTA.
- Depending upon the installation required, the H/U may repeatedly shut down and restart up to 3 times. The screen shown below does not indicate an unsuccessful or failed installation.

**NOTE:** The volume will go to default level suddenly even if the volume was previously turned down during or prior to the update. This is normal operation.
