SERVICE BULLETIN

APPLICABILITY: 2022MY Forester

NUMBER: 07-209-22R

SUBJECT: EyeSight® Reprogramming
DTC B28A6 Internal Stereo Camera
Communication 1

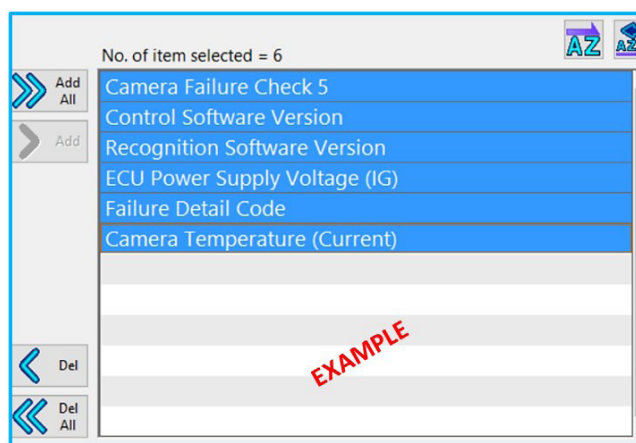
STEP 2: Confirm the following Data Monitor Values prior to any attempt to reprogram:

- 1. Camera Failure 5 is “**0000000B**”
- 2. Control Software Version is “**0421011E**”
- 3. Recognition Software Version is “**07210004**”
- 4. ECU Power Supply Voltage (IG) is **13.5 Volts**
- 5. Failure Detail Code is **C213**

NOTE: If Failure Detail Code C213 is not displayed, check the fault freeze frame data (FFD) of B28A6. If C213 is listed in the FFD, the parameter has been met.

- 6. Camera Temperature is **less than 176 degrees Fahrenheit (80 degrees Celsius)**

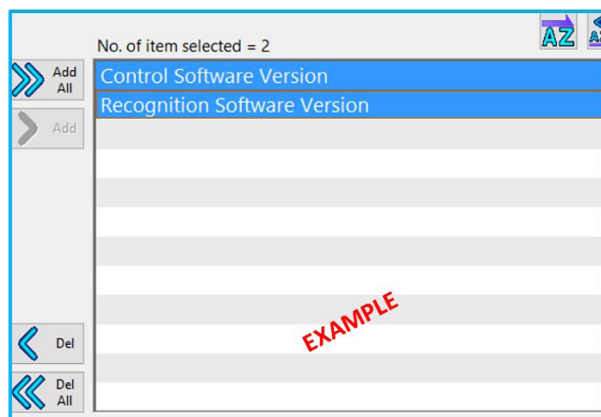
STEP 2: Confirm the following Values:

1. Control Software Version is “04210801”
2. Recognition Software Version is “07210802”
