SERVICE INFORMATION BULLETIN

APPLICABILITY: 2019MY Legacy and Outback w/ 8-in. Navi System **NUMBER:** 15-255-19R
 2019-**23**MY Impreza and Crosstrek w/ 8-in. Navi System **DATE:** 11/08/19
 2019-**23**MY Crosstrek Hybrid w/ 8-in. Navi System **REVISED:** 05/15/23
 2019-**24**MY Forester w/ 8-in. Navi System
 2019-**21**MY WRX WRX STI w/ 7-in. Navi System
 2019-22MY Ascent w/ 8-in. Navi System
 2019-**21**MY BRZ with 7-in. Navi System

SUBJECT: Map Data Update Procedure for Harman Gen 3.1 Navigation Equipped Head Units (H/U)

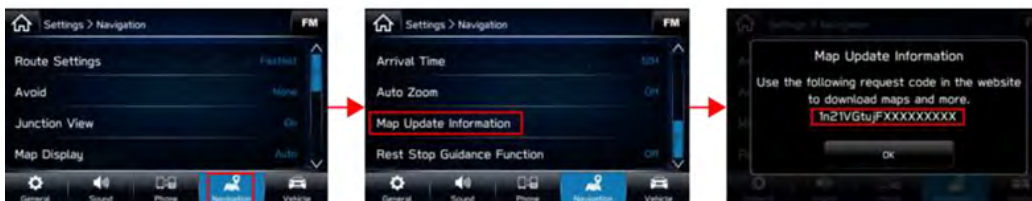
A. How to check Request Code from the vehicle Head Unit

- You can check Request Code. Home>Settings>Navigation>Map Update Information.
- Please take a picture / memo of Request Code.
