## SERVICE BULLETIN

**NUMBER:** 09-80-21R

**SUBJECT:** DTC # P2682 & P26Ax\*\* / Thermo Control Valve – Design Change

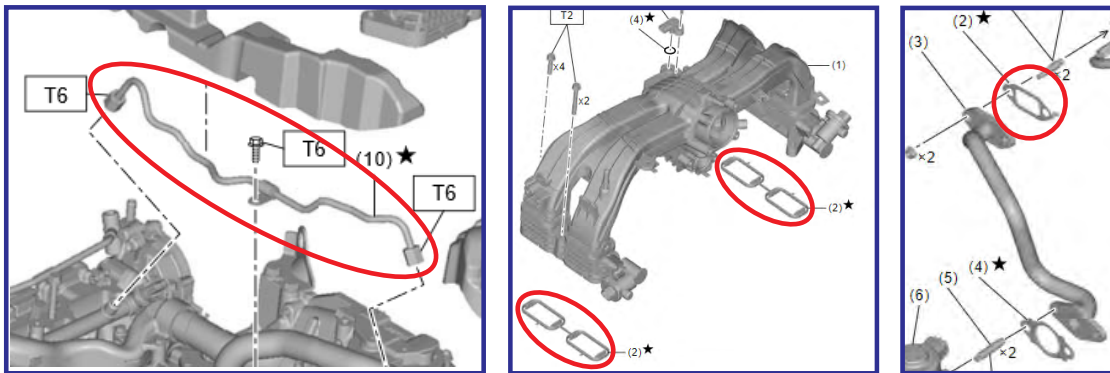
- The Service Manual uses a black star (★) in the component breakdown illustrations to indicate one-time use parts. The high-pressure fuel delivery pipe, intake manifold gaskets, and EGR cooler gaskets are one-time use parts (shown below).
