**SERVICE INFORMATION BULLETIN**

**APPLICABILITY:** 2020MY Legacy & Outback  
2019MY Forester

**NUMBER:** 12-248-23

**SUBJECT:** Rattle-Type Sound From B-Pillar Area

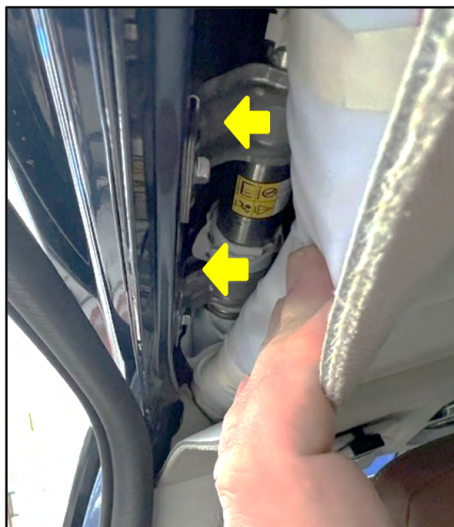
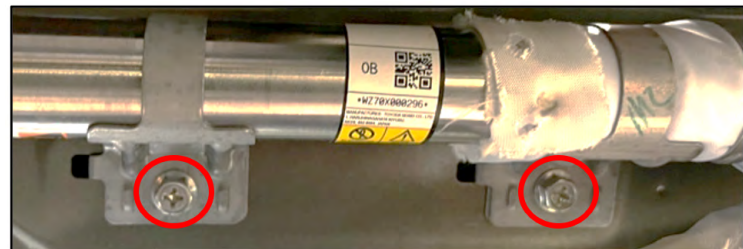
**STEP 5:** Inspect the affected air bag curtain bolts for looseness and the mounting bracket for any signs of play. If looseness is found proceed to **STEP 7**. If no looseness is found, remove the affected curtain air bag inflator bolts then proceed to **STEP 6**.

**NOTE:** Muting the noise by pressing the bracketing with your finger can be useful when confirming the rattle-type sound source.
