SERVICE BULLETIN

APPLICABILITY: 22-**23MY** WRX Models **NUMBER:** 15-301-22R
SUBJECT: Reprogramming File Availability for Optimization of Gen 4 Denso CP1 Infotainment Systems **DATE:** 09/09/22
REVISED: 05/22/23

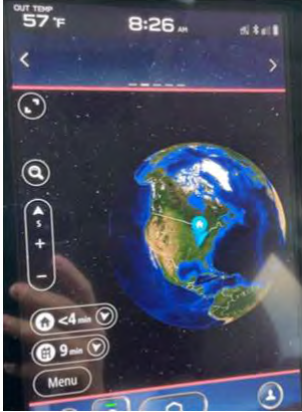
Number	Symptoms to be Improved:
14	<p>Navigation map scale is changed to the lowest setting (globe is displayed).</p>

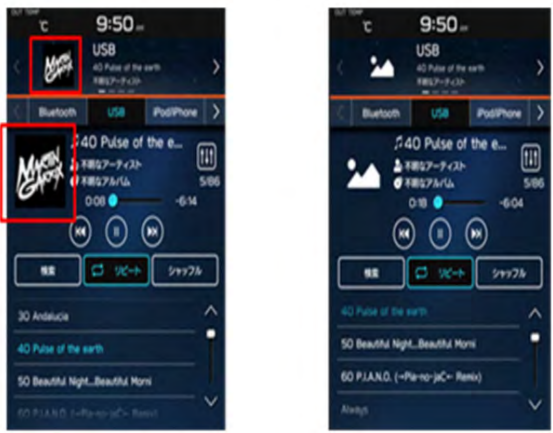
Number	Symptoms to be Improved:
18	<p>Cover art of previous music is displayed when playing music without cover art in USB audio. It can occur when music with and without cover art is mixed and stored together a single USB.</p>

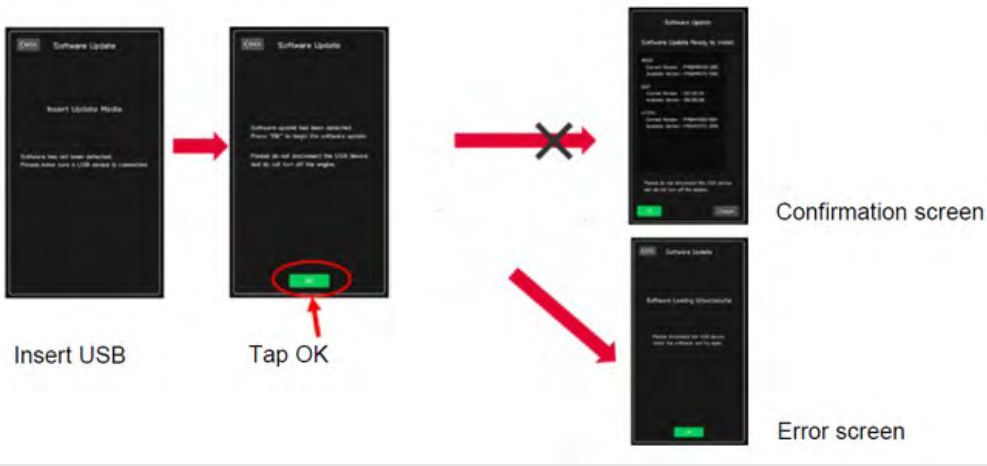
Number	Symptoms to be Improved:
12	<p>When conducting USB reprogramming, the screen transition to error screen instead of confirmation screen.</p>

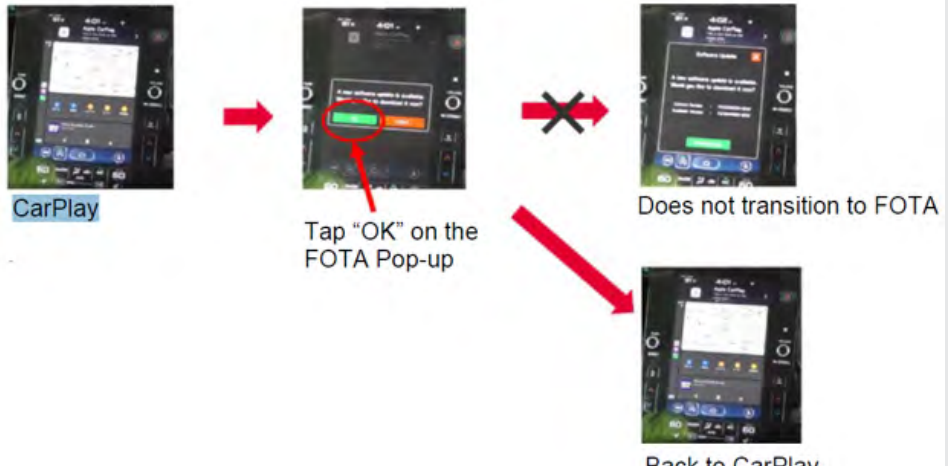
<p>Note* In case this USB update failure occurs, retry updating according to the instructions in “Appendix A”</p>
14	<p>When the FOTA pop-up (new software availability notification) is displayed while the CarPlay is being used, the display comes back to CarPlay screen even if the customer tries to get into the FOTA screen.</p>

<p>CarPlay Tap “OK” on the FOTA Pop-up Does not transition to FOTA Back to CarPlay</p>

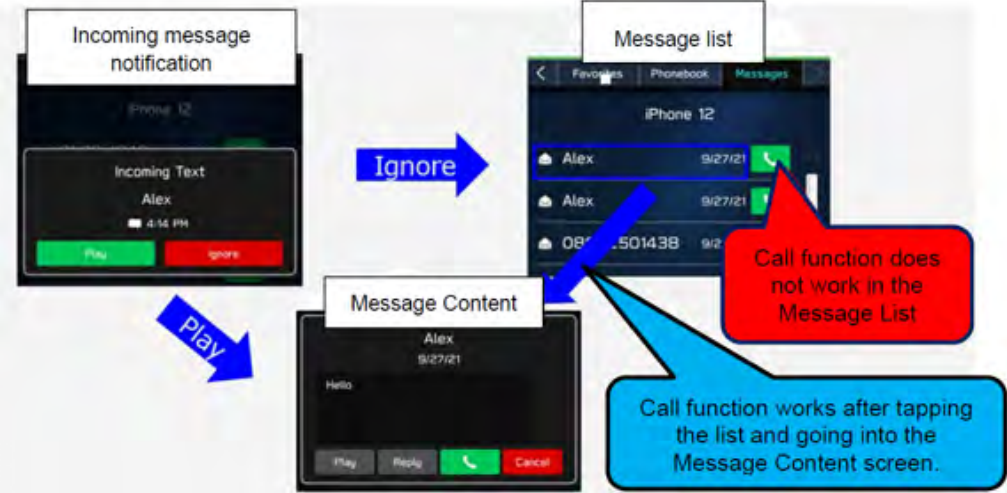
Number	Symptoms to be Improved:
15	<p>Call function does not work in the Message List (after ignoring the incoming message notification.). However, the call function can still be used after getting into the Message Content screen by tapping the message list.</p>

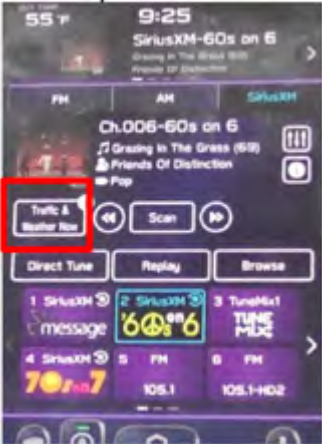
Number	Symptoms to be Improved:
25	<p>No response when touching “Traffic & Weather Now (TWN)” on SMX screen.</p>

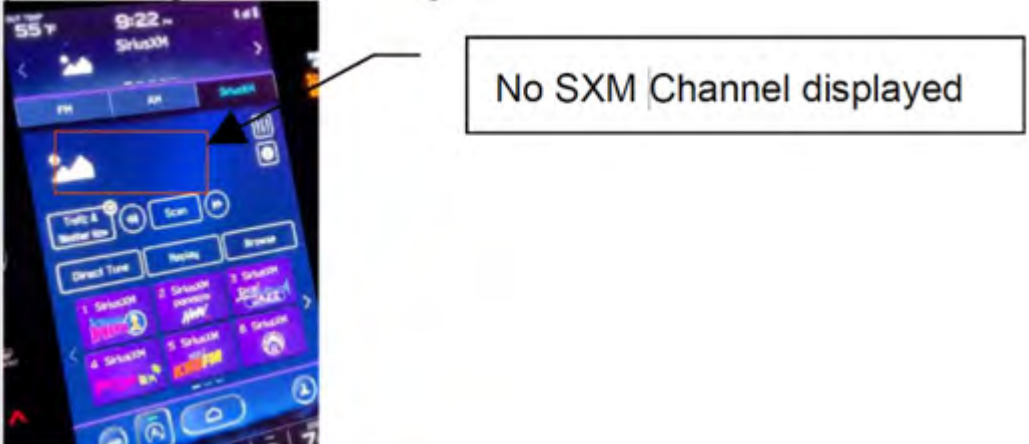
26	<p>SXM has blank screen and no sound when the SXM screen had been selected as audio source at the previous ignition off timing.</p>

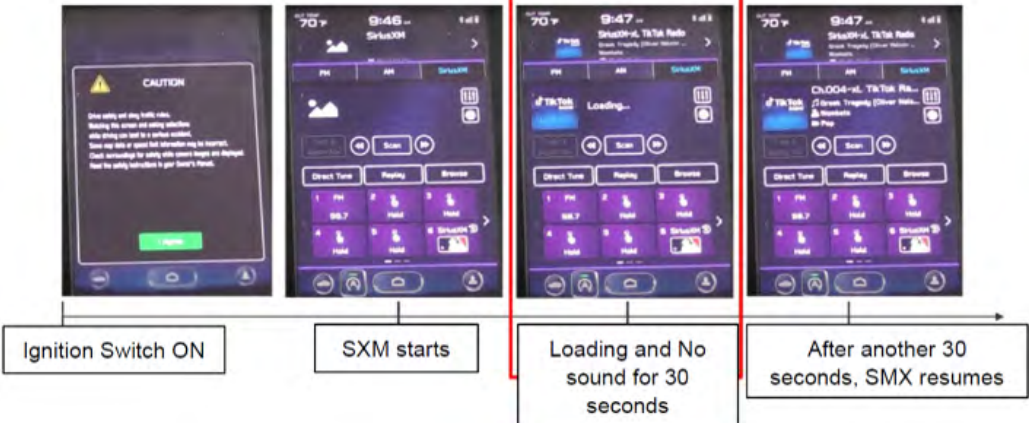
27	<p>About 30 seconds after starting the SXM the operation is paused with loading screen and resume after another 30 seconds. This symptom occurs when the SXM screen had been selected as audio source at the previous ignition off timing.</p>

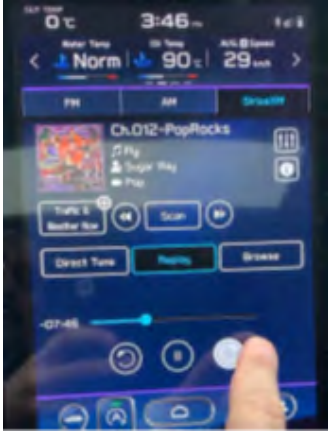
Number	Symptoms to be Improved:
29	<p>“Fast forward” does not work in SXM replay function. (Fast Rewind works.)</p>

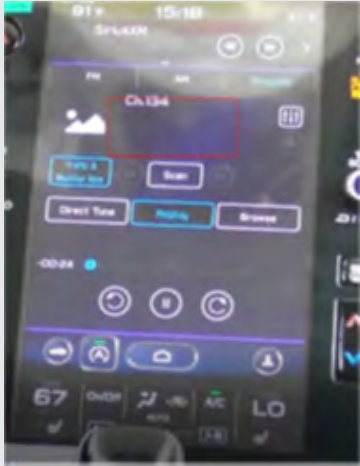
30	<p>The channel information becomes blank when the seek button (<</>>) of the steering satellite switches is pressed continuously to control the Traffic & Weather Now (TWN) in SXM.</p>

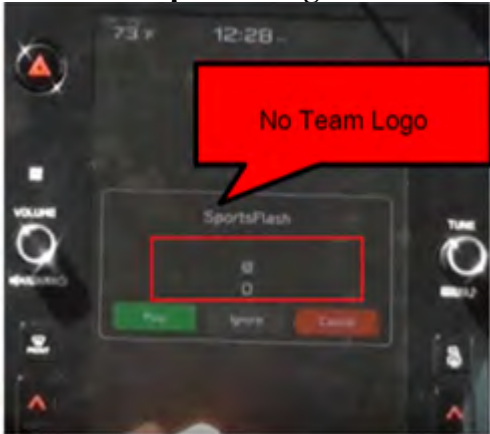
31	<p>The team logo is not displayed on Sports Flash screen when the SXM screen had been selected as audio source at the previous ignition off timing.</p>

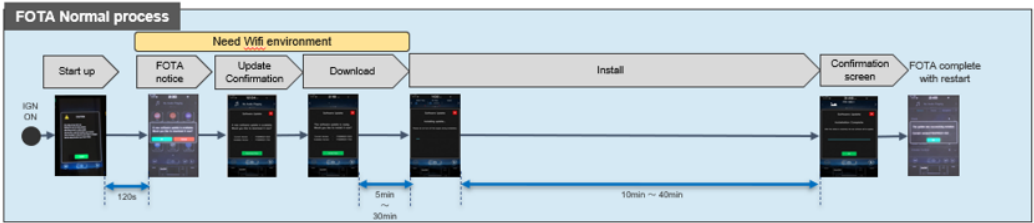
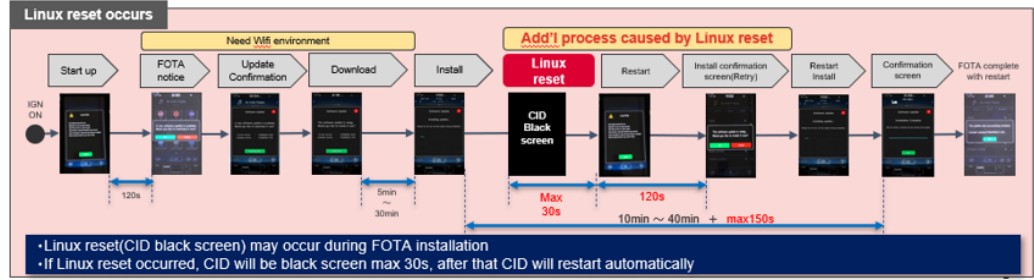
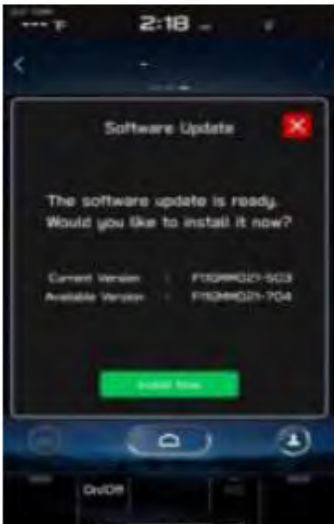
Number	Symptoms to be Improved:
1	<p>System restarts itself during FOTA (Firmware Over The Air) update. FOTA operation is conducted in two processes: downloading (from the server to the Cockpit Control Unit via Wi-Fi) and installation (inside the Cockpit Control Unit). During the FOTA operation, after the new software has been downloaded to the Cockpit Control Unit (CCU) customer is to push “Install Now” on the Center Information Display (CID) to start installation of the software.</p>

<p>However, in rare case, the CCU restarts itself* during installation.</p>

<p>Note* Even if this symptom occurs, after approximately 2 minutes, the system resumes, and the CID comes back to the below screen. Customer can then push the “Install Now” to proceed with the installation.</p>
