SERVICE INFORMATION BULLETIN

APPLICABILITY: Models with Harman and Denso CP1 Infotainment
NUMBER: 15-304-22R
DATE: 10/11/22
SUBJECT: Procedure for Techline Infotainment Concern Data Collection and Sharing via TechShare
REVISED: 06/28/23

This bulletin supersedes TSB 15-192-22 “Infotainment Concern Data Collection Guidelines” and explains the process of using the Infotainment Form for Infotainment cases submission.

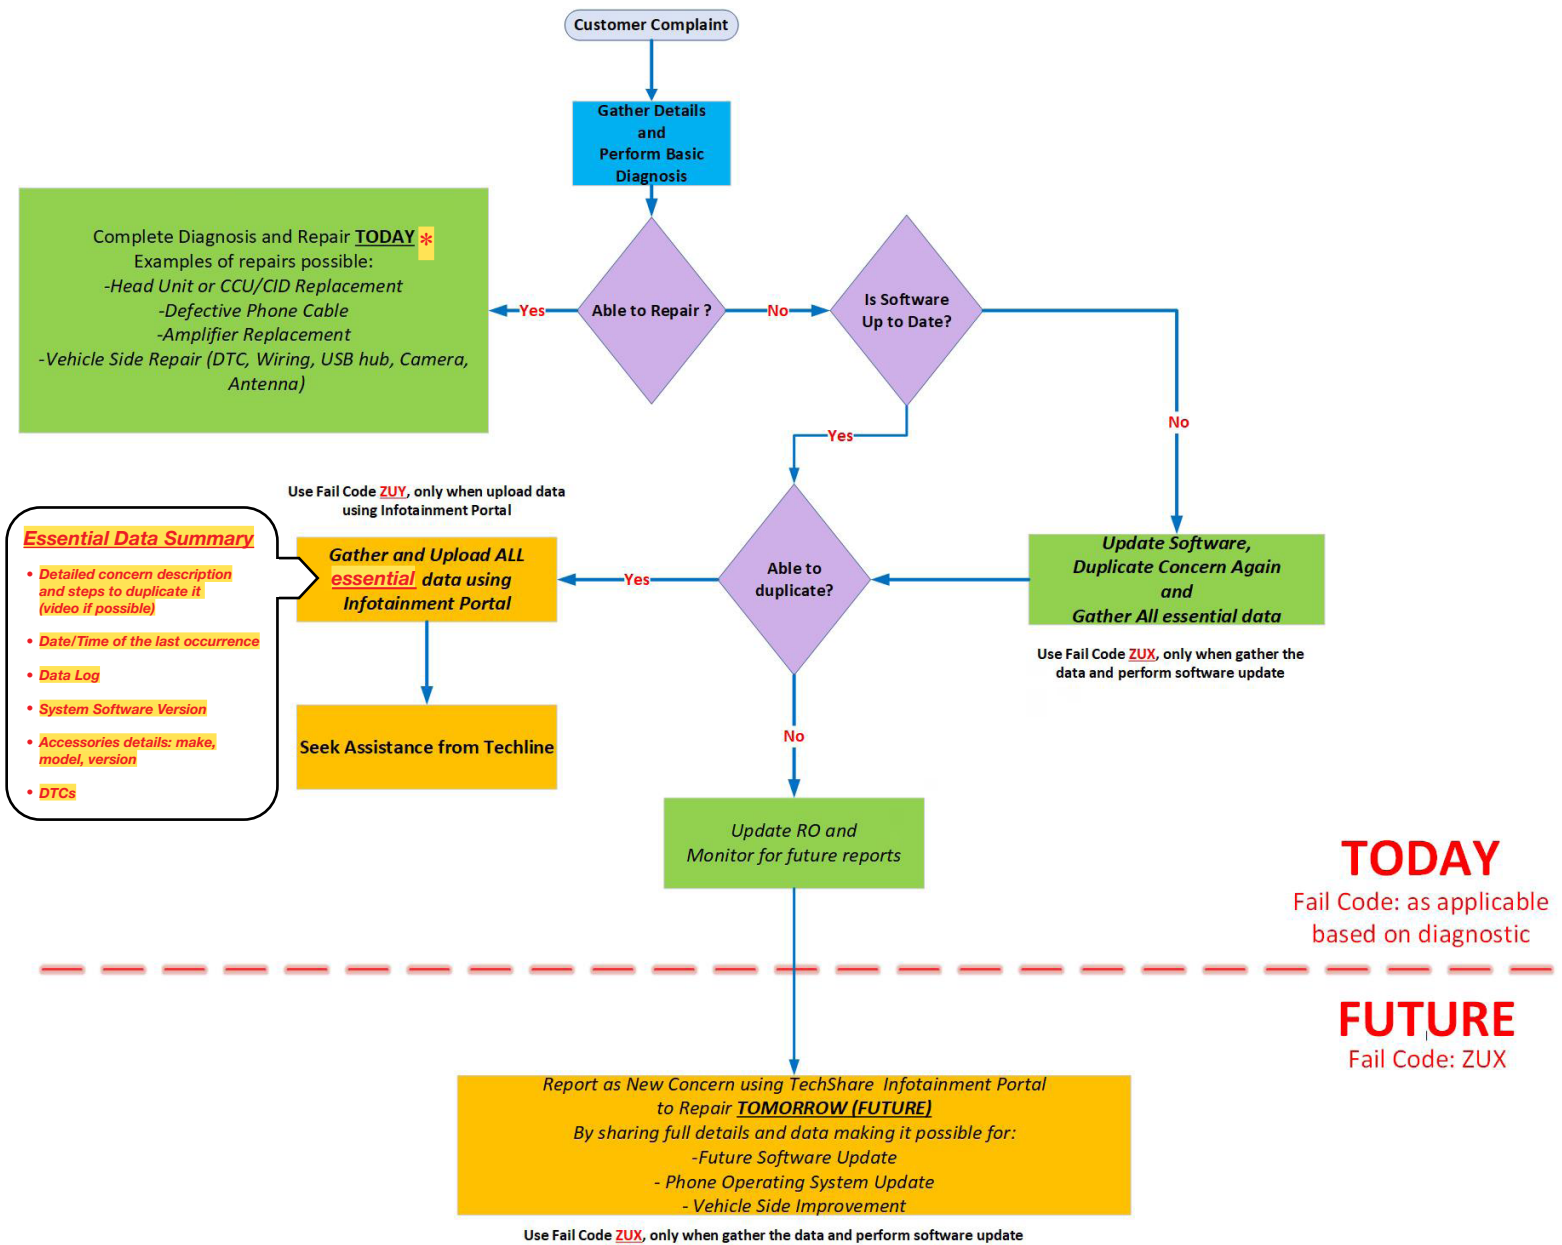
Infotainment Concern Diagnostic and Reporting Flow

*** NOTE:** In case of CP1 Black Display concern confirm it is duplicated with the latest software version. If yes, it would be due to the hardware failure in the CCU (Cockpit Control Unit) part of CP1 system. CCU replacement is advised as the next step to repair this concern. Please follow proper exchange procedure.

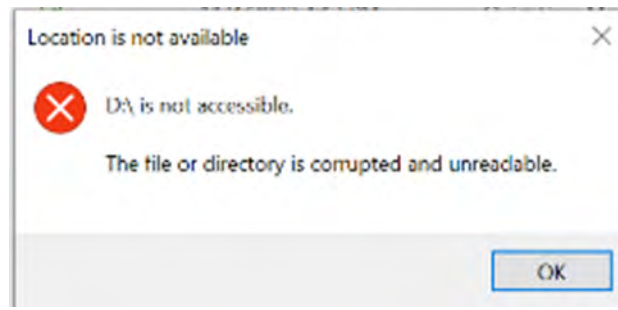
3. Log files are not overly large, 1GB size is sufficient.
4. In case you encounter an error shown below, after accessing USB flash drive from your PC, consider a recovery steps outlined in this section.

a. Recovery steps

- i. Reformat USB Flash drive to NTFS format.
- ii. Write any file under 300MB from PC to the USB flash drive, while it is still inserted in the port.
- iii. Properly remove USB flash drive from PC.
- iv. Repeat the data log collection.
- v. If you are still encountering issues, please use a USB flash drive from another manufacturer.
