SERVICE BULLETIN

APPLICABILITY: 2012-21MY Forester
 2012-21MY Impreza
 2015-20MY WRX

NUMBER: 02-131-12R

SUBJECT: Oil Seepage Diagnosis and Repair Procedures

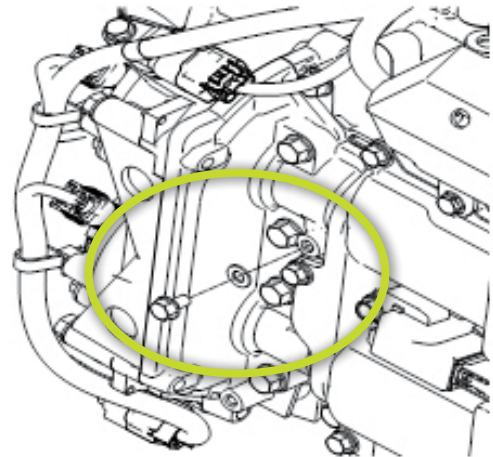
If oil seepage is verified coming from the 6mm threaded hole in the left-hand camshaft cap, install the specified bolt and flat washer.

Bolt: Part# 800206180

Washer: Part# 031106000

Tightening Torque: 6.4 +/- 0.5 Nm
 (57 +/- 4 inch-pounds)

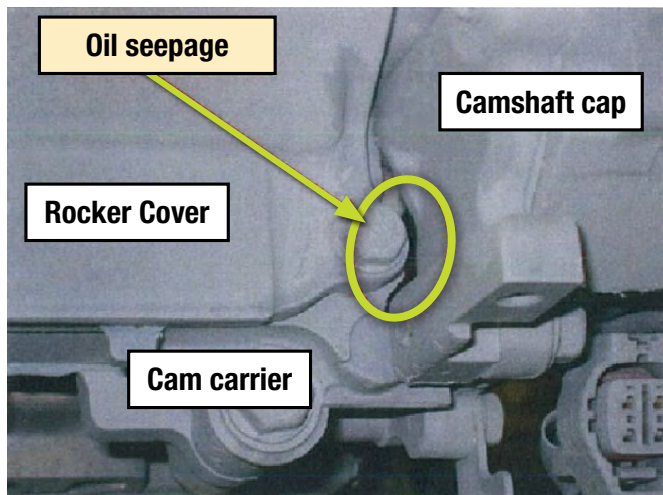
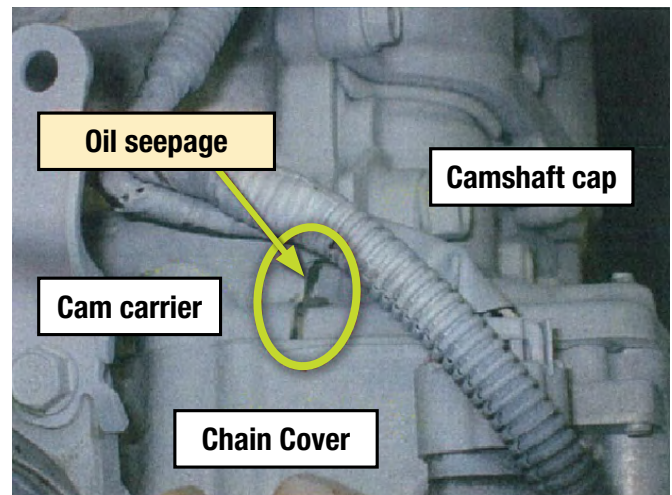
If oil seepage is verified coming from the front camshaft cap or cam carrier as shown in the photos below, remove the cam cap and clean both surfaces thoroughly before applying sealer. **Note:** The 2 o-rings between the camshaft cap and the cam carrier will need to be replaced as they are not re-usable.

Apply Liquid Gasket, ThreeBond 11217H (SOA868V9610) or equivalent* as shown below:

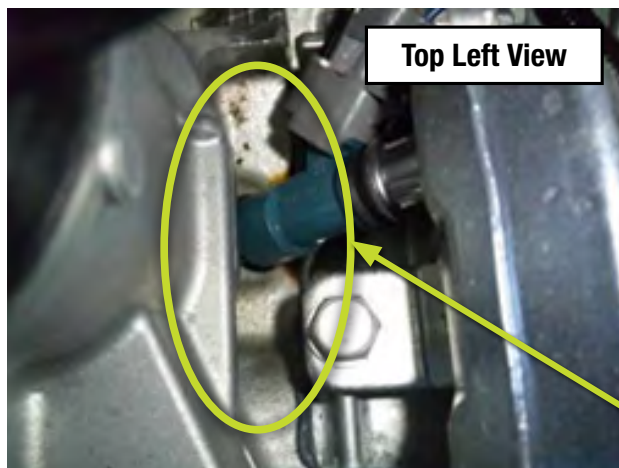
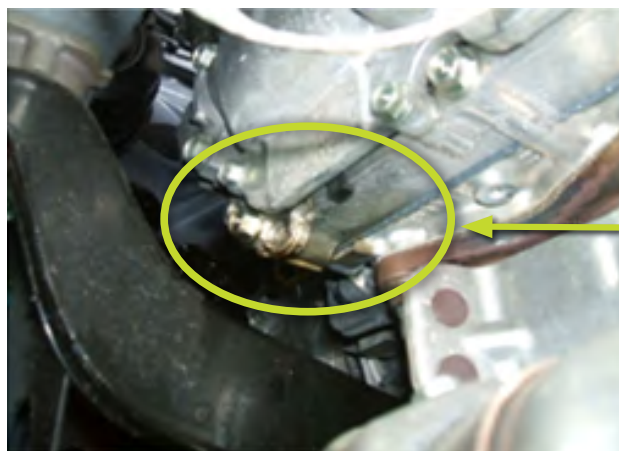
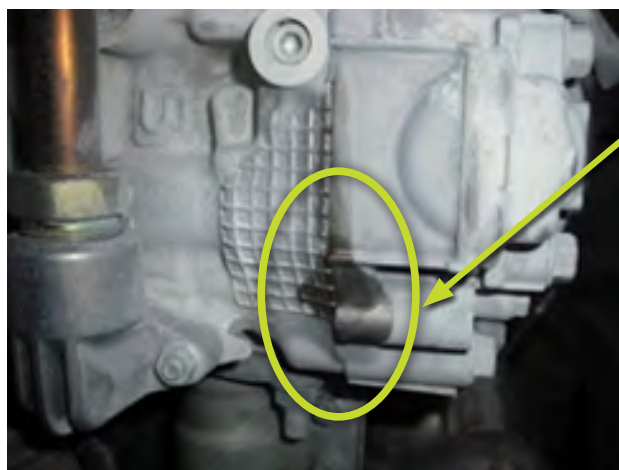
If oil seepage is verified coming from between the cam carrier and the cylinder head as shown in the photos below, remove the cam carrier. Clean the machined sealing surfaces thoroughly and then re-seal using Liquid Gasket ThreeBond 1217H (SOA868V9610) or equivalent*. As shown in the photos below, the o-rings between the cam carrier and the cylinder head will need to be replaced as they are not re-usable. This would also be a good time to clean the Active Valve Control System (AVCS) filter screens which are contained in the cam carriers. **NOTE:** The filter screens are one-time use and must be replaced if they need to be removed. The replacement filter part# is 14451AA050.

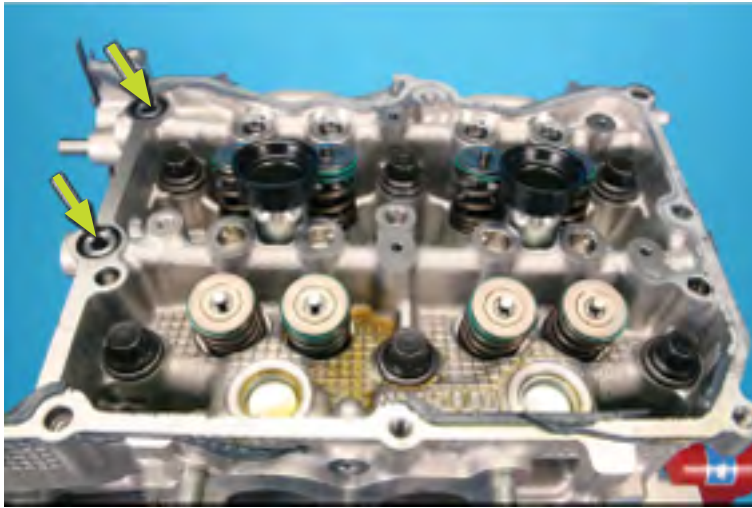
Cam carrier o-rings requiring replacement

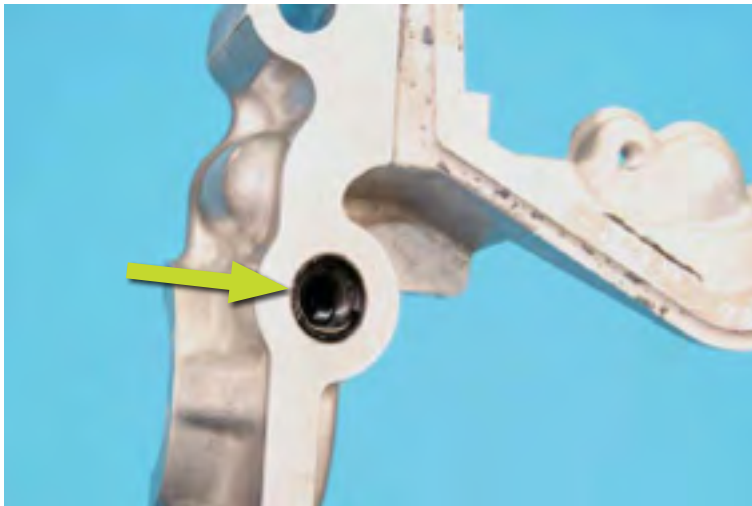
AVCS filter screen in cam carrier

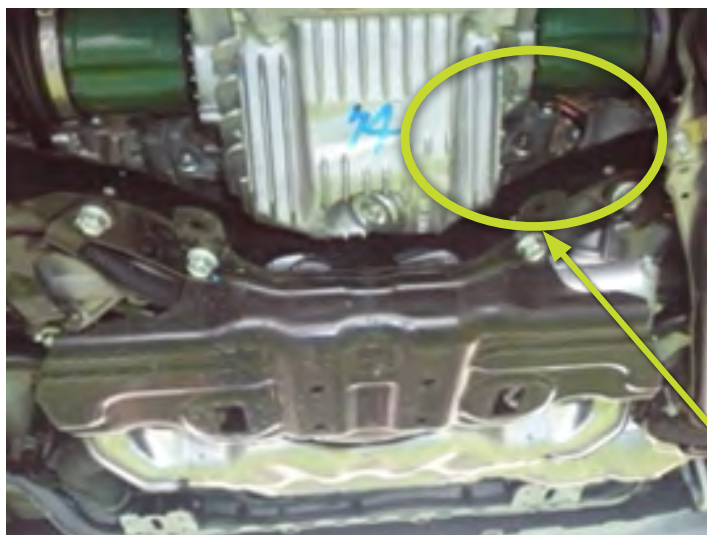
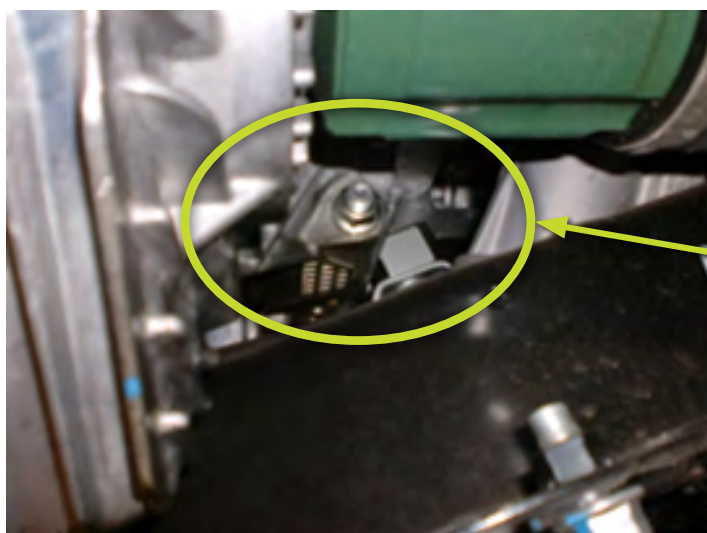
As viewed from the rear, oil seepage from the upper pan to engine block sealing area may be present in these areas.

If you find engine oil seepage between the cylinder block and upper oil pan, remove the upper oil pan, clean the machined sealing surfaces thoroughly and then re-seal using Liquid Gasket ThreeBond 1217H (SOA868V9610) or equivalent*. **Note:** The o-rings between the upper oil pan and the cylinder block along with those between the upper and lower oil pan will need to be replaced as they are not re-usable.

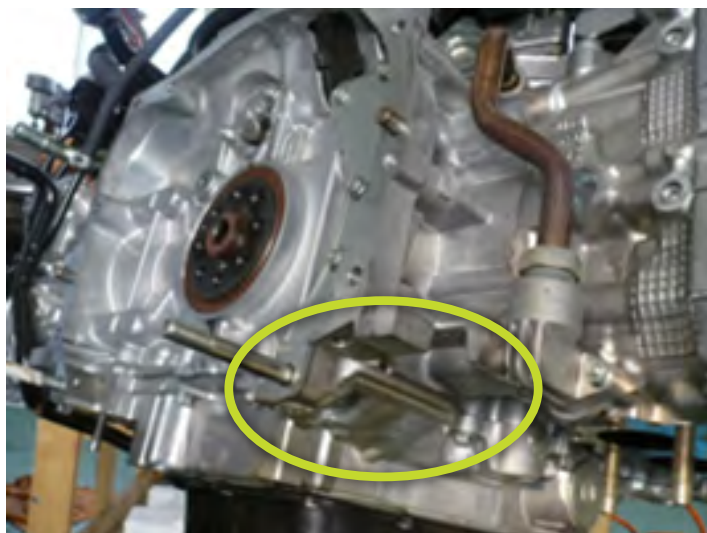
Photo shows seepage from upper oil pan to engine block sealing surfaces.

IMPORTANT: The oil level switch o-ring is a one time use part and should be replaced when the switch is removed, replaced, or when the upper oil pan is resealed.

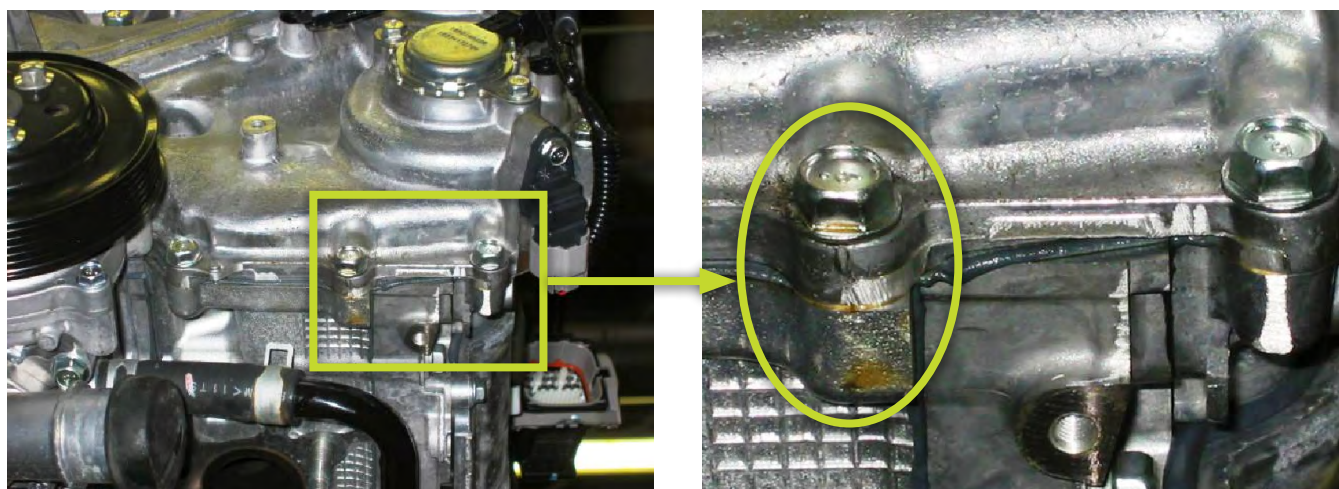
Note: Only reseal the front chain cover AFTER confirming there is no oil seepage coming from the cam retainer cap (area 1) as previously described.

1. If there are no oil droplets found on the engine under-cover or the lower radiator hose, thoroughly clean the chain cover sealing area along with the surrounding cylinder head and crankcase areas. Re-check for oil seepage again at the next service interval.
2. If the front chain cover is leaking and needs to be resealed, follow the repair procedure in the applicable Service Manual. Thoroughly clean and inspect the sealing surfaces then re-seal using Liquid Gasket ThreeBond 1217H (SOA868V9610) or equivalent*.
