**TECHNICAL SERVICE BULLETIN****Non-Hybrid - Radio Static And/Or Poor Radio Sound Quality When Moving****23-2208**

12 July 2023

Ford 2020-2023 Explorer	Non-hybrid
Lincoln 2020-2023 Aviator	Non-hybrid

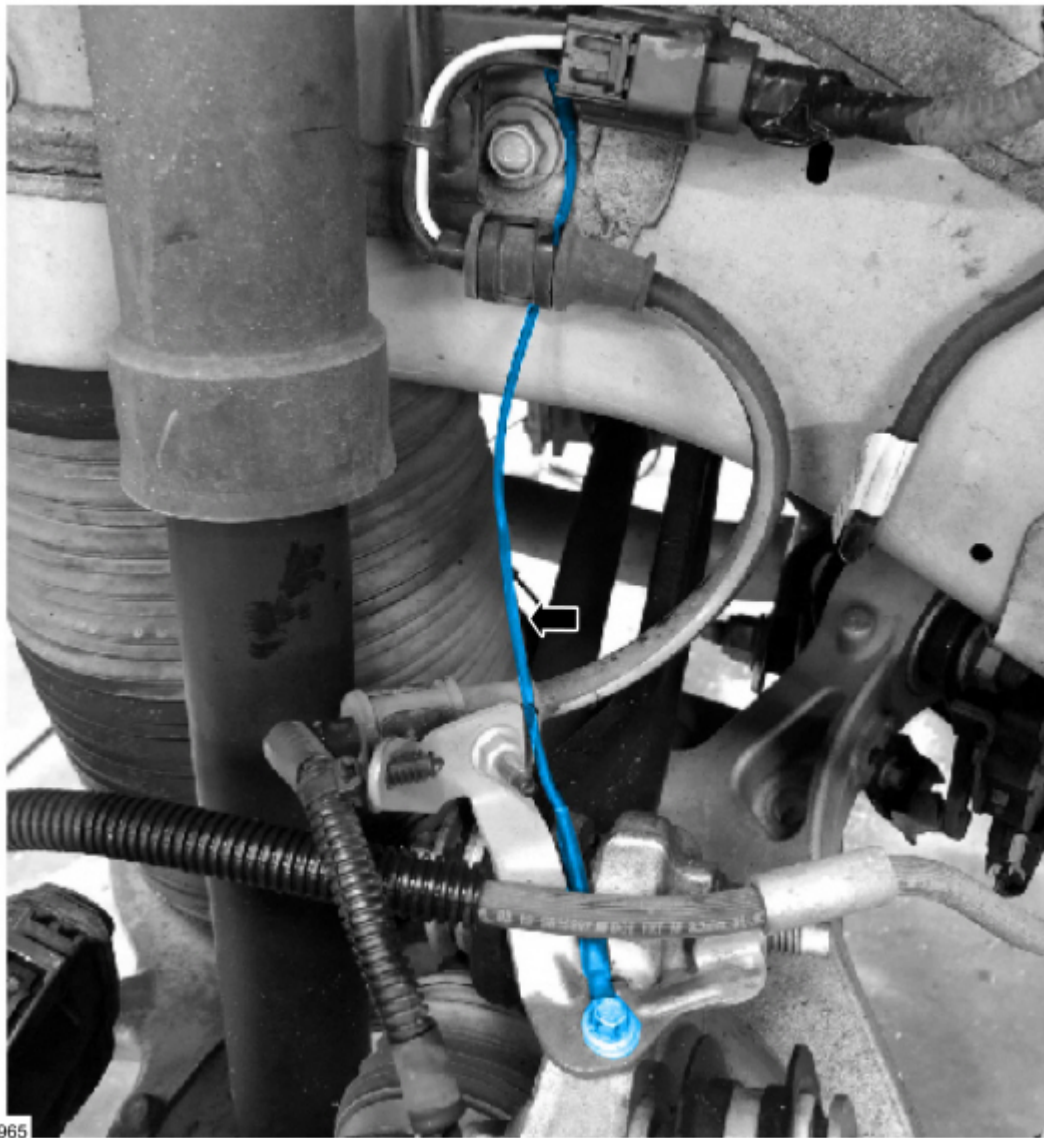
Figure 1

Issue: Some 2020-2023 Explorer/Aviator non-hybrid vehicles may exhibit radio static and/or poor radio sound quality when moving. This may be more noticeable on AM radio stations. This may be caused by an electromagnetic interference concern. To correct the condition, follow the Service Procedure to install new grounds on the rear knuckle.

1. Install new ground straps on each side of the vehicle on top of the brake hose bracket bolt on the rear knuckle. Tighten to 133 lb-in (15 Nm). Refer to Workshop Manual (WSM), Section 204-02. (Figure 1-2)

2. Install the other side of the ground straps underneath the rear wheel speed sensor harness bracket mounting stud. Tighten to 62 lb-in (7 Nm). Refer to WSM, Section 206-09. (Figure 1-2)
