TECHNICAL SERVICE BULLETIN

Soft Top Material Wear Above The B-Pillar

23-2229

Ford 2021-2022 Bronco

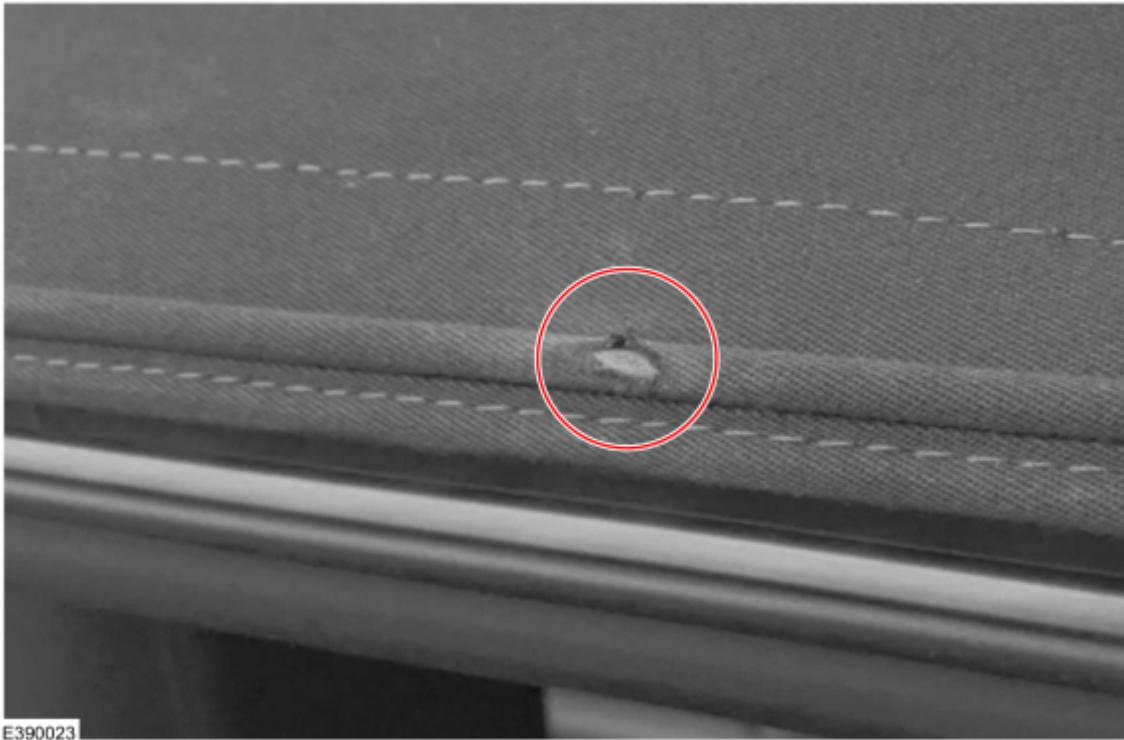
Figure 1

Issue: Some 2021-2022 Bronco vehicles equipped with a soft top may exhibit exterior wear on the sides of the soft top material above the B-pillar. This may be due to contact and rubbing between the soft top frame and soft top material. To correct the condition, follow the Service Procedure to replace both right and left deflectors attached to the soft top frame and soft top material.

1. Does the soft top exhibit wear above the B-pillar similar to Figure 1?

(1). Yes - proceed to Step 2. Updated deflectors will be installed on both sides of the soft top frame assembly to prevent wear.
