TECHNICAL SERVICE BULLETIN

Non-Tremor - Shudder/Vibration When Accelerating

23-2251

Ford
2019-2023 Ranger

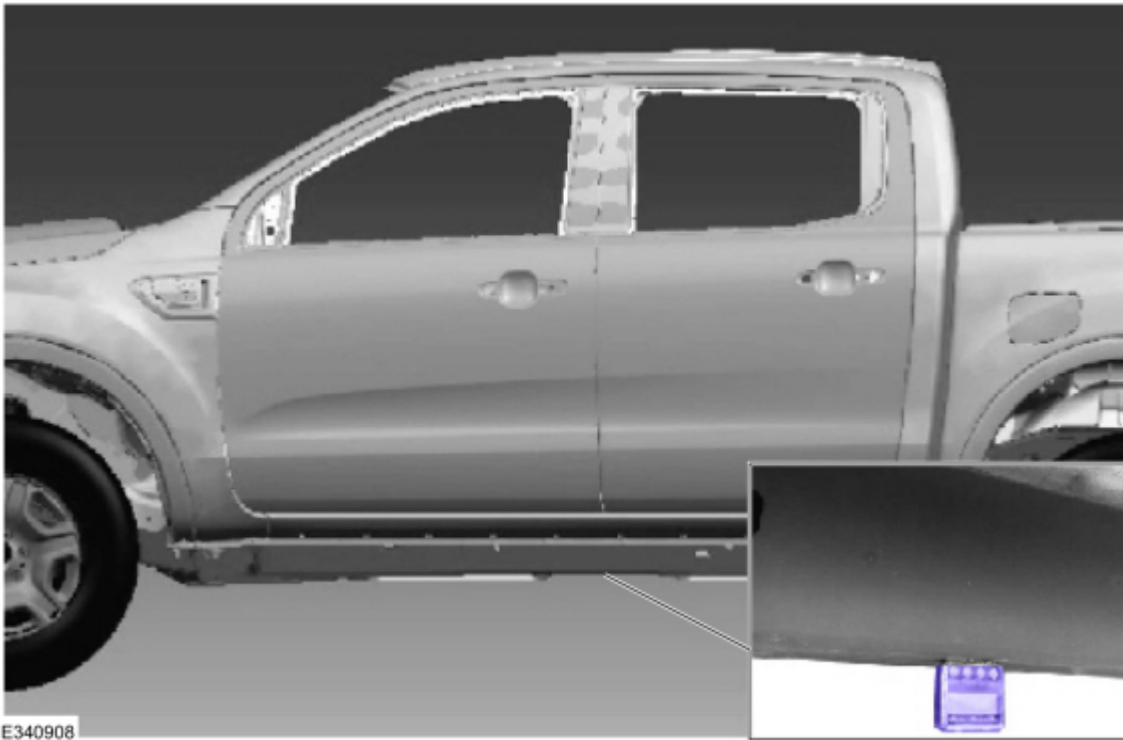
Figure 1

NOTE: Do not use an analog dial gauge angle/finder protractor to measure rear axle pinion angle; an accurate reading will not be obtained. (Figure 1)

1. Park the vehicle on a level surface such as a drive-on hoist or alignment rack.
2. Verify the front and rear ride height is within specification. Refer to Workshop Manual (WSM), Section 204-00. Is the ride height within specification?
 - (1). Yes - proceed to Step 3.
 - (2). No - this article does not apply. Refer to WSM, Section 204-00 for further diagnostics.
3. Calibrate the digital inclinometer by placing it on a clean, flat and level section of the vehicle frame rail as indicated in Figure 1. Zero the tool.
