SERVICE INFORMATION BULLETIN

APPLICABILITY: 2022MY Legacy & Outback
 2022MY Outback Wilderness
 2022MY Ascent

NUMBER: 16-142-23
DATE: 08/15/23

SUBJECT: DTC P2715 (Pressure Control Solenoid “D” Stuck On) Diagnosis

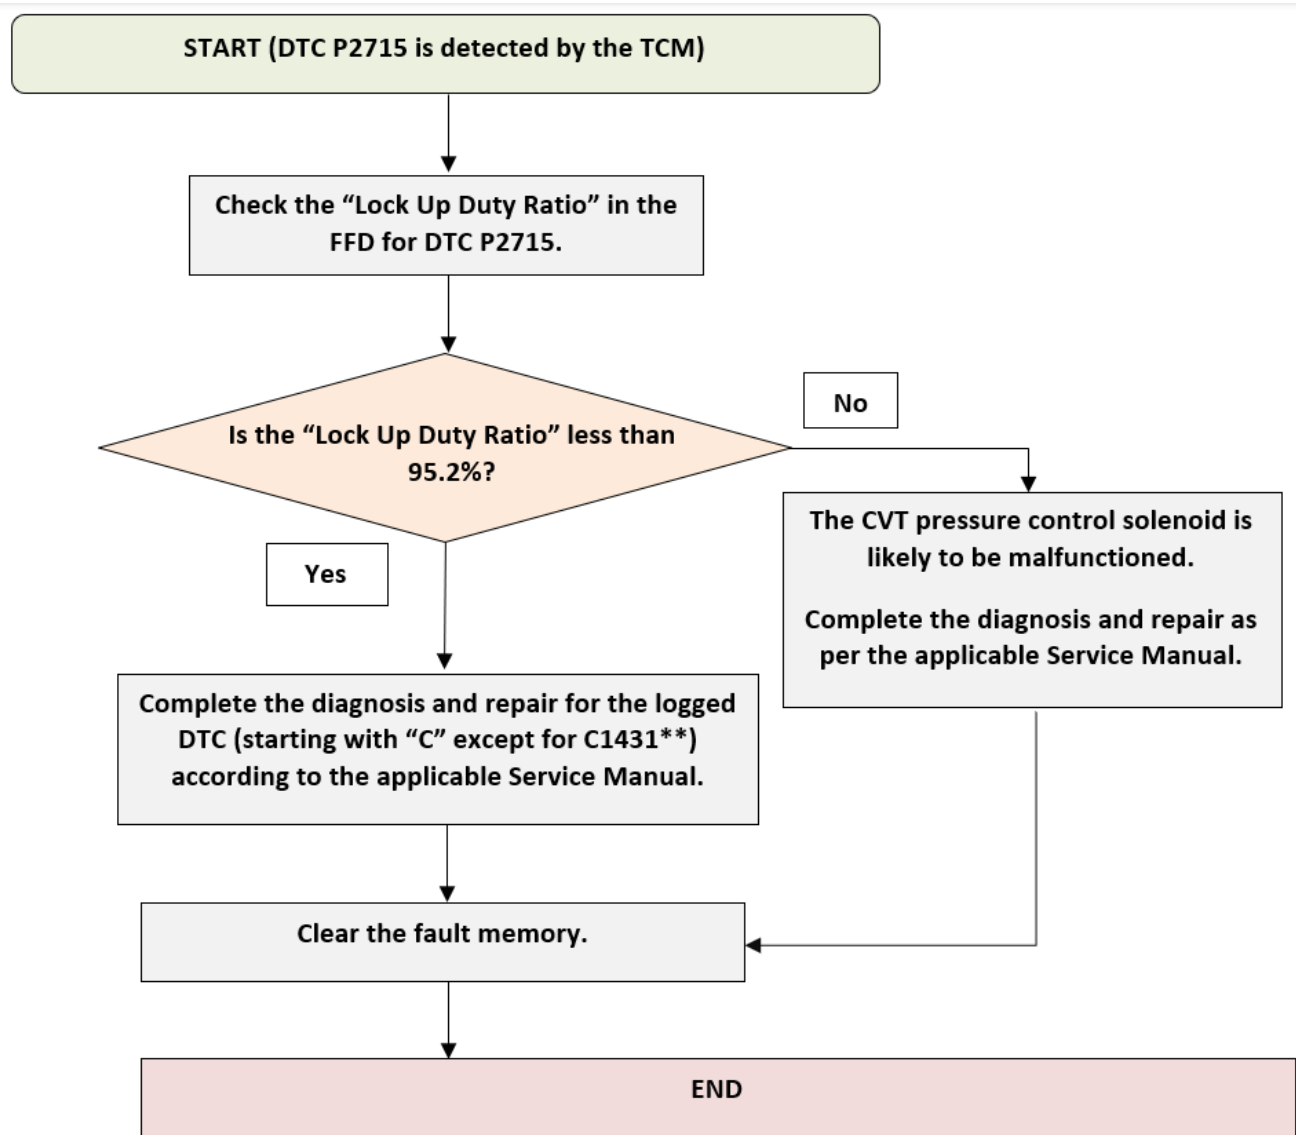
SERVICE PROCEDURE FLOW CHART:

STEP 2: Read the freeze frame data of DTC P2715. Is the “Lock Up Duty Ratio” less than 95.2%?

NO – The CVT Pressure Control Solenoid is likely to be the fault source. Confirm the CVT Pressure Control Solenoid status by performing the diagnostic procedures outlined in the applicable Service Manual. Clear the fault memory when repairs are completed.

YES – P2715 has been inaccurately detected. Perform the diagnosis and repair for chassis fault codes (C-Type) stored in the VDC control module by performing the diagnostic procedures outlined in the applicable Service Manual. Clear the fault memory when repairs are completed.

**** NOTE:** Avoid following the trouble tree diagnosis for code C1431 when diagnosing P2715 misdetection. The trouble tree workflow for C1431 can lead to some automatic transmission testing procedures.
