## SERVICE BULLETIN

**APPLICABILITY:** 2019-21MY Forester

**NUMBER:** 07-202-23

**SUBJECT:** Headlight Water Intrusion / Design Changes

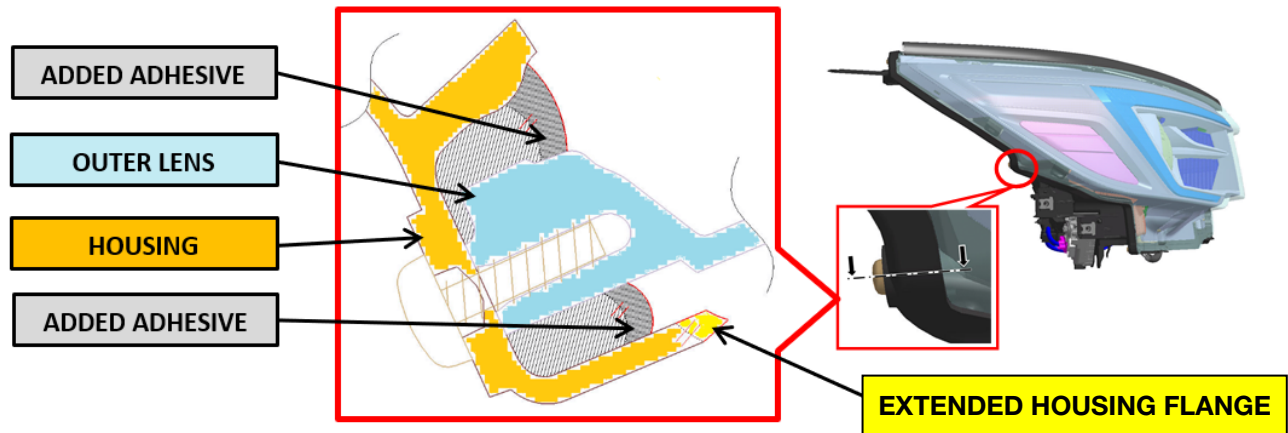
#### AREAS OF DESIGN CHANGE

This bulletin announces the design changes to the headlights. The new assemblies are fitted with an extended flange on the housing along with an increased amount of adhesive added to provide optimum sealing. These changes reduce the chance of moisture entering the headlights. The headlight(s) should be replaced if water intrusion is found.

Determine water intrusion is present and not a fogging situation. TSB 07-59-07R provides information on headlamp fogging. Confirm the headlamp(s) water intrusion is not a result of outside influence, such as physical damage, modification, etc.
