SERVICE BULLETIN

APPLICABILITY: 2019-22MY Ascent

NUMBER: 12-245-23

SUBJECT: Rubbing-Type Sound from Gear Selector Cover

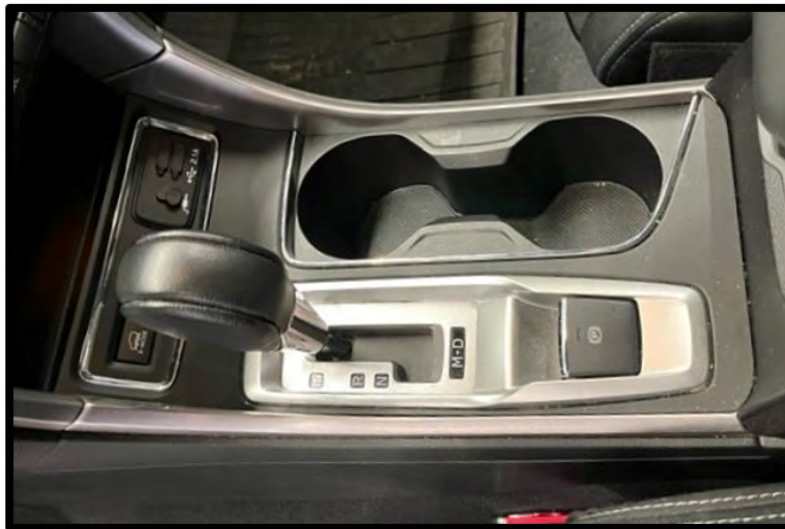
This bulletin announces the repair procedure for a rubbing-type sound that can be heard from the side of the console box when it comes in contact with a passenger’s knee or when the gear selector is moved. This is caused by the fitment between the gear selector cover and the console box. If this sound is duplicated the gear selector cover will require replacement.
