TECHNICAL SERVICE BULLETIN

Equipped With Hybrid Engines - Illuminated Powertrain Malfunction Indicator Lamp With DTC P0A1E In The PCM

23-2279

31 August
2023

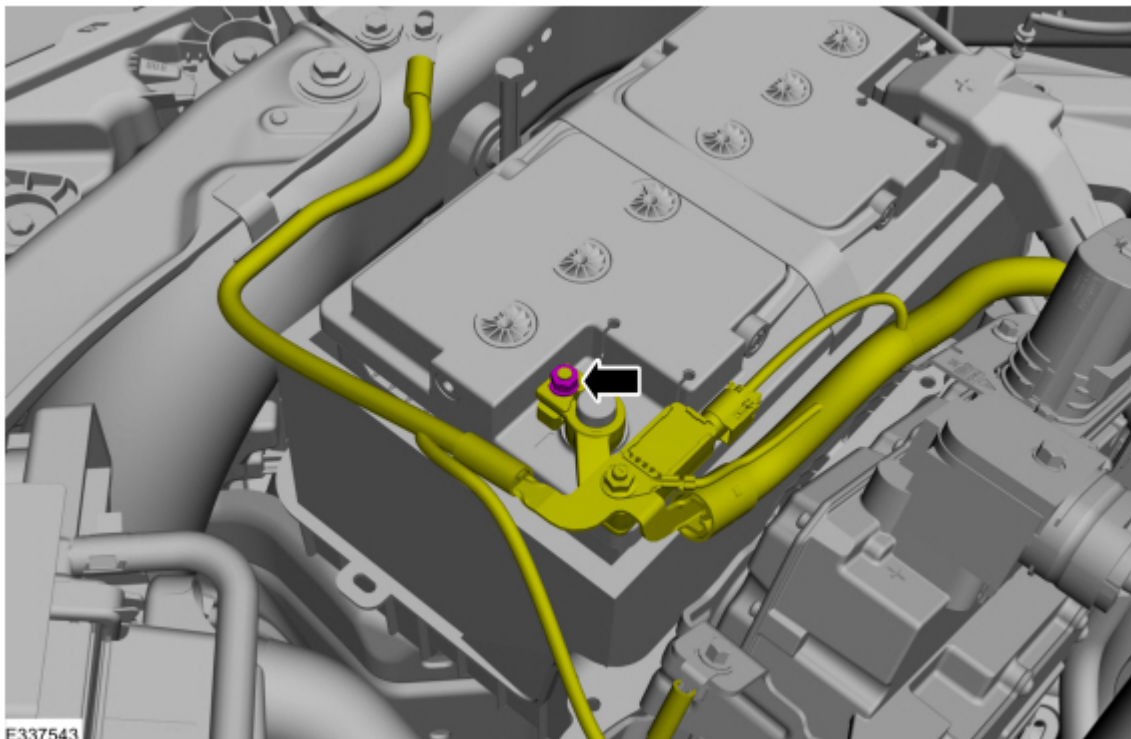
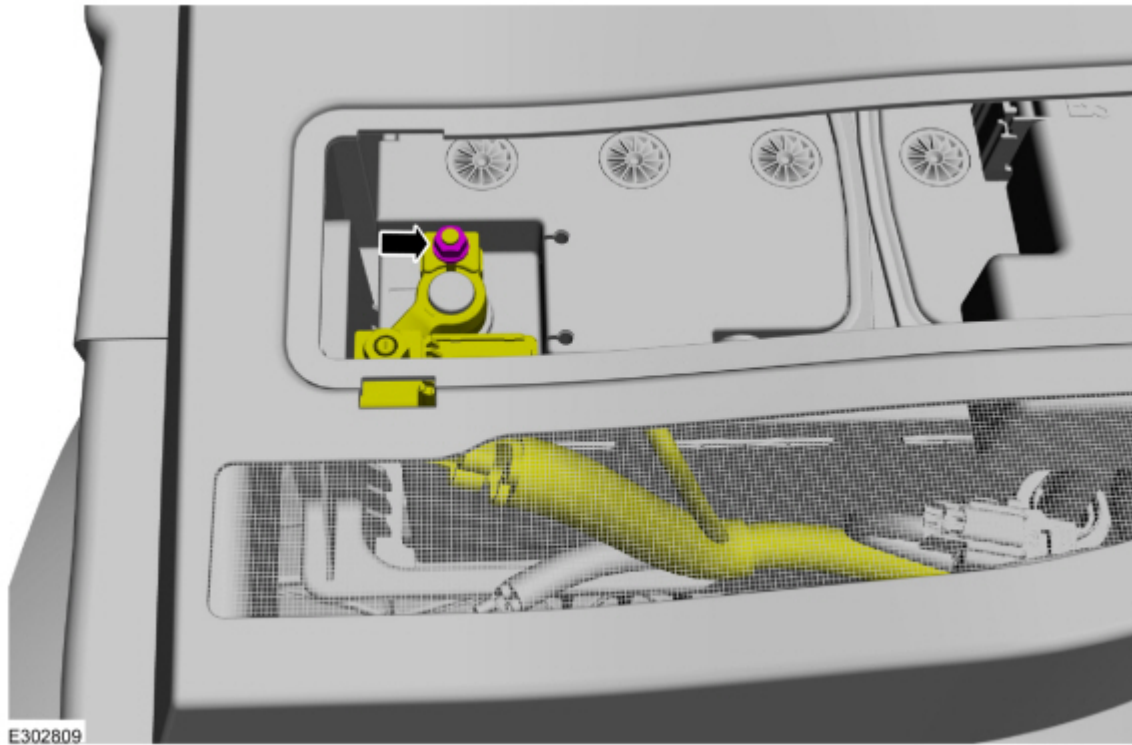
- (1). Yes - repair is complete.
 - (2). No - proceed to Step 5.
5. At the 12V battery negative post, inspect the nut securing the battery monitoring sensor to the negative battery post. (Figures 1-2) If it is loose, tighten the nut to the specified tightening value. Refer to WSM, Section 414-01 Battery, Mounting and Cables, General Procedures, Battery Disconnect and Connect.

- For F-150 vehicles with a 3.5L hybrid engine, tighten to 55 lb.in (6.2 Nm).
 - For Explorer/Aviator vehicles equipped with a hybrid engine, tighten to 48 lb.in (5.4 Nm).

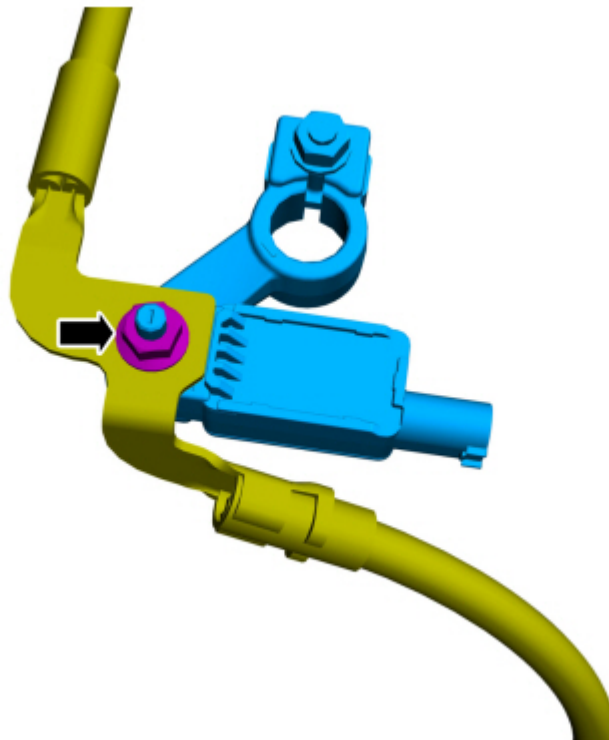
Figure 3

6. At the battery monitoring sensor, inspect the nut attaching the sensor to the ground cable. (Figure 3) If it is loose, tighten the nut to the specified tightening value. Refer to WSM, Section 414-01 Battery, Mounting and Cables, Removal and Installation, Battery Monitoring Sensor.

- For F-150 vehicles with a 3.5L hybrid engine, tighten to 97 lb.in (11 Nm).
- For Explorer/Aviator vehicles equipped with a hybrid engine, tighten to 80 lb.in (9 Nm).

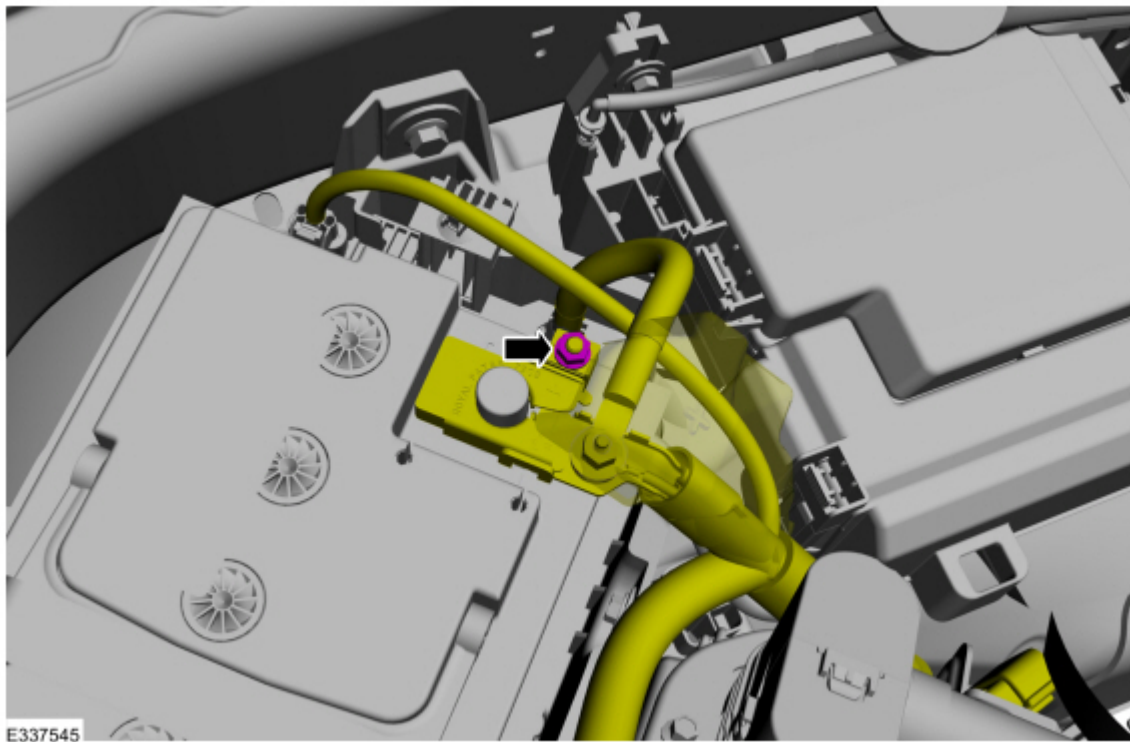
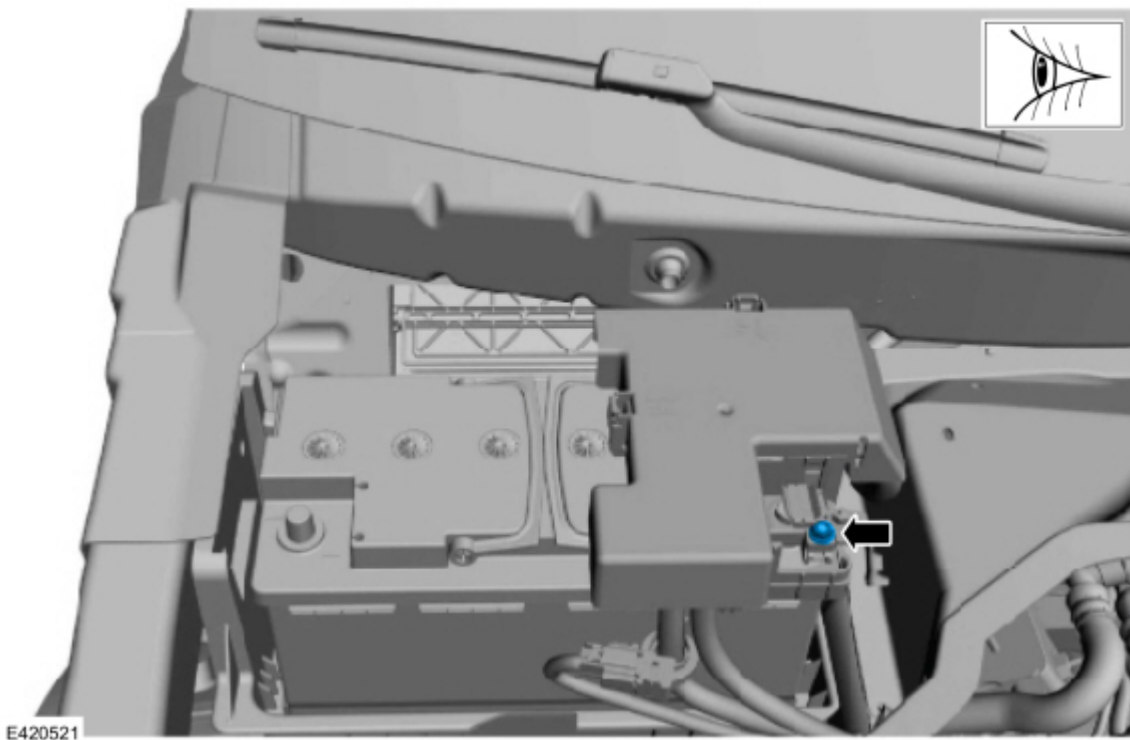
7. At the 12V battery positive post, inspect the nut securing the positive battery cable to the post. (Figures 4-5) If it is loose, tighten the nut to the specified tightening value. Refer to WSM, Section 414-01 Battery, Mounting and Cables, General Procedures, Battery Disconnect and Connect.

- For F-150 vehicles with a 3.5L hybrid engine, tighten to 55 lb.in (6.2 Nm).
- For Explorer/Aviator vehicles equipped with a hybrid engine, tighten to 48 lb.in (5.4 Nm).

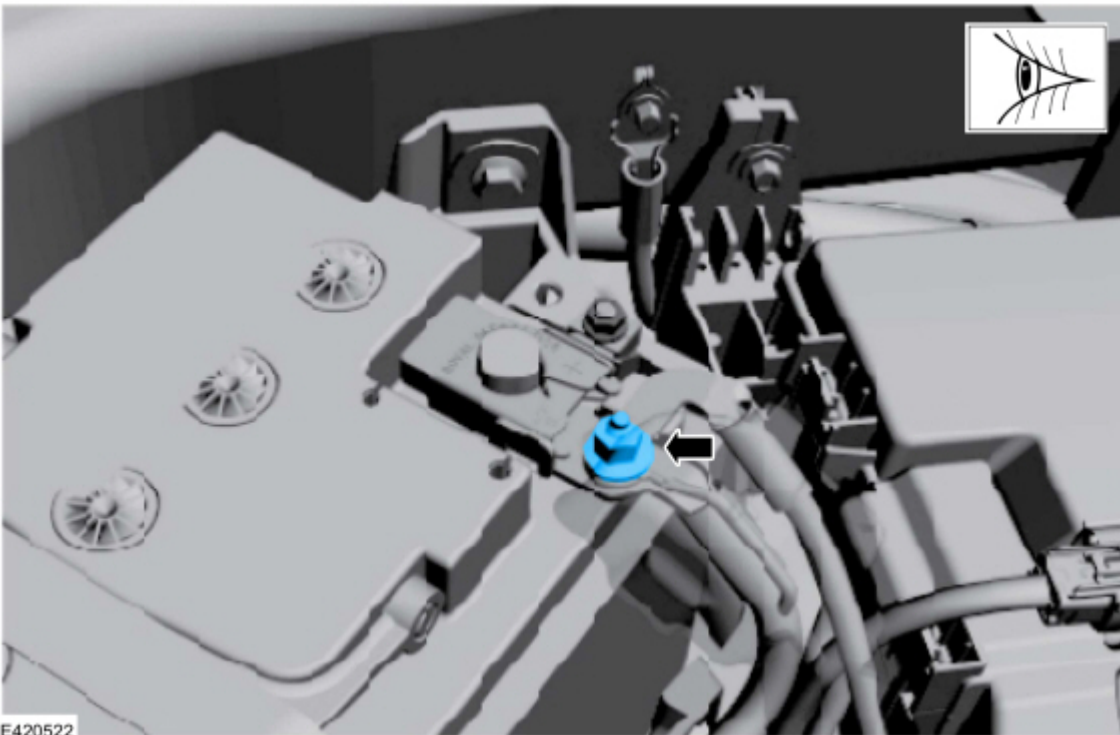
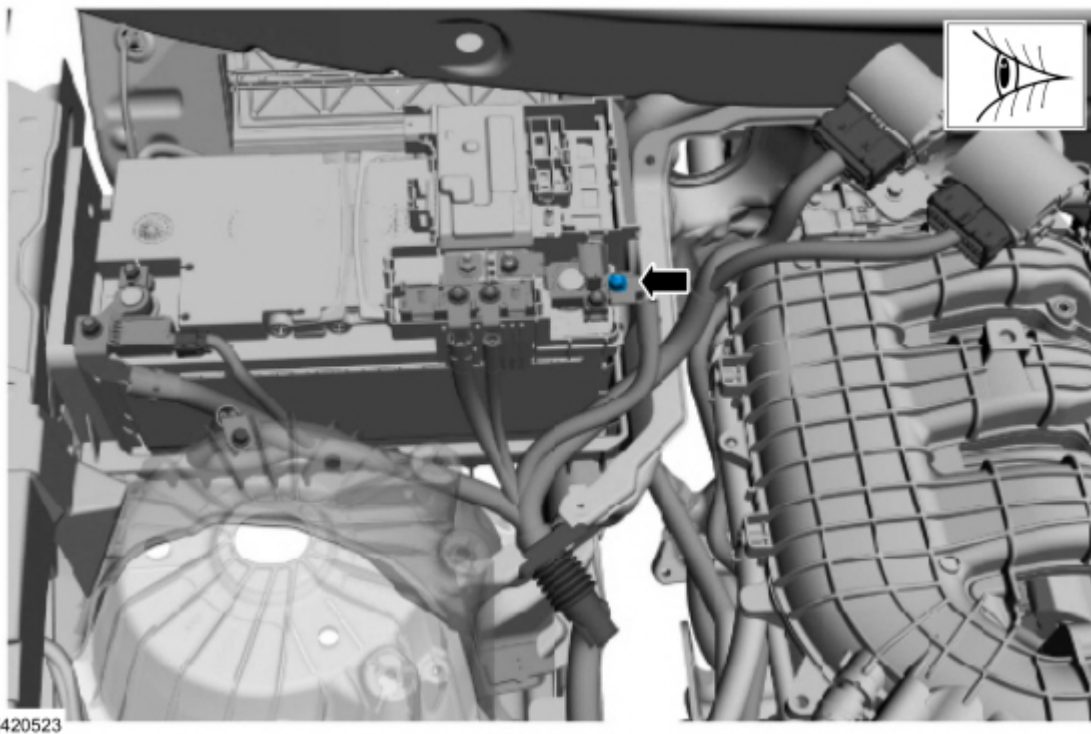
8. At the 12V battery positive post, inspect the nut securing the positive cable eyelet lug. (Figures 6-7) If it is loose, tighten the nut to the specified tightening value. Refer to 414-01, Battery, Mounting and Mounting Cables, Removal and Installation.

- For F-150 vehicles with a 3.5L hybrid engine, tighten to 80 lb.in (9 Nm).
- For Explorer/Aviator vehicles equipped with a hybrid engine: 80 lb.in (9 Nm).

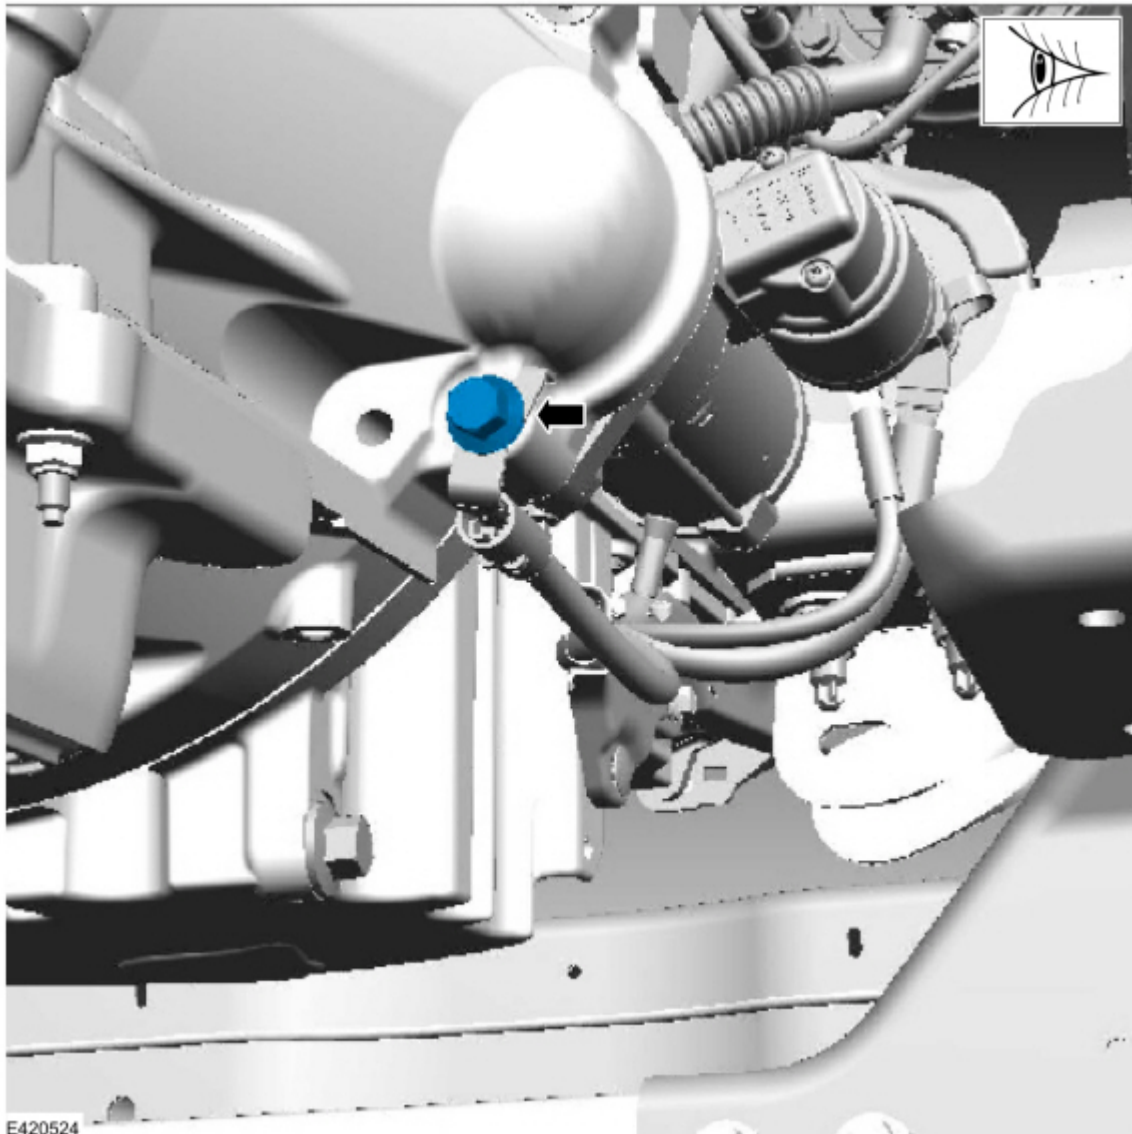
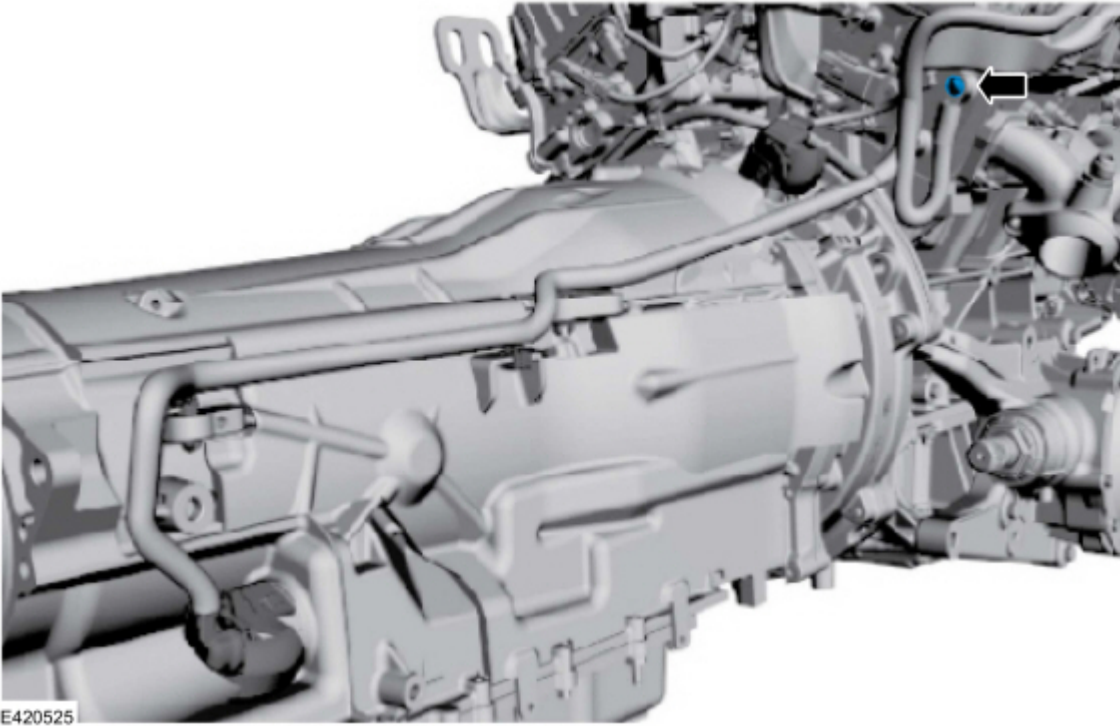
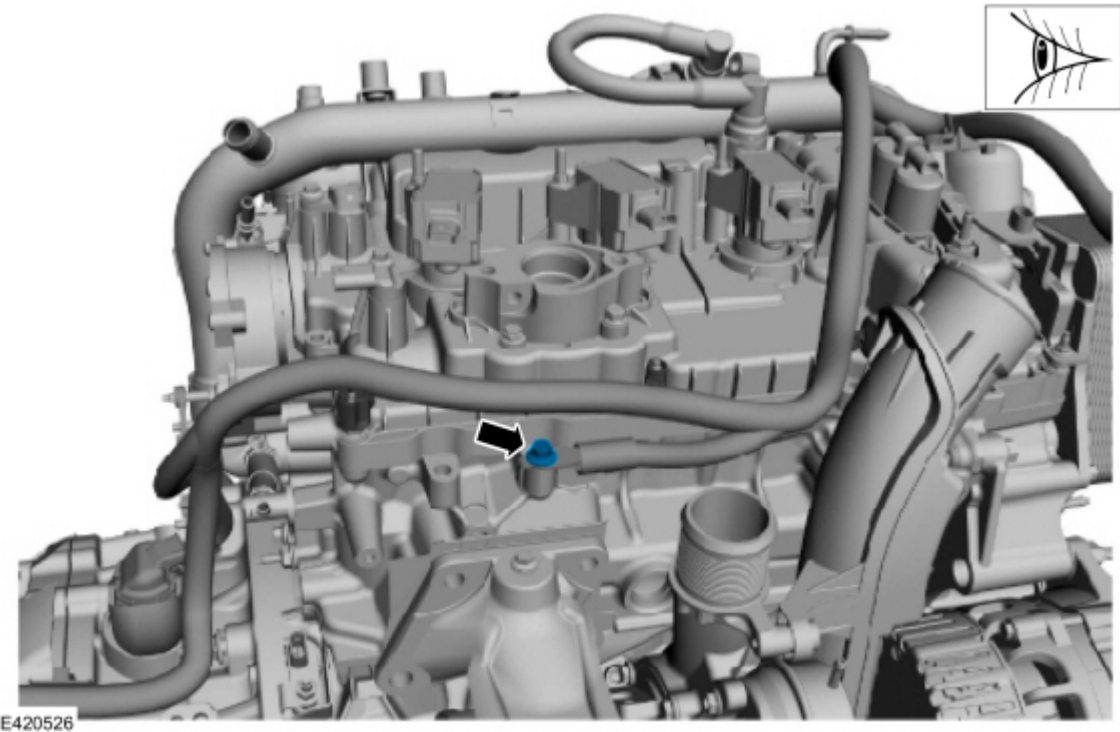
9. Inspect engine ground G105. (Figures 8-10) Refer to Wiring Diagram, Cell 010, G105. If it is loose, tighten the bolt to the specified tightening value.

- For F-150 vehicles with a 3.5L hybrid engine, tighten to 35 lb.ft (48 Nm).
- For Explorer/Aviator vehicles equipped with a hybrid engine, tighten to 106 lb.in (12 Nm).
