TECHNICAL SERVICE BULLETIN

Chassis Cab/Cutaway - False BLIS® Warning/Indication Or Too Sensitive While Driving - Built On Or Before 15-Mar-2023

23-2284

Ford 2023 Transit	Built on or before 15-Mar-2023
-----------------------------	--------------------------------

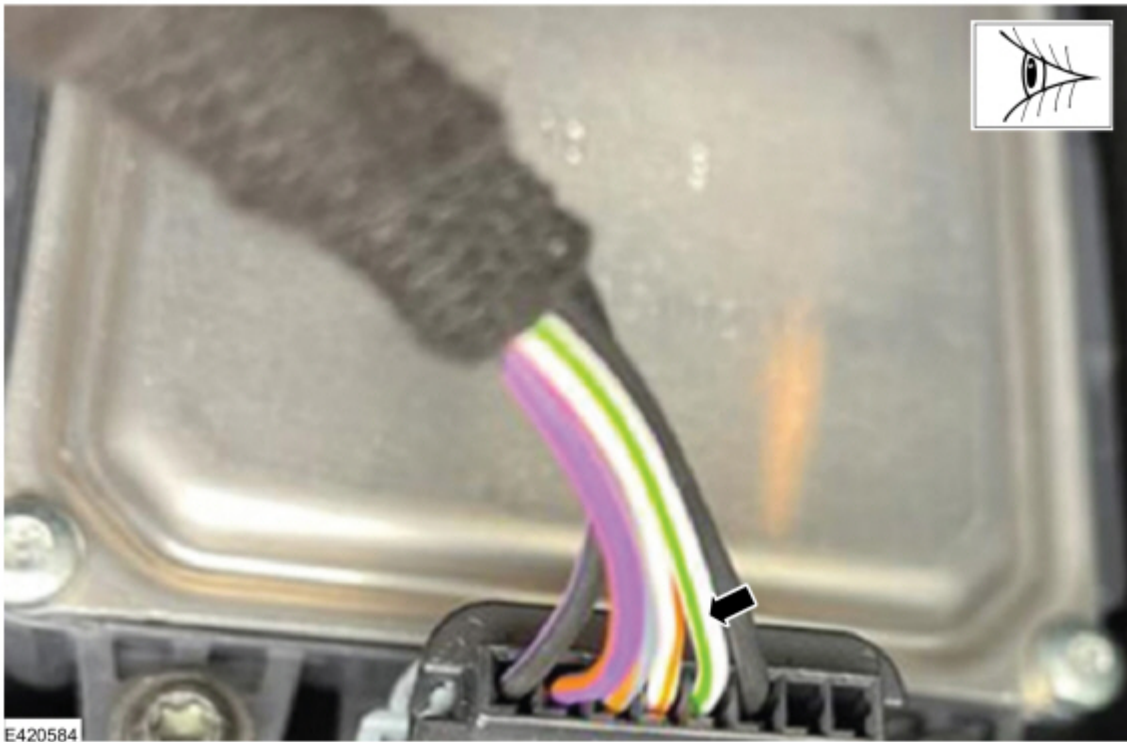
Figure 1

- (1). Yes - proceed to Step 3.
 - (2). No - the repair is complete.
3. Locate and remove both side obstacle detection control modules (SODR/SODL). Verify the connector C4369 with the circuit CRB03 (WH-GN) pin 4 is connected to the left side obstacle detection control module (SODL) and the connector C4370 with the circuit CRB01 (VT-BN) pin 4 is connected to the right side obstacle detection control module (SODR). (Figure 1 and 2). If the harness connectors are in the wrong SODL or SODR, unplug and install the connectors correctly, rerouting and securing the harness as necessary.
