# TECHNICAL SERVICE BULLETIN

## Rubber Seal Loose Between Spoiler Support And Liftgate

**23-2237**  
27 September  
2023

Lincoln 2019-2022 Nautilus
-------------------------------

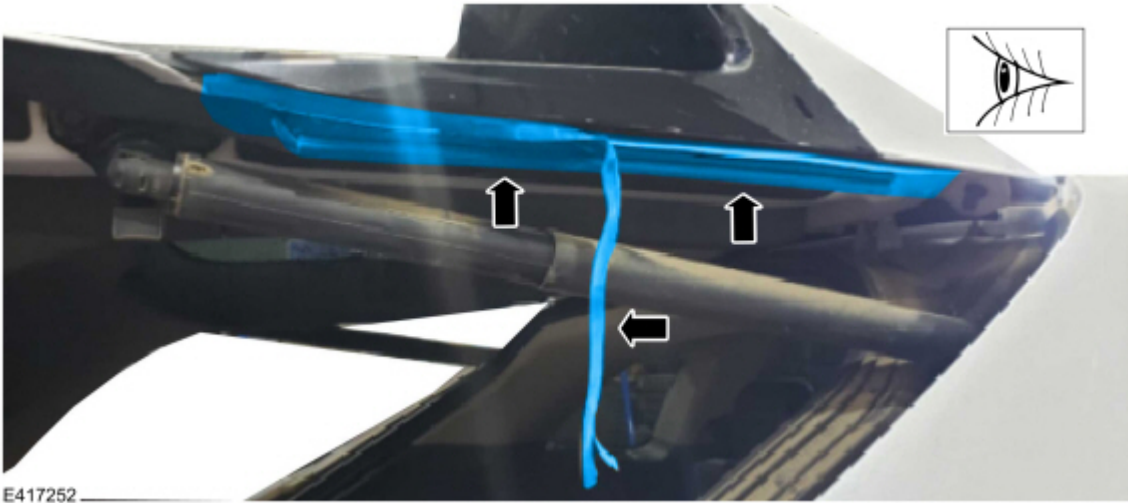
**Issue:** Some 2019-2022 Nautilus vehicles may exhibit the rubber seal between the spoiler support and the liftgate coming loose as shown in Figure 1. This may be due to poor adhesion between the spoiler and the rubber seal. To correct the condition, follow the Service Procedure to replace spoiler support rubber seal.

- 2019-2022 Nautilus
- Loose rubber seal between the spoiler support and the liftgate as shown in Figure 1

1. Remove the spoiler. Refer to Workshop Manual (WSM), Section 501-08 - Exterior Trim and Ornamentation - Removal and Installation - Rear Spoiler.
