TECHNICAL SERVICE BULLETIN

1.5L - Hissing Noise From Rear Liftgate Area When Driving Straight Between 35-50 MPH (56-80 Km/h)

23-2298
25 September
2023

Ford 2021-2023 Bronco Sport	Engine: 1.5L Built on 24-Jul-2021 and through 31-Aug-2023
---------------------------------------	--

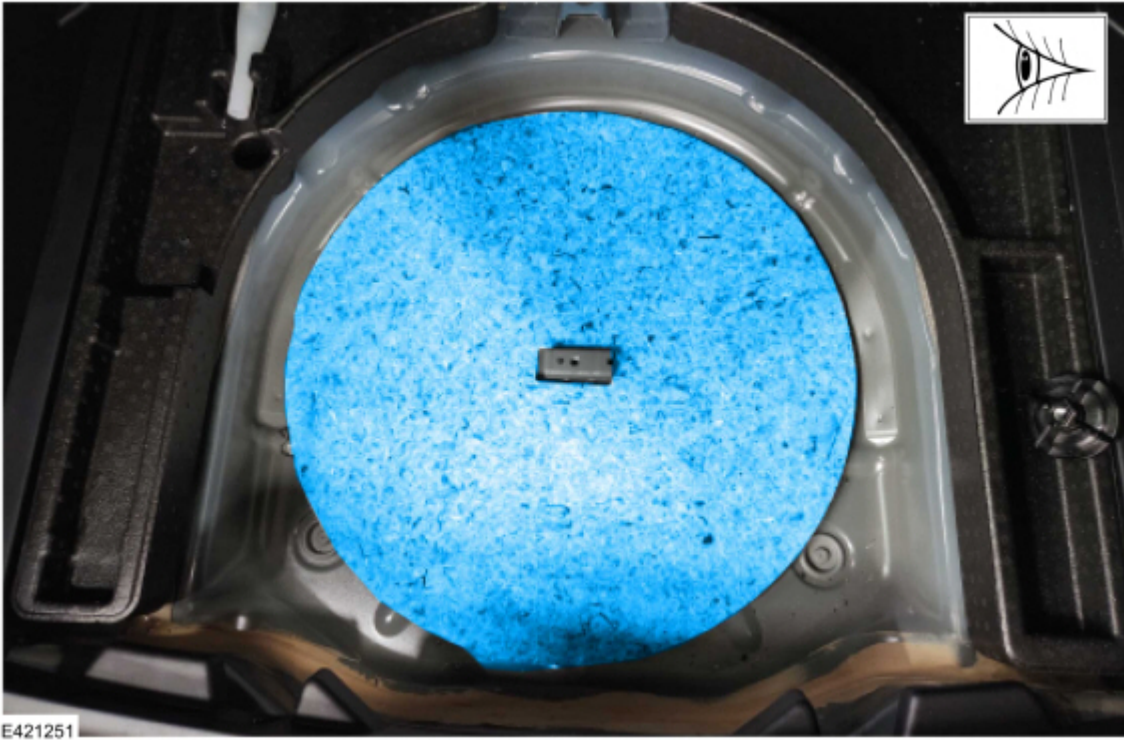
Figure 3

Issue: Some 2021-2023 Bronco Sport vehicles equipped with a 1.5L engine built on 24-Jul-2021 and through 31-Aug-2023 may exhibit a hissing noise from rear liftgate area when driving straight between 35-50 mph (56–80 km/h). This may be due to the absence of the rear floor insulator located in the spare tire compartment. To correct the condition, follow the Service Procedure to install a rear floor insulator in the spare tire compartment.

6. Install the rear floor insulator. (Figure 3)
