TECHNICAL SERVICE BULLETIN

Instrument Panel (IP) Topper Rub/Scratch/Buzz Noise From Right Front Passenger Side - Built On Or Before 29-June-2023

23-2311
02 October 2023

| Ford 2024 Mustang | Built on or before 29-June-2023 |

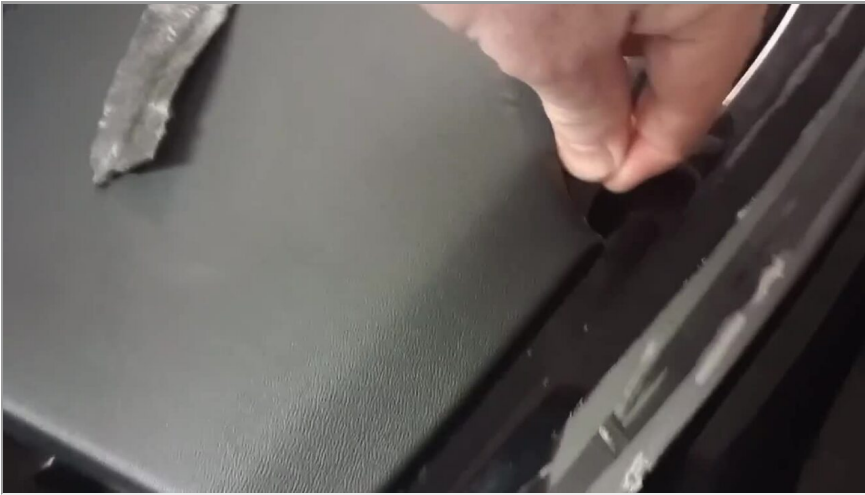
Video 1 - Example of IP topper scratch noise with windshield taken out

1. Does the IP topper make a rub/scratch/buzz noise from the forward right section directly adjacent to the defroster grille? Refer to Videos 1 and 2 for examples.

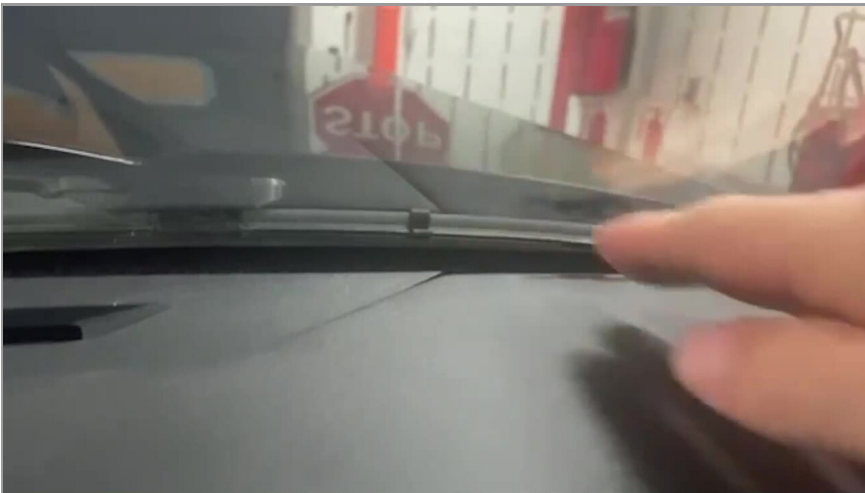
Video 2 - Example of the IP topper scratch noise in vehicle

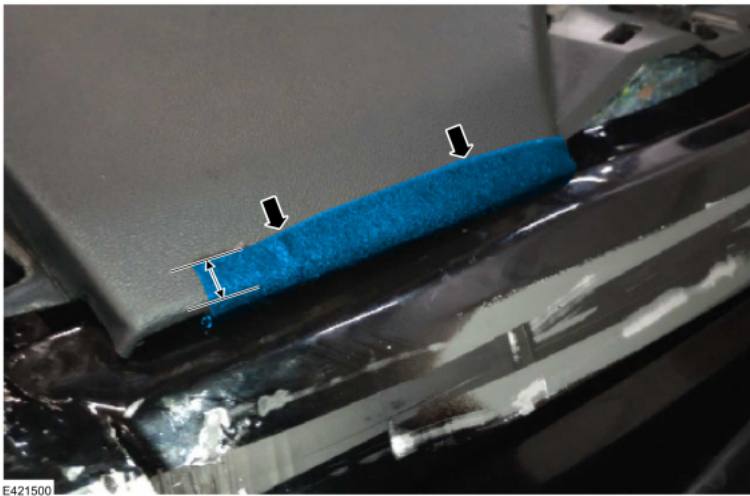
Figure 1 - View from right side of the vehicle with flock tape installed

5. Obtain a full section (6 in. long x 1.75 in. wide x .0625 in. thick) of flock tape (fuzzy) strip tape from the Rotunda Squeak and Rattle Kit or obtain flock tape separately from the kit. Wrap the flock tape around the leading edge of the IP topper as seen in Figures 1-2 with only 10 mm of the flock tape should be exposed on the top side of the IP topper, isolating the IP topper from directly touching the sheet metal.

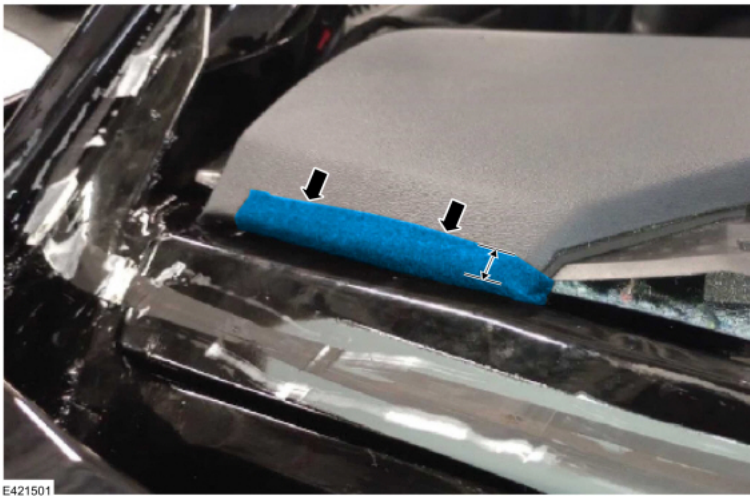
Figure 2 - View from left side of the vehicle with flock tape installed
