# TECHNICAL SERVICE BULLETIN

## Chatter/Shudder During Low Speed Turning Events

**23-2335**

26 October  
2023

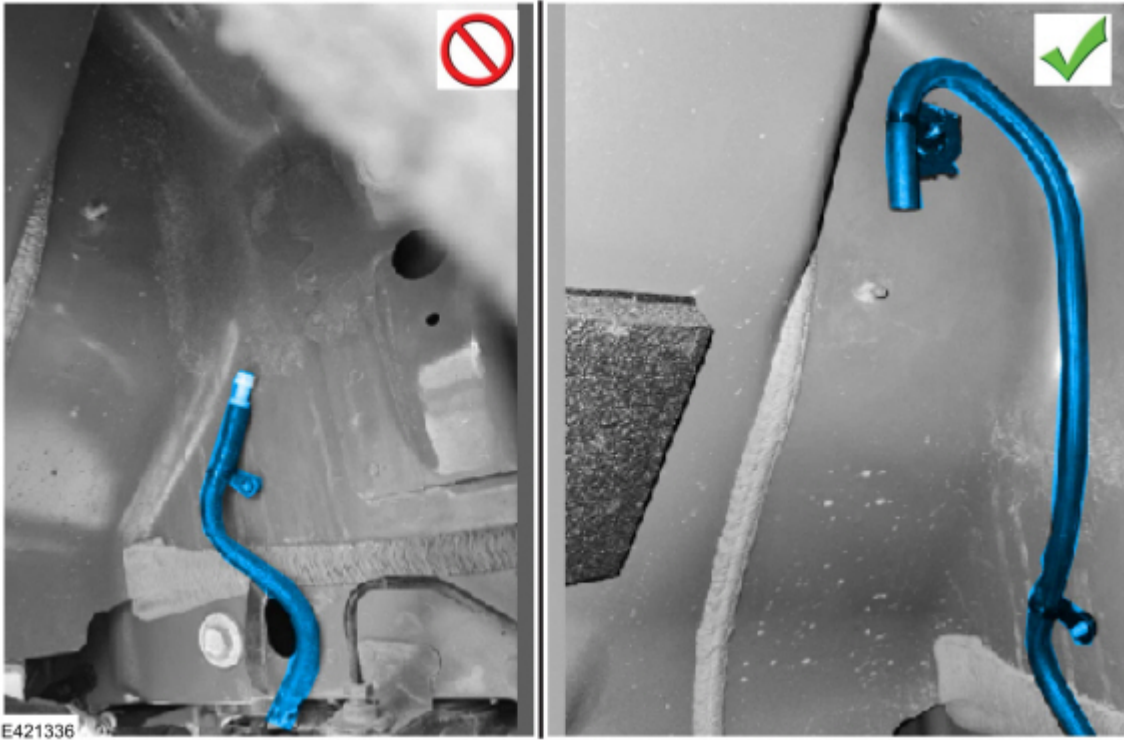
Figure 3

2. Inspect the RDU vent hose mounted behind the right rear fender splash shield. Is the vehicle equipped with the updated RDU vent hose as shown in the image with the green check mark in Figure 3?

- (1). Yes - this article does not apply. Continue with normal diagnosis.
  - (2). No - proceed to Step 3.
- 3.** Remove the right rear wheel. Refer to Workshop Manual (WSM), Section 204-04A.
  - 4.** Remove the retainers and screws from the right rear fender splash shield shown in Figures 4-6. Lower and fold the right rear fender splash shield in front of the brake caliper to access the RDU vent hose and upper section of the wheel well.
