# TECHNICAL SERVICE BULLETIN

## 2.7L/3.0L EcoBoost - Oil Pan Leaking

**23-2338**

30 October  
2023

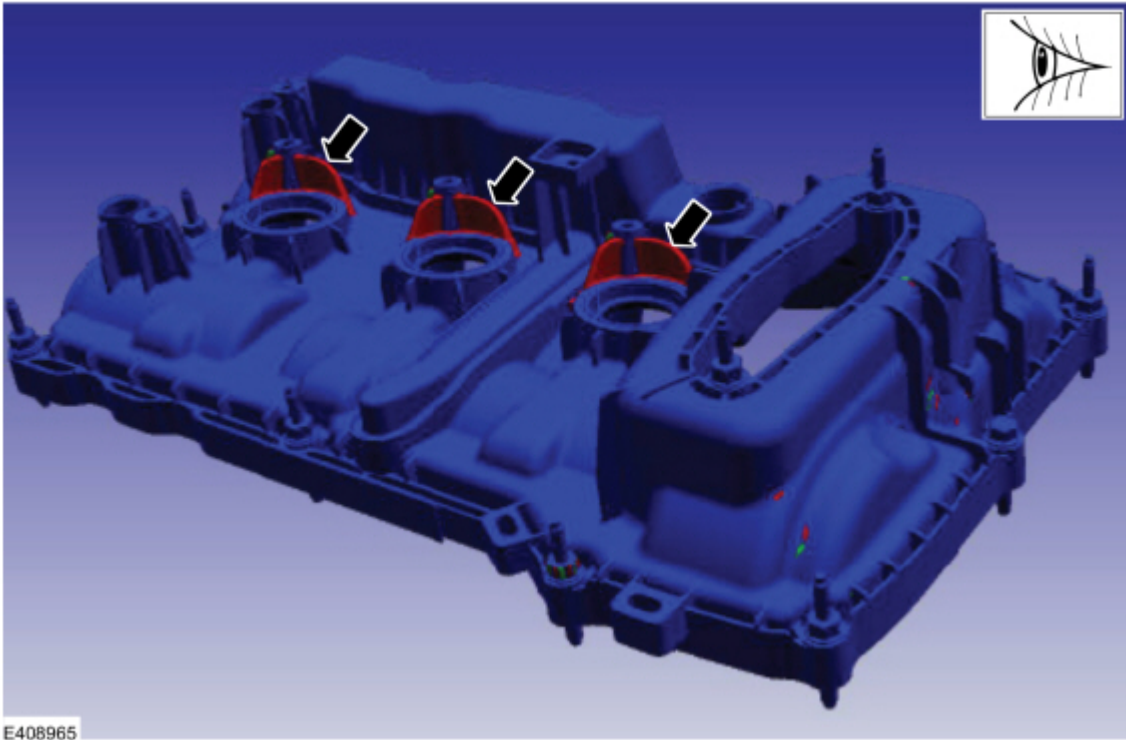
Figure 1

1. Inspect the valve cover design around the ignition coils on both sides. Does the coil location have the extended plastic protective ribbing as shown in red? (Figure 1)

(1). Yes - proceed to Step 3.

(2). No - proceed to Step 2.

2. Replace both valve covers. Refer to Workshop Manual (WSM), Section 303-01, Removal and Installation > Valve Cover LH and Valve Cover RH. Proceed to Step 3.
3. Remove and discard the oil pan and oil pump seal. Refer to WSM, Section 303-01, Removal and Installation > Oil Pan.
4. Clean and prepare the engine sealing surface. Refer to WSM, Section 303-00 General Procedures.
5. Install the new oil pump seal. Refer to WSM, Section 303-01, Removal and Installation > Oil Pan.
6. Apply a 18 mm (0.708 in.) bead of Motorcraft® High Performance Engine RTV Silicone to the oil pan where the front cover-to-cylinder block joint areas contact. (Figure 2)
