SERVICE BULLETIN

APPLICABILITY: 2019-23MY Impreza
 2019-23MY Crosstrek (Including Hybrid Model)
 2019-24MY Forester
 2019MY Legacy/ Outback
 2019-21MY WRX
 2019-21MY WRX STI
 2019-21MY BRZ- Navigation -equipped ONLY
 2019-22MY Ascent

NUMBER: 15-236-18R
DATE: 12/04/18
REVISED: 12/08/23

SUBJECT: Reprogramming File Availability for Optimization of Harman Gen 3.1 and Gen 3.1α Audio and Navigation Head Units

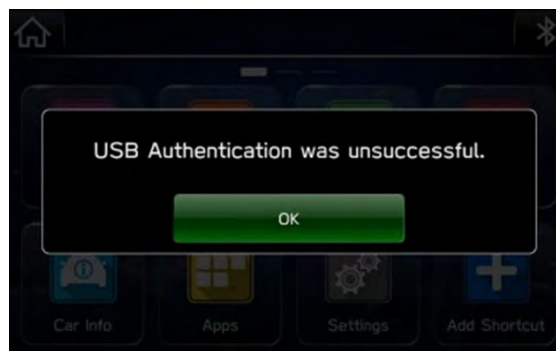
NOTE: If an attempt is made to install the wrong “grade” file into the wrong grade head unit (EXAMPLE: “Base” update file into a “Base Plus or Mid” or “High” head unit), the USB Authentication error screen below will be displayed:

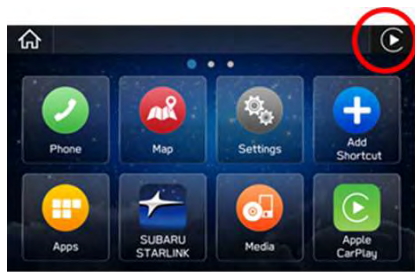
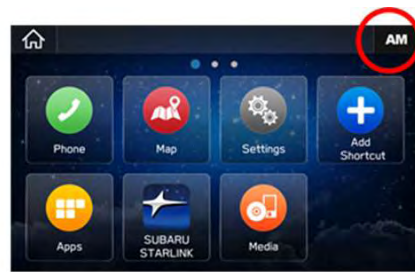
On Ver. 6.0 and before:

Music playing via iPhone in CarPlay.

After disconnecting, the music source changes to Radio automatically.

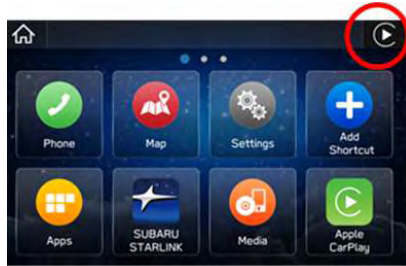
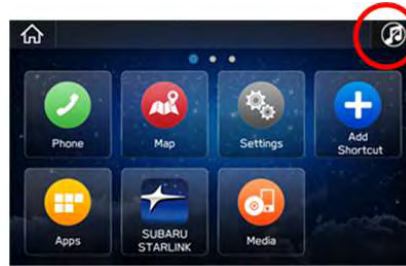
Music playing via iPhone in CarPlay.

After disconnecting, no music source is selected automatically.

If a source of music other than CarPlay has been playing when the iPhone is disconnected, the music source remains same (it is not turned off.)

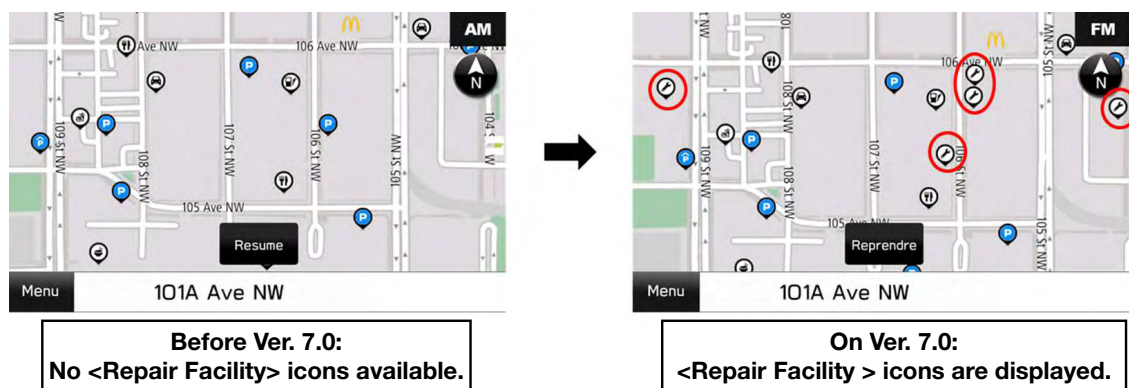
NOTE 4: Displaying Repair Facility POI icons:

<Repair Facility> Icons can be displayed in the NAVI Map.

<Repair Facility> Icons can be turned On or OFF by going to: Settings > Navigation > POI Icons.

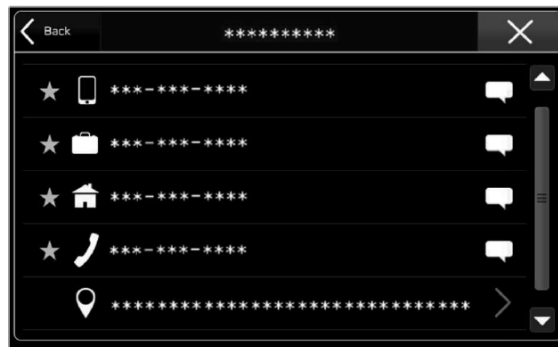
- 1) AM/FM radio station presets are lost.
- 2) Favorite Phone Contacts list is lost.

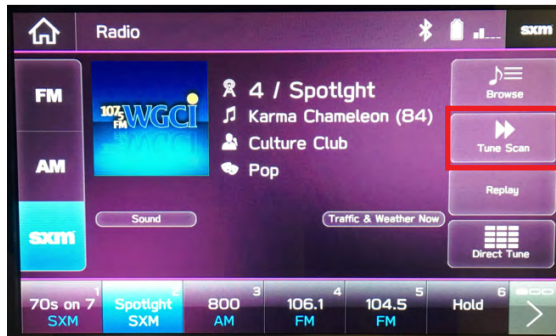
<Scan> previously displayed on SXM screen was changed to <Tune Scan> (a.k.a. SEEK).

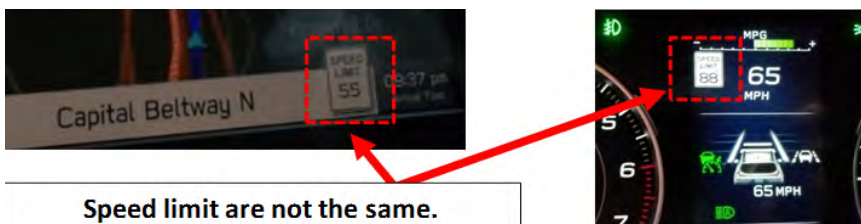
- 12) Mismatch of Speed Limit between Navigation display and the Speed Limit displayed in the Combination Meter Multi-Function Display (MFD).

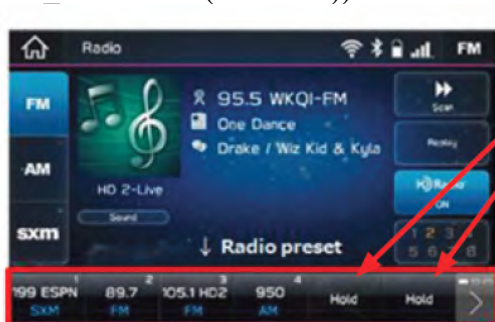
- 1) Station presets are lost. Touch buttons read “Hold”. (Applicable for software versions Rel_4.18.25.50 (or before)). Included in software version Rel_U1.18.38.50.
