# TECHNICAL SERVICE BULLETIN

## MT88 Manual Transmission - No 3rd Gear And/Or Grinding Noise Going Into 3rd And/Or 4th Gear

**23-2409**

Ford 2021-2023 Bronco	Transmission: MT88 Manual Transmission
--------------------------	--

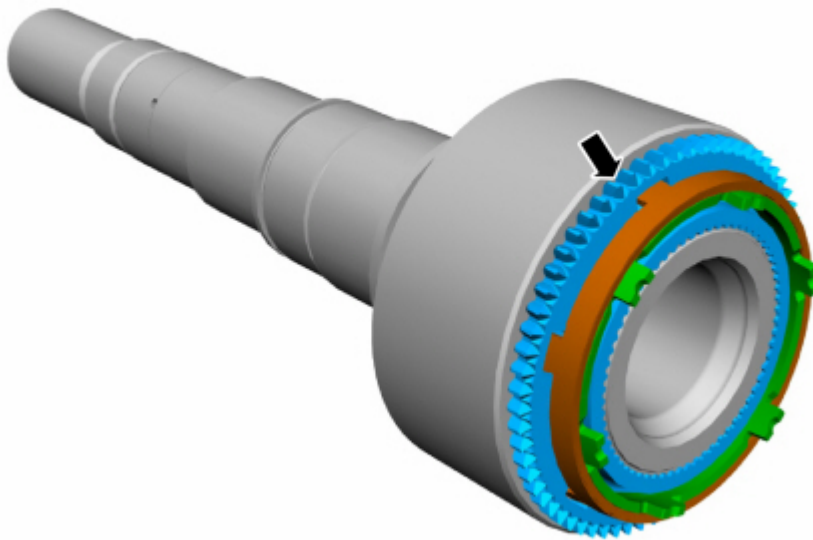
Figure 1

1. Remove the transmission from the vehicle. Refer to Workshop Manual (WSM), Section 308-03.
2. Disassemble the transmission. Refer to WSM, Section 308-03 > Disassembly > Transmission, Steps 1-34.
3. Remove the output shaft from the transmission case to gain access to the 3rd and 4th gears and synchronizer assemblies. Refer to WSM, Section 308-03 > Disassembly and Assembly of Subassemblies > Input Shaft, Steps 1-5.
4. Replace the following components and any associated damaged parts. Refer to WSM, Section 308-03.
  - 3rd gear.
  - Synchronizer assemblies for 3rd and 4th gears.
  - 4th gear synchronizer ring. (Figure 1)

- Inspect and replace any other damaged parts as needed.

**NOTE: 3rd gear is part of the input shaft. The 4th gear assembly is part of the output shaft assembly and does not require replacement, unless damage is found. In this transmission 4th gear uses a synchronizer ring to align the synchronizer assembly with the gear during shifts.**
