SERVICE INFORMATION BULLETIN

APPLICABILITY: 2023 Ascent

NUMBER: 18-233-23

SUBJECT: Service Manual Correction / 360 Surround Multiview Monitor

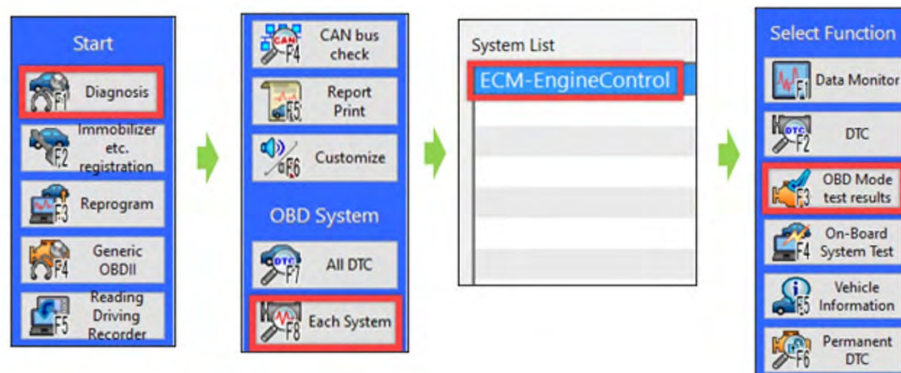
- Corrected icon position when CAN message error occurs.
