SERVICE BULLETIN

APPLICABILITY: 2019-21MY Crosstrek PHEV

NUMBER: 09-82-23

SUBJECT: DTC P0452 EVAP System (CPC) Pressure Sensor/Switch Circuit Low
Design Changes to Fuel Tank Assembly & Vent Tubes

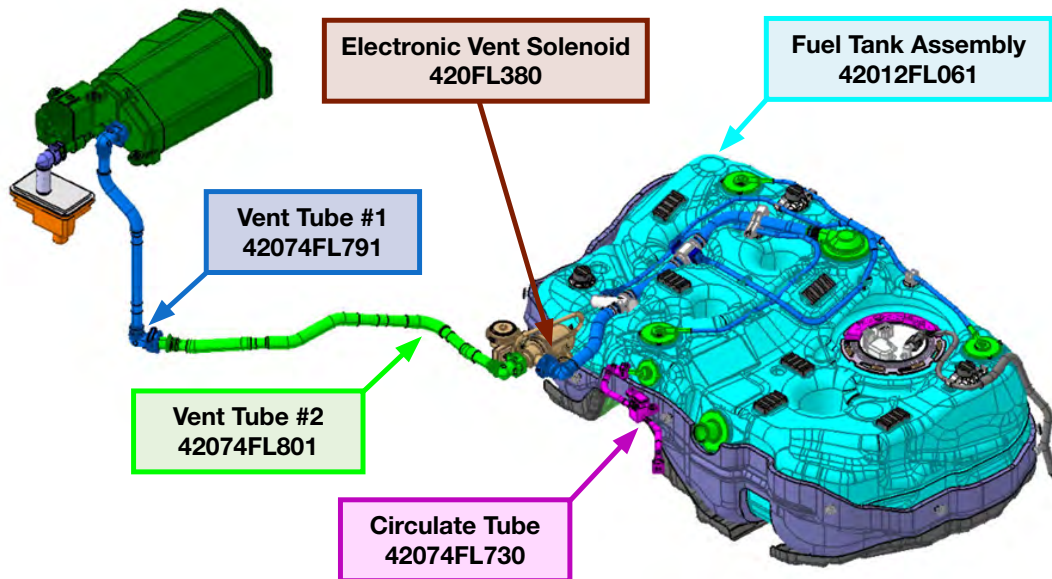
PART INFORMATION:

IMPORTANT NOTE: No design changes were made to the Circulate Tube or the Electronic Vent Solenoid.

Part Description	Part Number
TANK COMPLETE-FUEL	42012FL061
TUBE-AIR VENT	42074FL791
TUBE-AIR VENT	42074FL801
TUBE ASSEMBLY	42074FL730
VALVE-VENT	42084FL380

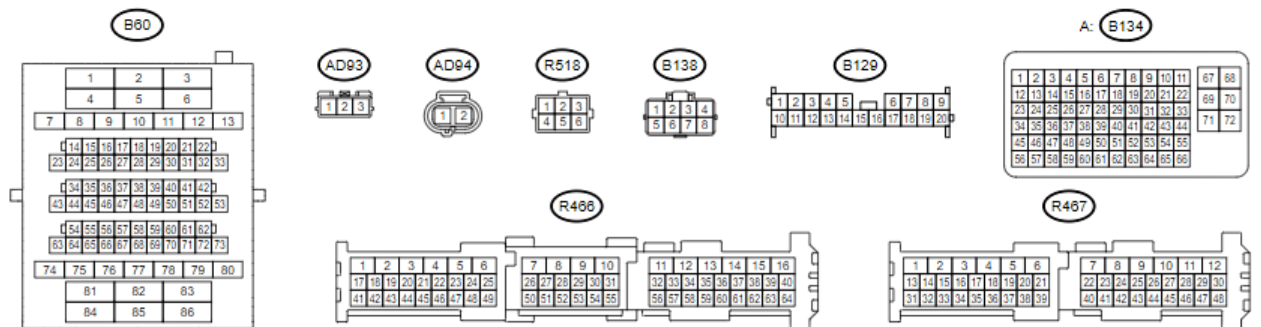
Wiring Diagram:

Check the Tank Pressure Sensor power supply for short to ground (see wiring diagram provided below).

Connector & Terminal (AD93) No. 3 (+) – Chassis Ground (-):
Is the voltage 4.5 Volts or more?
