SERVICE BULLETIN

Classification: TF02-001	Reference: NTB02-019	Date: February 19, 2002
-----------------------------	-------------------------	----------------------------

1999-2002 FRONTIER & 2000-2002 XTERRA "BEARING NOISE" FROM TRANSFER CASE AREA

APPLIED VEHICLES: 1999-2002 Frontier (D22)
2000-2002 Xterra (WD22)

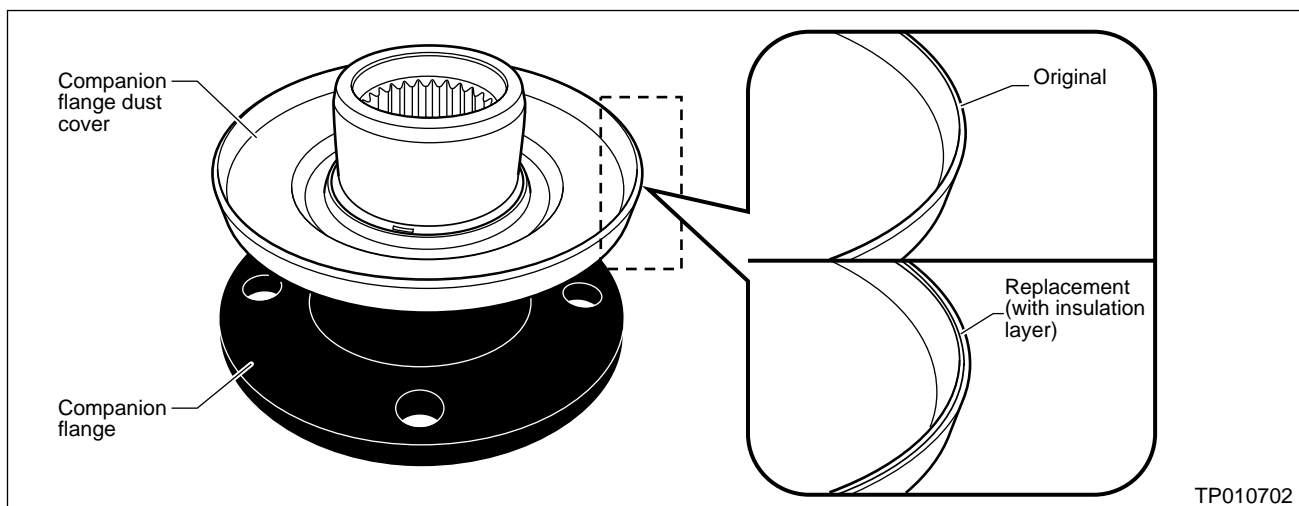
Figure 1

The original transfer case companion flange dust cover may be amplifying the sound of the bearing.

- A replacement companion flange designed to dampen the noise emitted from the bearing, should it occur, has been developed (see Figure 1).
- Use the Service Procedure provided in this bulletin to verify and repair this incident, if it should occur.

3. Install the replacement companion flange and self-locking nut (see the PARTS INFORMATION section for more information) and re-assemble the parts removed in Step 2 in reverse order. Torque the self-locking nut to 226-324 N-m (23.0-33.0 kg-m, 166-239 ft-lbs.)
