SERVICE BULLETIN

EM02-001

April 10, 2002

COOLANT LEAK FROM INTAKE MANIFOLD WATER OUTLET

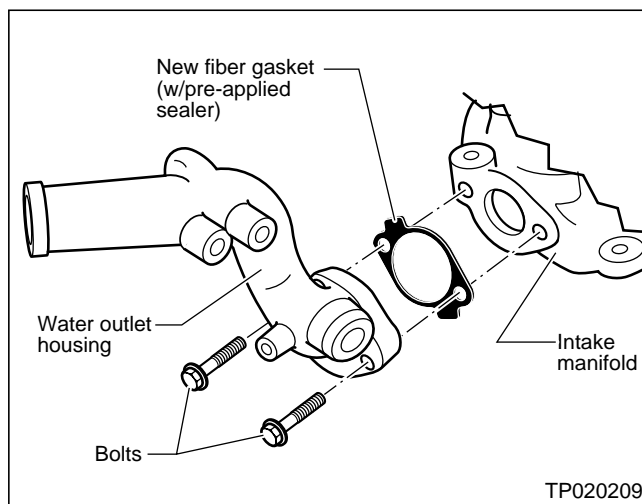
Figure 1

The cause may be coolant leaking between the water outlet housing and intake manifold sealing surfaces (see Figure 1). Refer to the Service Procedure on page 2 to resolve this incident, should it occur.

NOTE: A leak from the above noted area can be verified by a visual inspection.

Install the new fiber gasket (refer to the Parts Information section) between the water outlet housing and intake manifold as follows:

1. Verify the coolant leak **is** coming from the water outlet housing/intake manifold sealing surfaces.
2. Use the valve on the lower radiator tank to drain coolant, into a clean bucket (or other clean, suitable container), to just **below** the level of the water outlet housing.

3. Remove parts necessary to access the water outlet housing.
4. Remove the water outlet housing from the intake manifold.
5. Thoroughly clean the sealing surfaces of the water outlet housing and intake manifold, making sure **all** old sealer is completely removed.
6. Install the new fiber gasket onto the water outlet housing as follows:
 - A. First, install the two mounting bolts through the holes in the water outlet housing.
 - B. Then, slide the fiber gasket over the bolts until it is flush against the sealing surface of the housing. The bolts will keep the gasket in place while installing the housing.
7. Install the water outlet housing to the intake manifold and tighten the bolts to 16.3 – 20.3 N-m (1.7 – 2.1 Kg-m, 12 – 15 ft-lbs).
8. Re-install all components that were previously removed.
9. Re-fill the radiator:
 - With the coolant that was drained and captured in step 2
