SERVICE BULLETIN

Classification: BR02-003	Reference: NTB02-080	Date: July 24, 2002
-----------------------------	-------------------------	------------------------

2001-02 FRONTIER/XTERRA ABS WARNING LIGHT DIMLY LIT

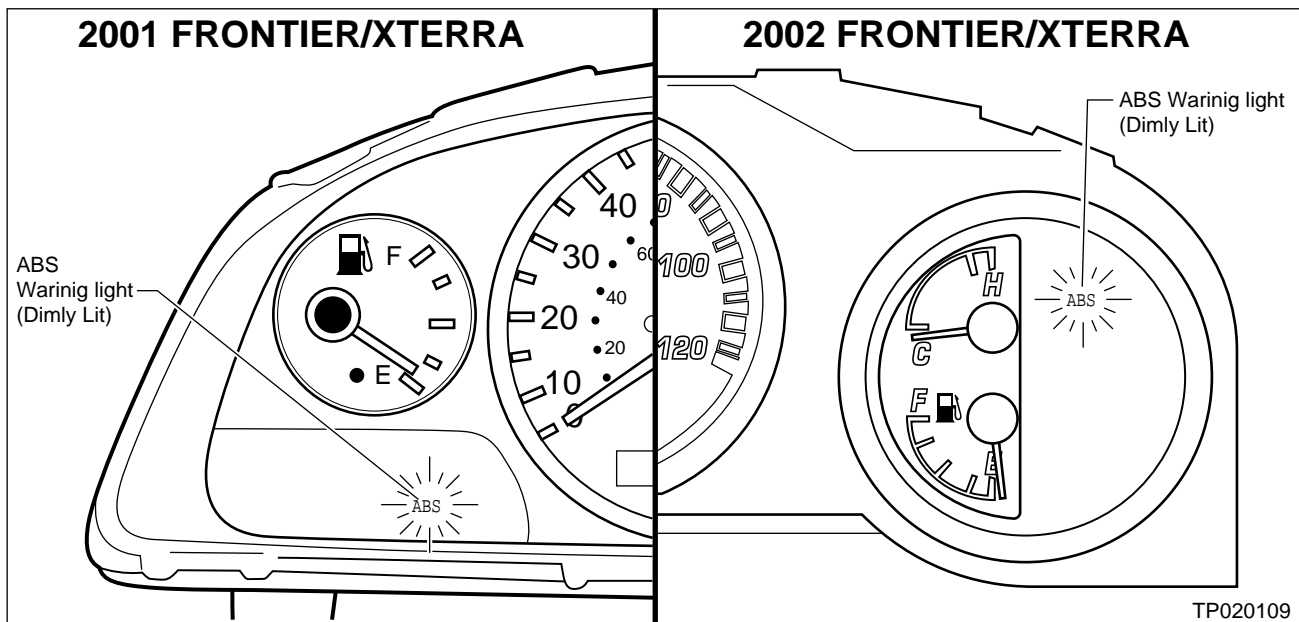
Figure 1

If an applied vehicle has an Anti-Lock Brake System (ABS) warning light (see Figure 1) that is **dimly** lit when:

- The engine is not running but the ignition key is in the "ON" position
- The engine is running,

NOTE: The vehicle may have to be in a shaded area to see the dimly lit ABS warning light.

Perform the Service Procedure on page 2.
