# SERVICE BULLETIN

Classification:	Reference:	Date:
EM06-004b	NTB06-072b	September 3, 2009

## DRIVE BELT NOISE

**APPLIED VEHICLES:** 2005 – 2008 Xterra (N50)  
 2005 – 2008 Pathfinder (R51)  
 2005 – 2008 Frontier (D40)

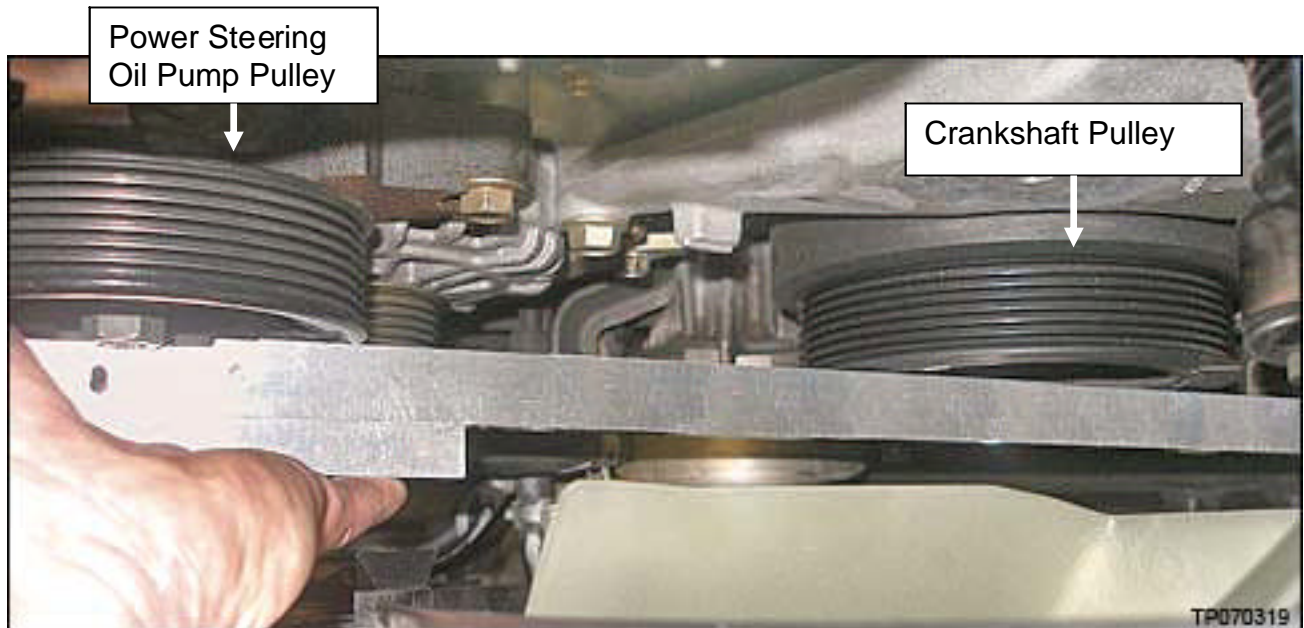
Figure 1

5. Using a straightedge (or other equivalent tool), visually check the power steering oil pump pulley and crankshaft pulley alignment. The pulleys should be evenly aligned as shown in Figure 1.

- If the pulleys are not evenly aligned, go to Step 6.
- If the pulleys are evenly aligned, go to Step 12.
