# SERVICE BULLETIN

Classification: EM16-005	Reference: NTB16-083	Date: August 23, 2016
-----------------------------	-------------------------	--------------------------

## 2013 – 2015 SENTRA; REAR TORQUE ROD SERVICE

**APPLIED VEHICLE:** 2013-2015 Sentra (B17)

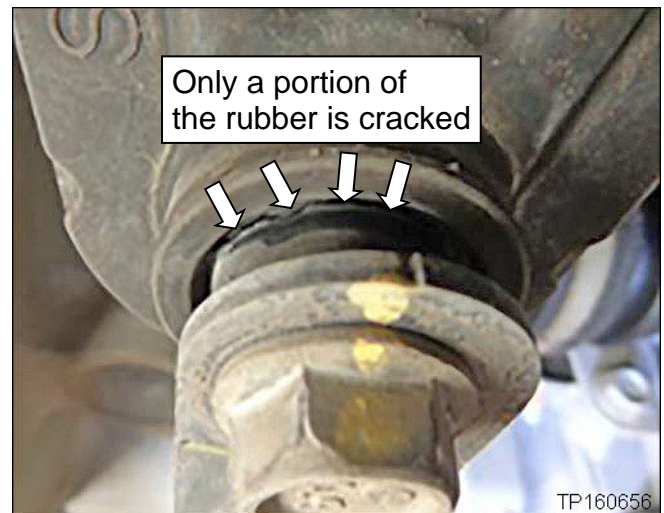
Figure 1 shows a crack in the rubber of the forward end of the rear torque rod that **does not extend** the complete circumference (all the way around) the rubber. This may occur during normal service life.

- **Do not** replace the torque rod for a crack that **does not** extend all the way around the rubber part of the forward end.
