**Technical Service
Information Bulletin**

Title:
HEAT SHIELD RATTLE

Models:
'02 ES 300

NV001-02

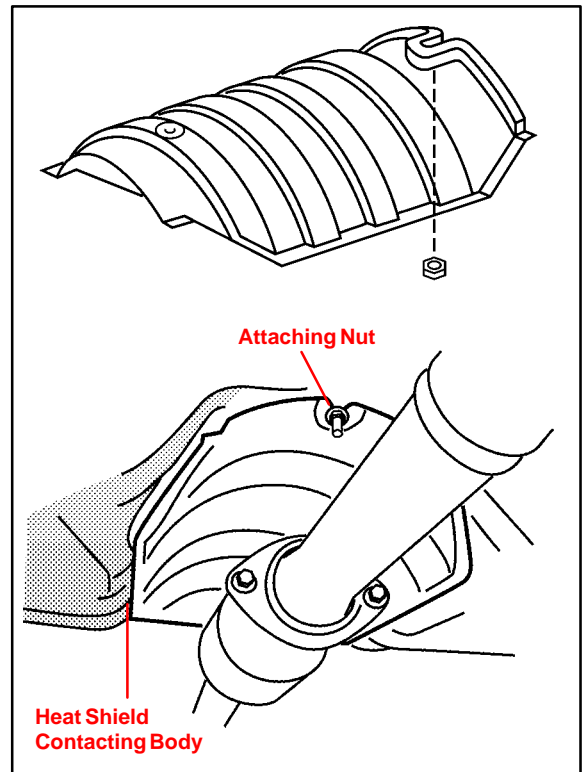
Introduction Under certain conditions, the heat shield for the catalytic converter on some 2002 model year ES 300 vehicles may be the source of a rattling sound. This rattle noise is most noticeable when driving at vehicle speeds above 50 mph, at which time, the air passing under the vehicle may cause the heat shield to vibrate and contact the body. As a result of this, the heat shield may generate a metallic rattle that sounds like it emanates from the dash or center console area.

1. While wearing work gloves, loosen the two nuts that attach the heat shield to the vehicle body.
