Technical Service BULLETIN

HEAT SHIELD RATTLE

'02 Camry

REVISED
NV002-02
NVH

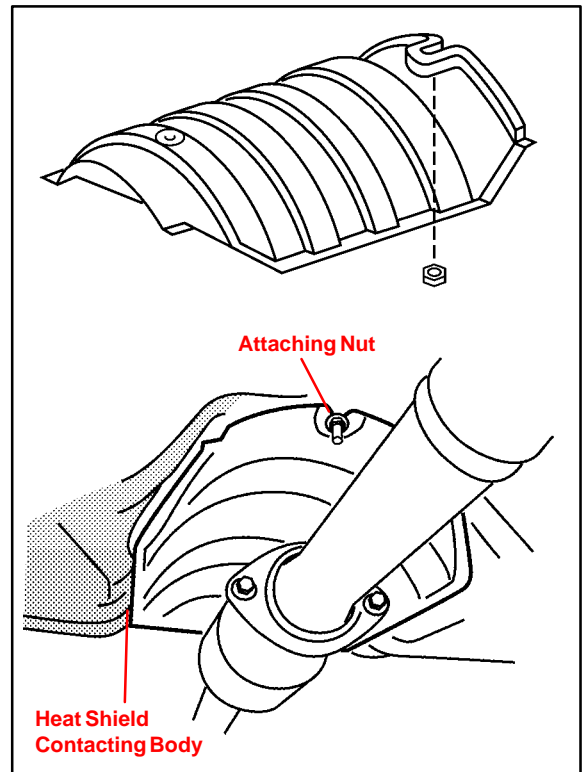
Introduction Under certain conditions, the heat shield for the catalytic converter on some 2002 model year Camry vehicles may be the source of a rattling sound. This rattle noise is most noticeable when driving at vehicle speeds above 50 mph, at which time, the air passing under the vehicle may cause the heat shield to vibrate and contact the body. As a result of this, the heat shield may generate a metallic rattle that sounds like it emanates from the dash or center console area.

1. While wearing work gloves, loosen the two nuts that attach the heat shield to the vehicle body.
