TO: Mercedes-Benz Dealer Principals, General Managers, Sales Managers, Service Managers, Parts Managers	FROM: Gregory Gunther, Department Manager, Vehicle Compliance and Analysis, Engineering Services
RE: Service Campaign Launch Notification Wiper Alignment MY19 177 (A-Class)	DATE: March 26, 2020

Service Campaign Launch Notification

Wiper Alignment

SUBJECT: **Model A-Class vehicles (177 platform)**
Model Year 2019
Wiper Alignment

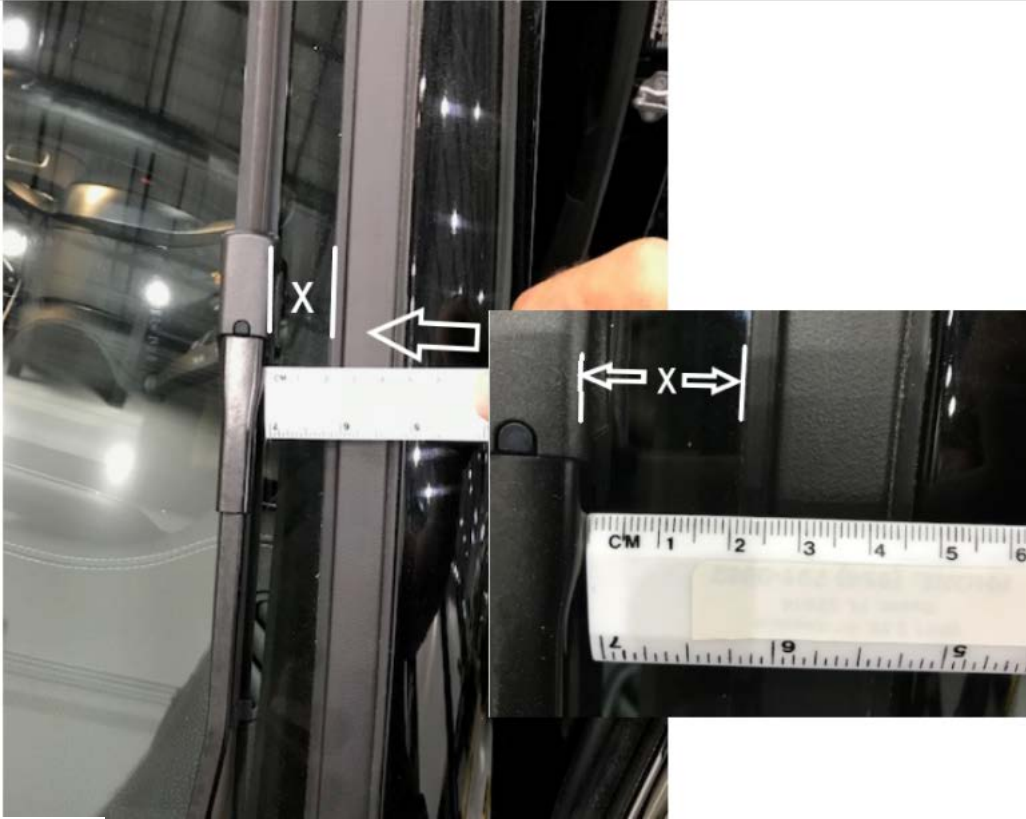
Figure 1

i Check Distance of driver-side wiper arm in the upper position to A-pillar (X, Figure 1) 22mm (-3/+4).

- a. If x is outside tolerance range (22 mm -3/+4mm) than **NOK**. Wiper arm setting **not** correct: Carry out **work procedure**.
- b. If x is within tolerance range (22mm -3/+4mm) Wiper arm setting correct: **End measure**.

1. Replace driver-side wiper arm.

i The wiper arm cannot be adjusted and must be replaced
