Campaign No. 2020030015, April 2020

SUBJECT: Model G-Class vehicles (463 platform)

Model Year 2019

Fuel Line Coating

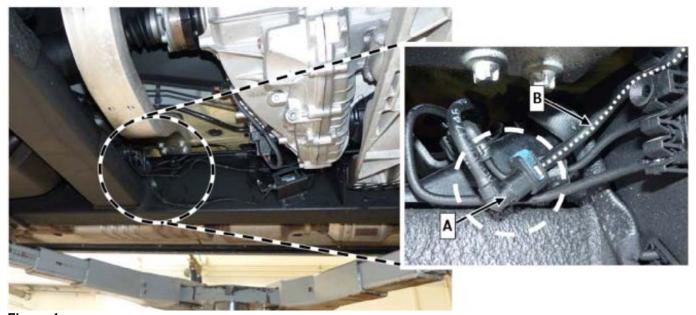
Figure 1

- 1. Lift vehicle with the drive-on lifting platform (vehicle inspection for example).
 - i Leave the ignition switched on!
- 2. Check leak tightness of the connector coupling (A, figure 1) of the fuel line (B, figure 1).
- i If the connector coupling (A, figure 1) is *leaky*, fuel will be visible "sweating" or "forming droplets".

- a. Connector coupling *leaky*: Perform Work procedure.
- **b.** Connector coupling not leaky: **End measure**.
