WORK DESCRIPTION FOR FIELD MEASURE

Code: 20P8891003

Check bumper impact absorber, retrofit if necessary

Model 190

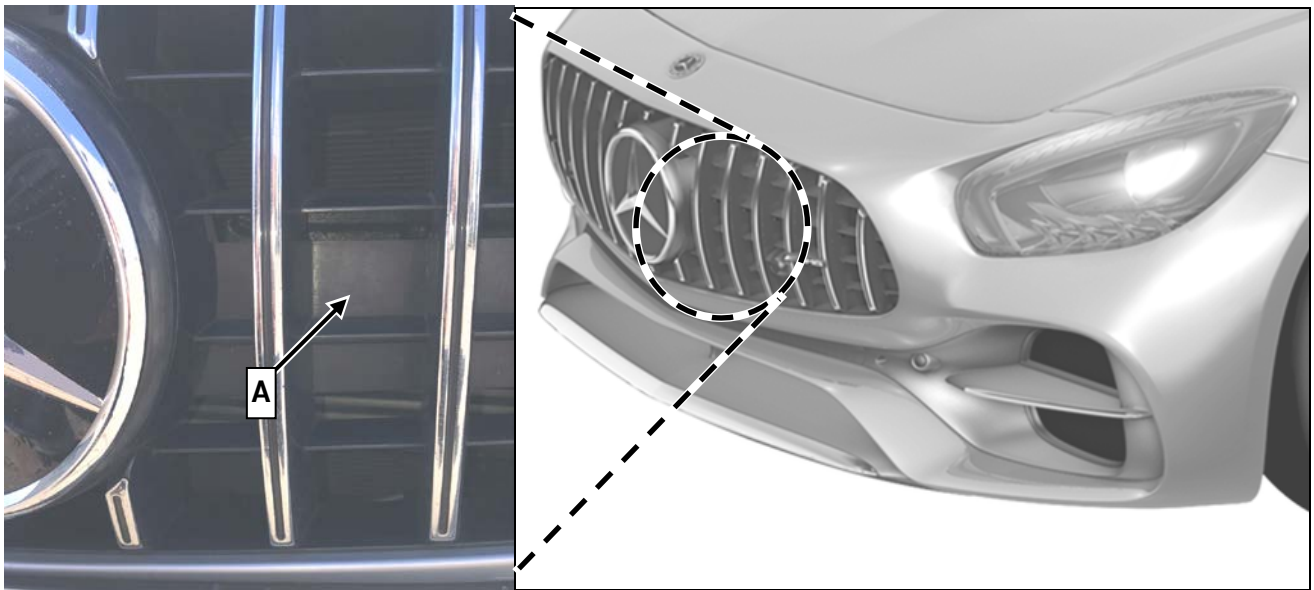
Figure 1

1. Check whether the impact absorber (A, Figure 1) is installed.
i Perform a visual inspection through the radiator grille.

- a. Impact absorber (A, Figure 1) installed: **End measure.**
- b. Impact absorber (A, Figure 1) **not** installed: **Carry out work procedure.**

1. Remove bumper.
i For basic data, see AR88.20-P-2000RG.
2. Install impact absorber and bumper support.
3. Assemble in reverse order.
